30013602

19 January 2024

RE: Terania Street Bridge – Structural soundness following impact

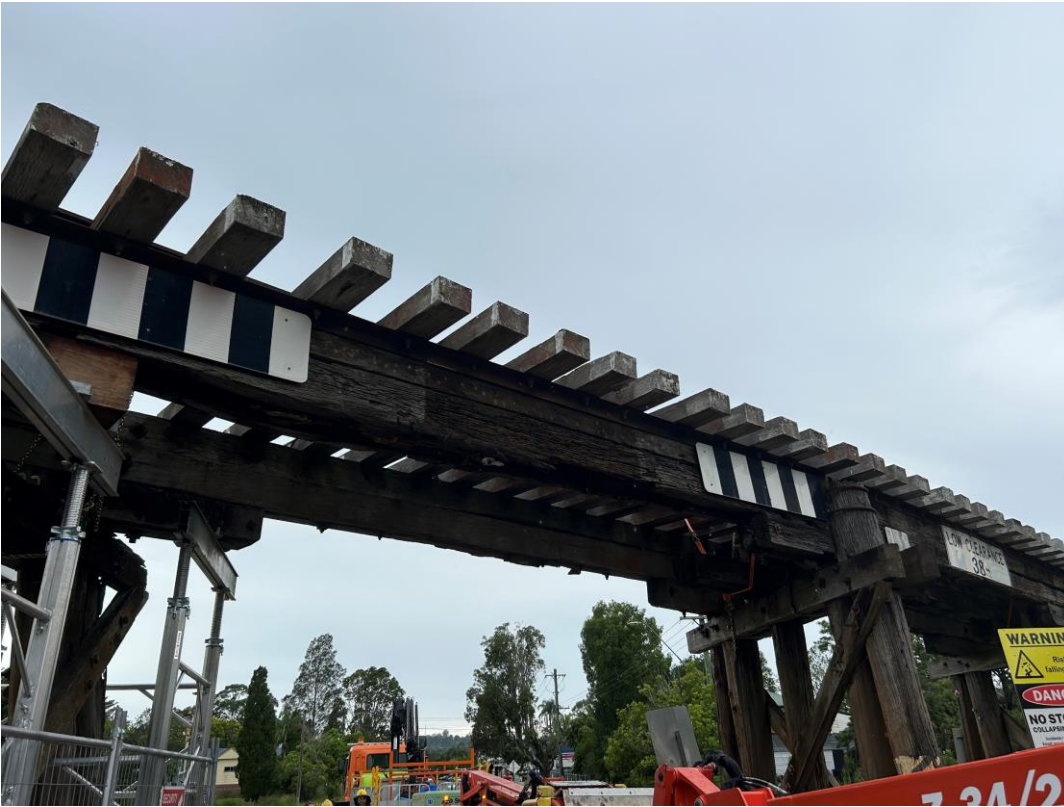
Photo 1: Span Arrangement

Each span consists of timber corbels over the piers with pairs of two timber beams as indicated in Photo 1 below.

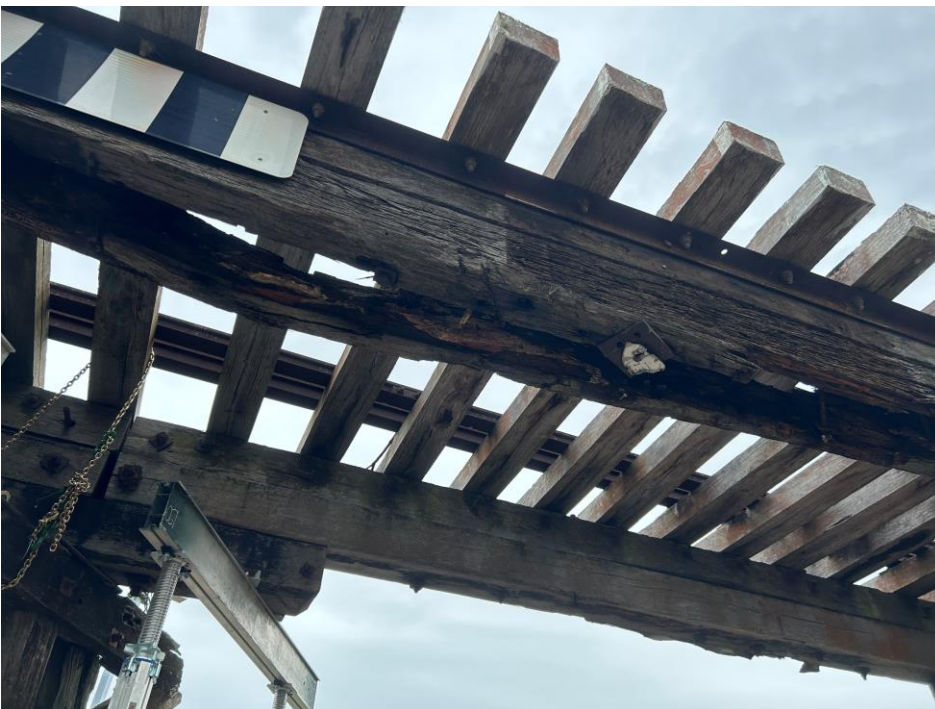
It appears that the truck caught one or more of the bolts protruding from the underside of the beam. This has resulted in a longitudinal split (see Photo 2 below).

Photo 2: Split in bottom beam

1. The damaged beam can no longer be relied upon to support any load.
2. In its current state, the damaged beam may drop debris onto vehicles.
3. The split in the beam reduces the bearing area of the beam at the support.
4. There remains a risk that the bridge could be hit again.

1. SMEC is to undertake a load capacity check of the top beam (ignoring any support from the bottom beam) to determine if the top beam is sufficient to carry the current loading.
2. Clamp the damaged beam together with threaded rod to close the split and strap the beam at intervals with packing straps to prevent falling debris and tie the bottom and top beams together.
3. Clamp the damaged beam together with threaded rod to close the split and restore the bearing area at the supports.
4. Update clearance signs to show that clearances differ between Span 5 and Span 6.

Given the poor condition of the bridge and the damage sustained from repeated truck impacts, SMEC recommends that the spans over the road be demolished as a matter of urgency.
