30013602

19 February 2024

RE: Terania Street Bridge – Structural soundness following impact on 07 February 2024

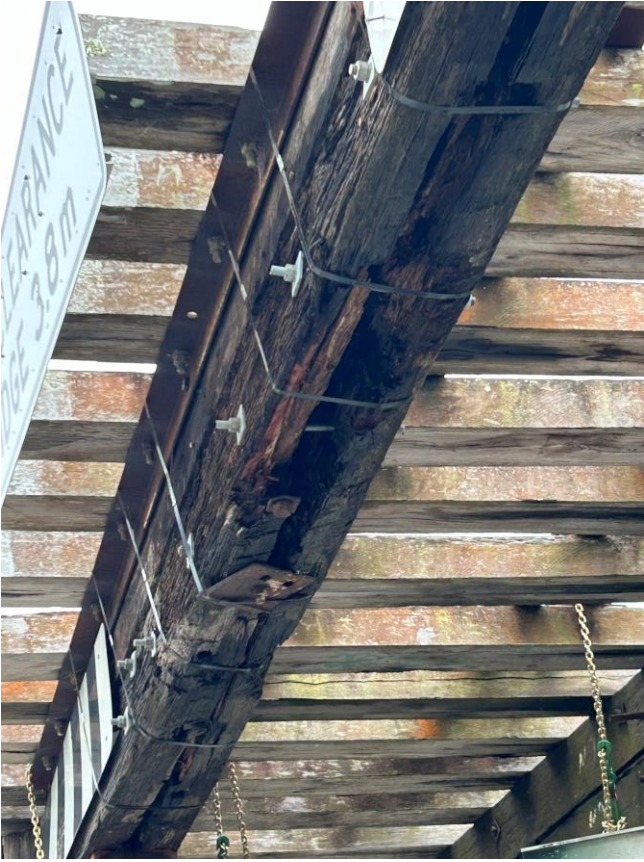
1. Bottom girder on western side of span 6 is split longitudinally from a truck impact (as discussed in SMEC's letter dated 19/01/24). Refer Photo 1 below.
2. Middle girder in span 5 appears to have displaced laterally. At one end it is slightly displaced from the corbel at the other end, the corbel has rotated (in plan) and provides less bearing support to the middle girder. Refer Photo 2 below.
3. Girders in spans over the traffic lanes and the footpath are generally sound (except the girder mentioned in item 1).
4. It appears that Pier 5 may have been displaced by approximately 10 mm. A holding down plate appears to have recently been bent. Comparing to previous photos it is hard to determine if this has definitively occurred. Refer Photo 3 below.

Photo 1: Split in bottom beam from impact in Jan 2024

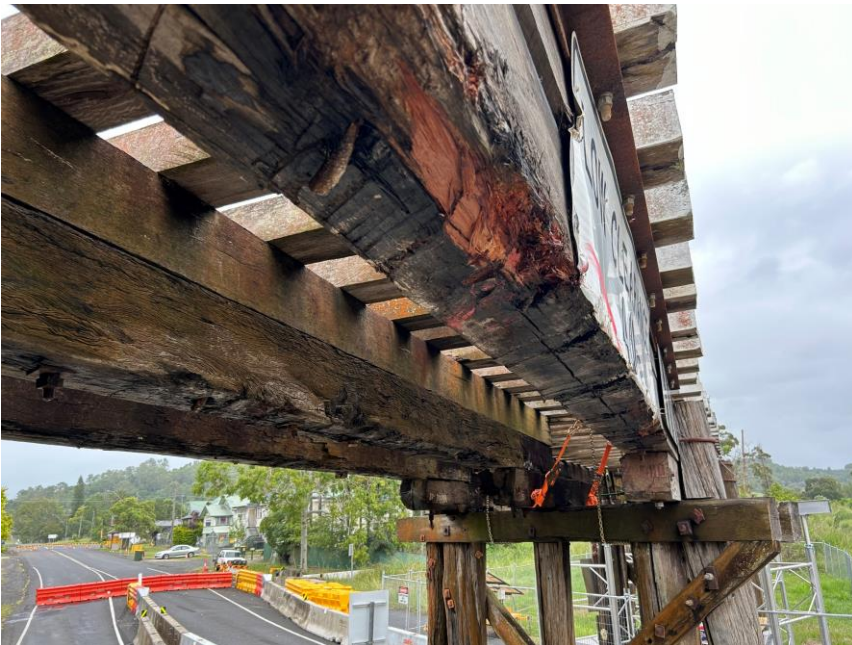
Photo 2: corbel displaced (far end) and damage to side of girder.

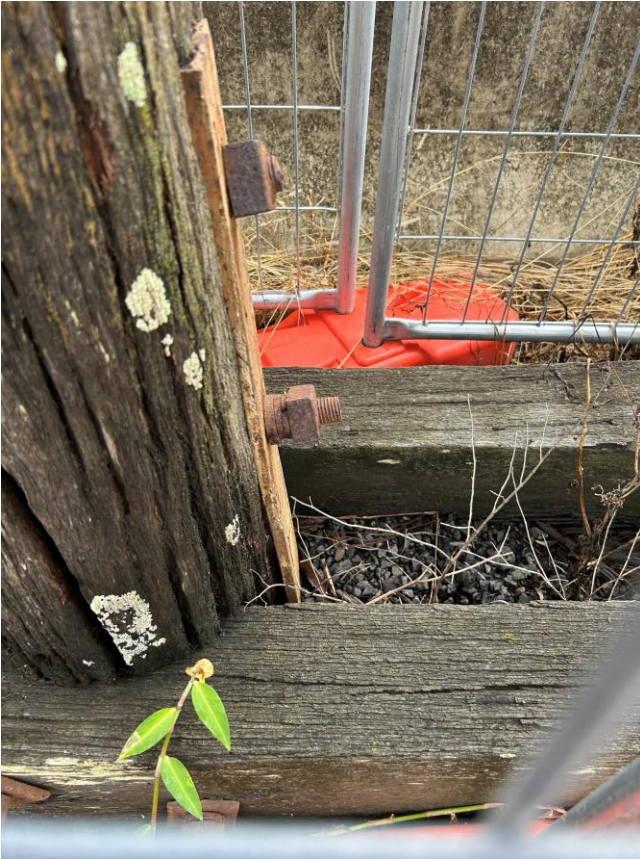
Photo 3: pier 4 column appears to be displaced in relation to plate
