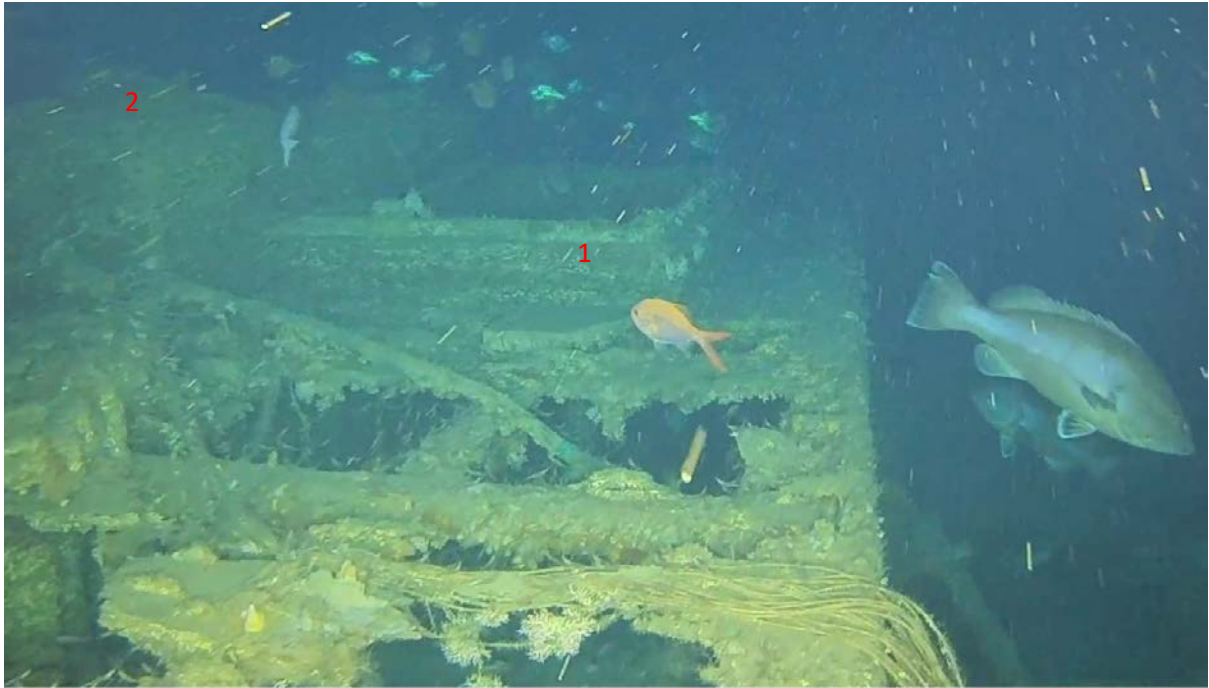
Figure 52: Bridge deck showing the chart house lower walls coaming (1) and possible steering platform well (2) (Image: Subsea 2022)

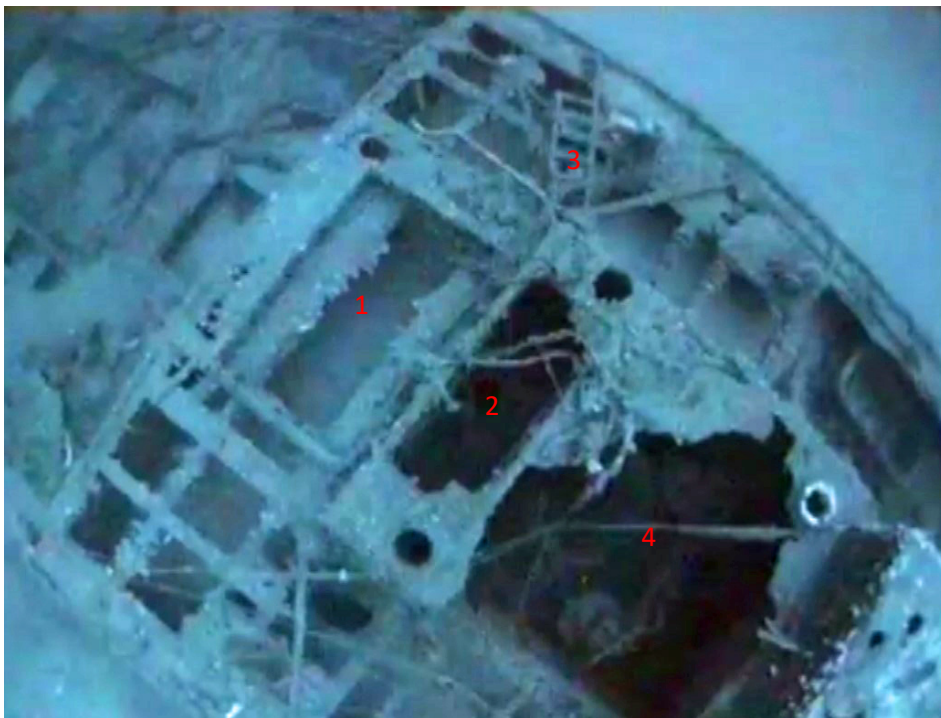
Figure 53: Bridge section - starboard side to top showing possible chart house coaming (1), steering platform and chain well (2), and the collapsed ladder (3) to access the pilot's bridge. Note the collapsed boiler room coaming (4) (Image: CSIRO 2023 - 3068)

The ladder implies that there was another deck above this area, possibly used for another higher but external ships steering wheel on a pilot's bridge. The location of these features in the centre of the vessel suggest that this was probably the bridge deck / and upper pilots bridge area, the latter of which was elevated about the surrounding main deck to improve visibility when steering. Figure 55 show a schematic diagram of the bridge deck of a late 19th century steamer. This also indicates therefore that the vessel was probably a three-island ship, with a raised stern and forecastle deck and raised central bridge deck (see schematic Figure 56).

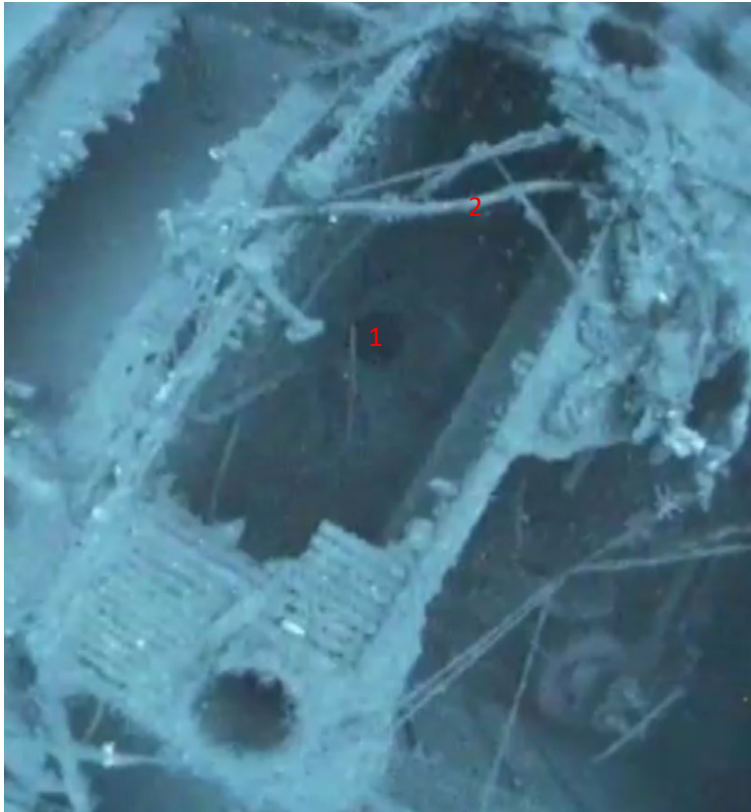
Figure 54: Closeup of steering chain well hole showing the hole for steering chains or pipes (1). Note the piping at the top of the image above the steering chain well which may be part of the handrail (2) (Image: CSIRO 2023 - 3096)

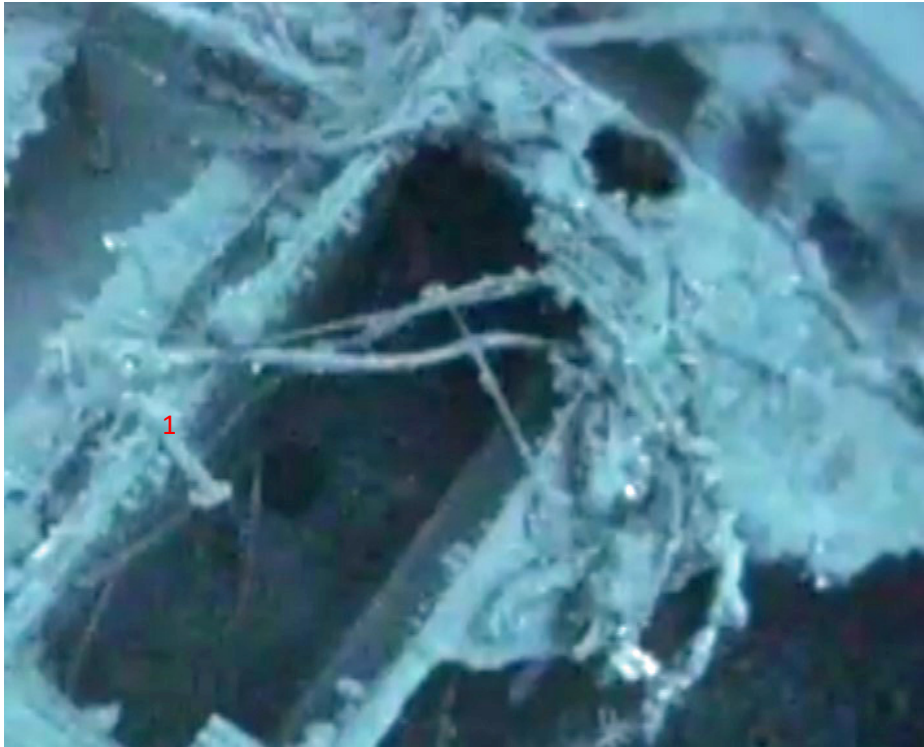
Remnants of what appears to be handrails were located over the steering well (Figure 57); parts of the fore main deck on the starboard aft side (Figure 58); and outside of the starboard hull below the bridge deck area (Figure 59, Figure 60). These are consistent with the types of handrails shown in Figure 55 which surround the upper bridge and pilot's bridge decks of late 19th century steamers.

Figure 57: Possible handrail sitting over the steering well (1) (Image: CSIRO 2023 - 3107).

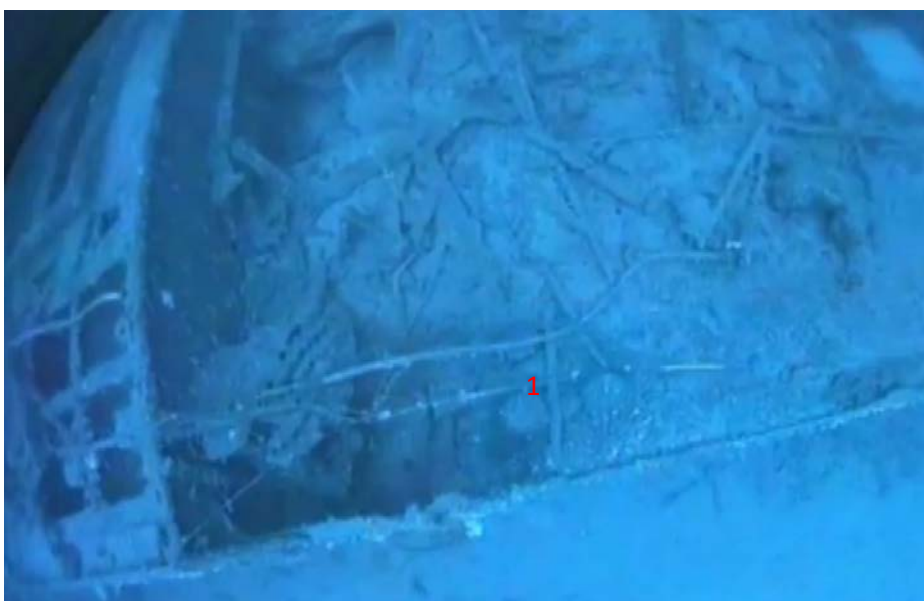
Figure 58: Bitts starboard side and handrails (1) (Image: CSIRO 2023 - 07834)

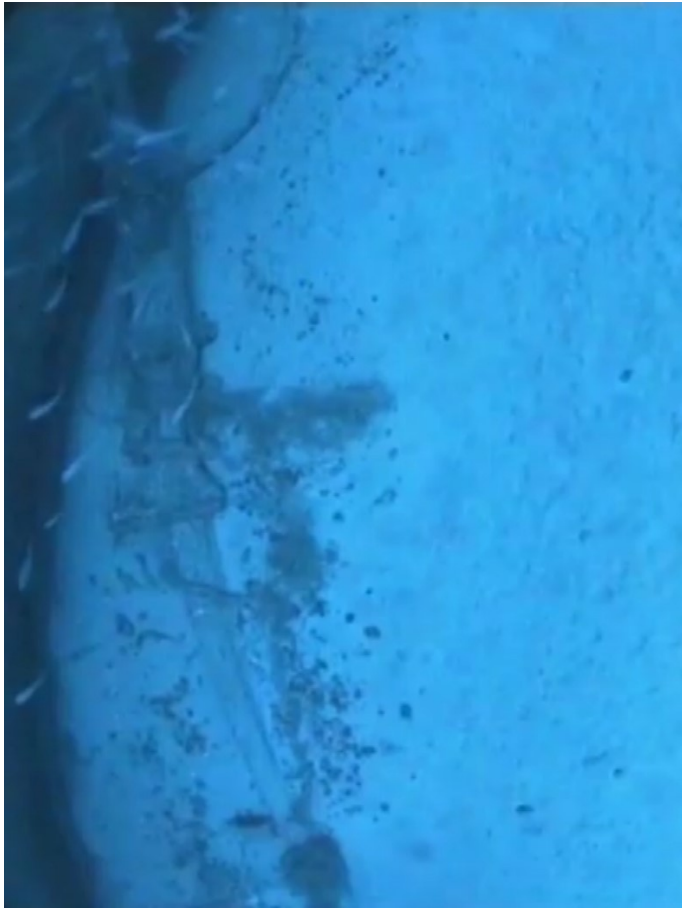
Figure 59: Possible handrail on outside of wreck, starboard side (Image: CSIRO 2023 - 07605)

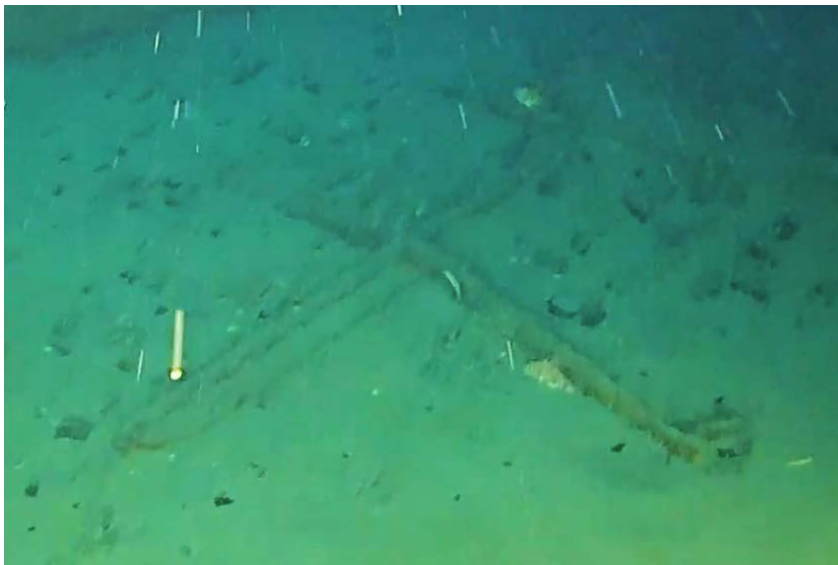
Figure 60: Possible Handrail starboard side outside of the wreck (Image: Subsea 2022)

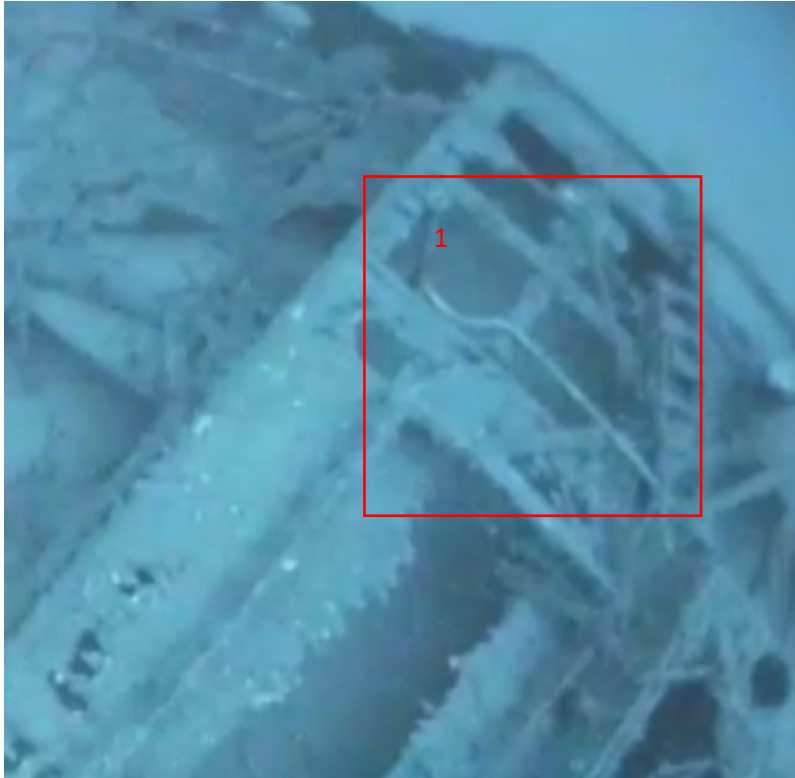
A horizontal pipe was observed leading forward just under the starboard side of the bridge deck, which joined up to a vertical pipe and flange in the fore part of the bridge deck. This hollow pipe suggests it was used for steam or liquids to the bridge deck and may have led to a steam whistle or other steam powered device (?).

Figure 61: Under deck piping at forward starboard bridge area showing vertical pipe (1) that possibly led to a steam whistle (Image: CSIRO 2023 - 0334)

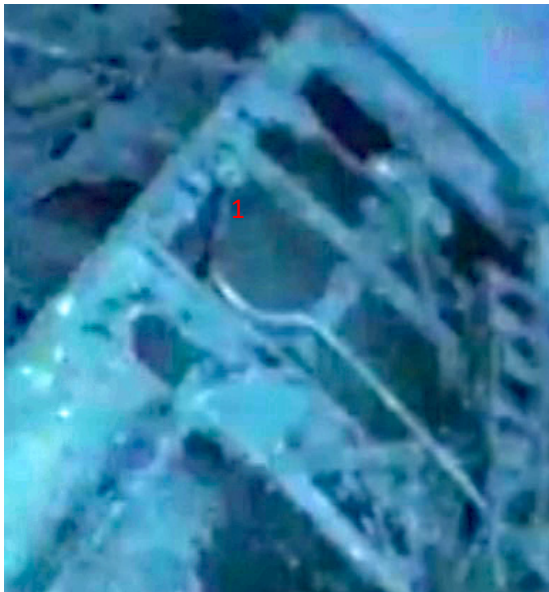
Figure 62: Closeup details of underdeck piping (1) and vertical piping / flange (2) at forward starboard section of bridge (Image: CSIRO 2023 - 03334 enhanced)

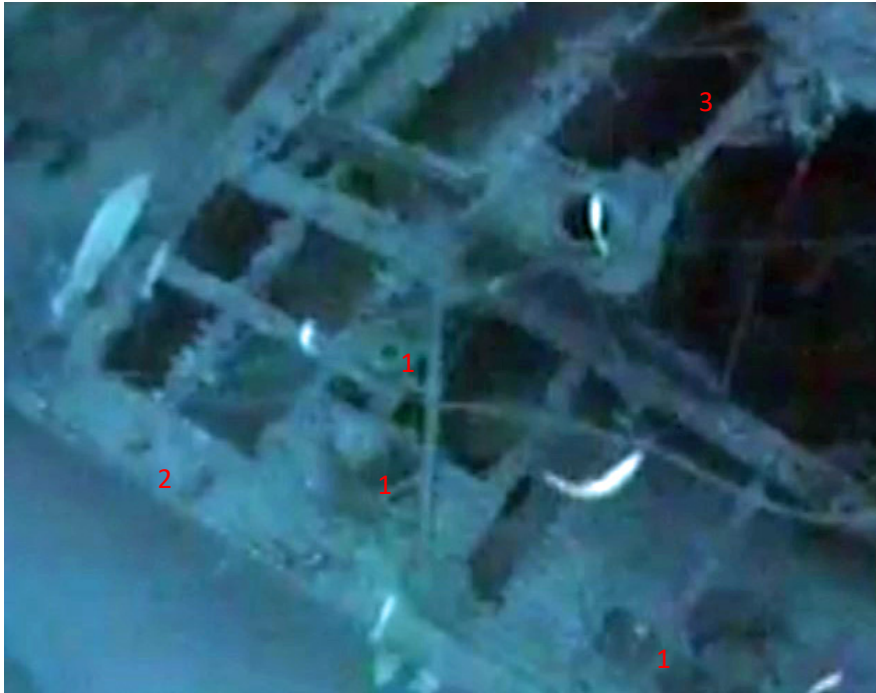
Numerous circular pole mounts were seen around the extremity of the bridge deck on both the port (Figure 63, Figure 74) and starboard sides (Figure 64). Some fittings also consisted of triangular mounts on the deck (Figure 63). Some raised fittings on the starboard side may have raised circular bases and may be davit socket mounts or boat cradle mounts (Figure 66). Figure 67 show a schematic of lifeboat fittings from late nineteenth century.

Figure 63: Possible davit socket mounts, pole or cradle mount (1), port side near bridge remains. Note bitts (2) to left and steering well recess (3) (Image: CSIRO 2023 - 2867 side)

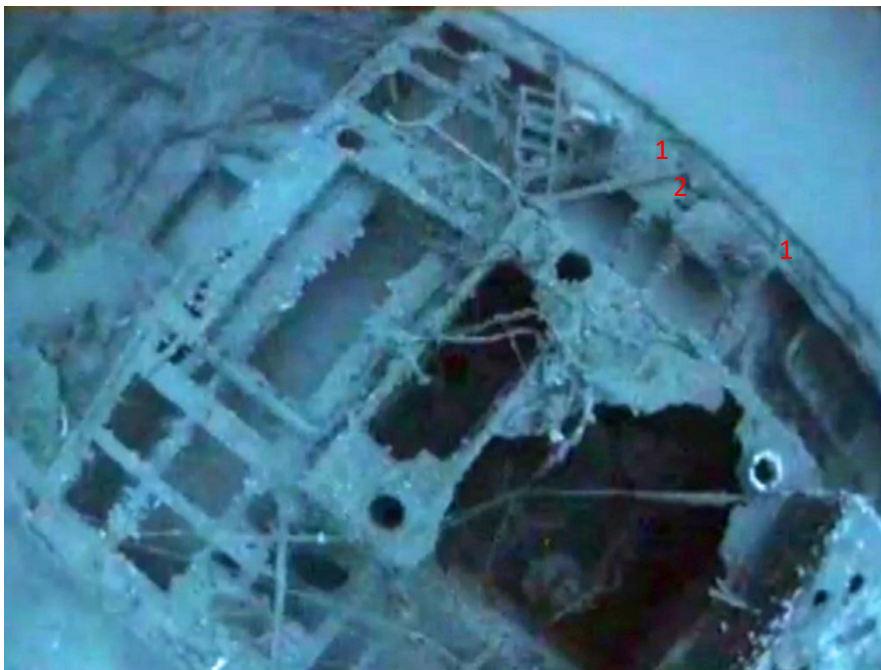
Figure 64: Possible lifeboat cradle mounts or davit socket mounts (1) on starboard side (Image: CSIRO 2023 - 3068 enhanced)

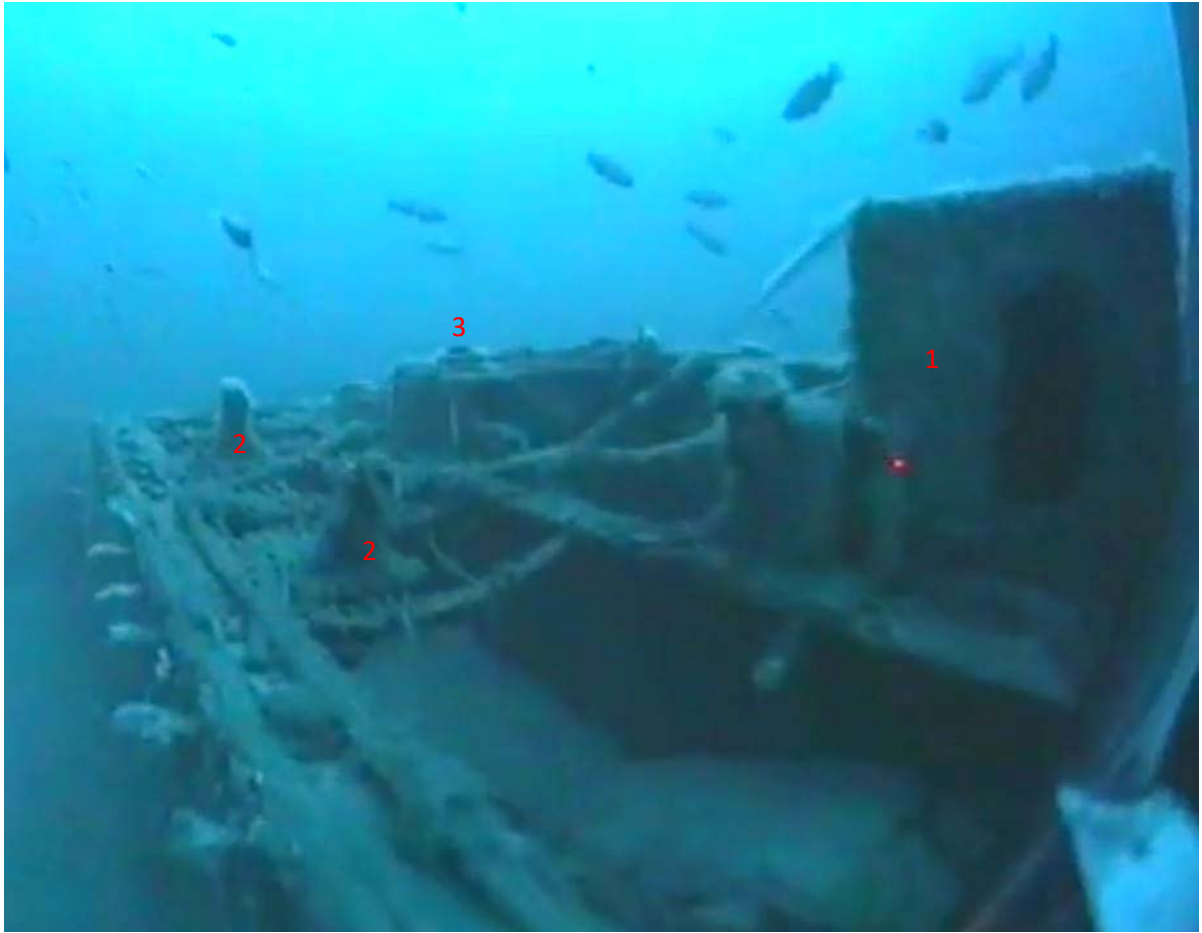
Figure 65: Port side looking forward from deck house (1) towards bridge showing the raised remains of lifeboat davits or boat cradles (2). Note the raised stokehold ventilators (3) (Image: CSIRO 2023 - Port Side drop Cam)

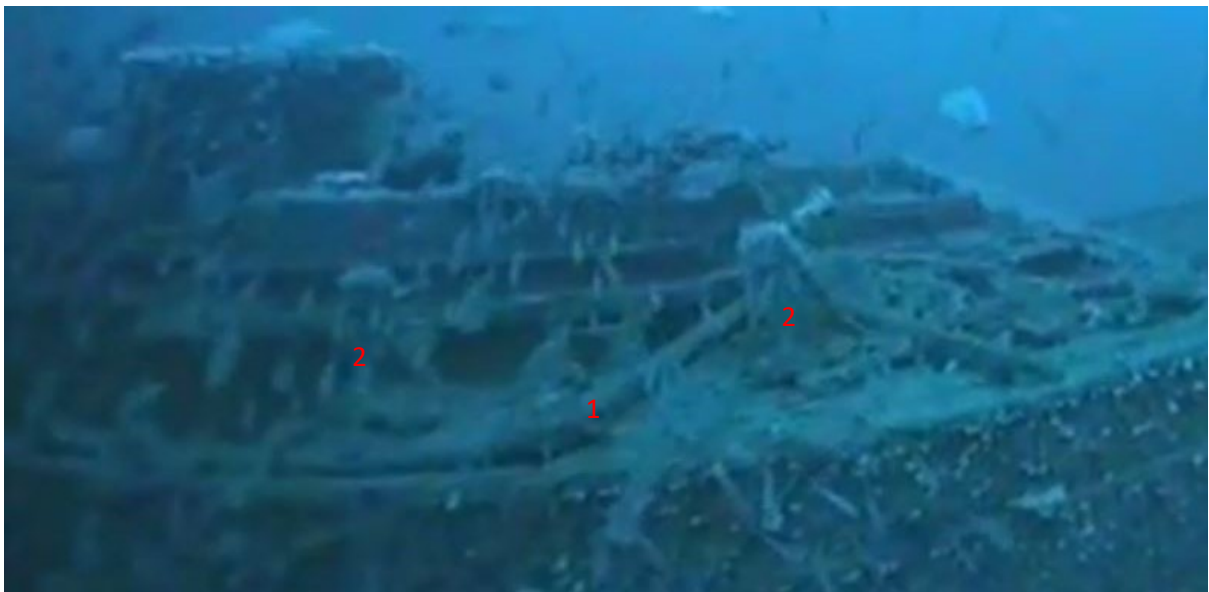
Figure 66: Possible lifeboat davit (1) and boat cradle mount (2), starboard side of bridge deck (Image: CSIRO 2023 - Lifeboat davit and mount bridge starboard side cam)

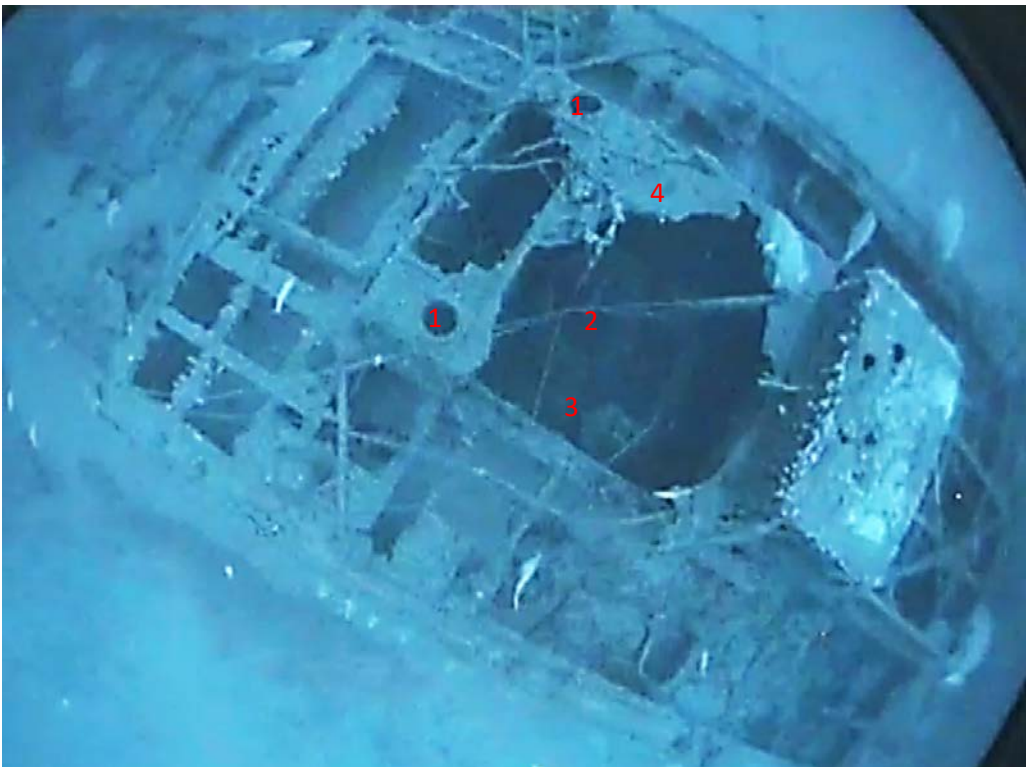
Directly behind the bridge are the remains of a collapsed boiler coaming (which would usually cover the boiler room), through which the boiler and top of the funnel outlet are visible. Also within this space is the top of the steam safety valve, which is usually mounted on the top of the boiler as a type of pressure relief valve (Figure 69, Figure 70, Figure 71) .

Circular holes located on top of the bridge deck either side of the steering platform well are likely the remains of the stokehold ventilators (Figure 69), which feed air in to cool the stokers in the boiler room.

The presence of a probable safety valve indicates that the vessel was steam powered.

Figure 69: Midship section showing stokehold ventilation pipes (1) funnel of boiler (2) and steam safety valve (3) below the boiler coaming (Image: CSIRO 2023 - 2964)

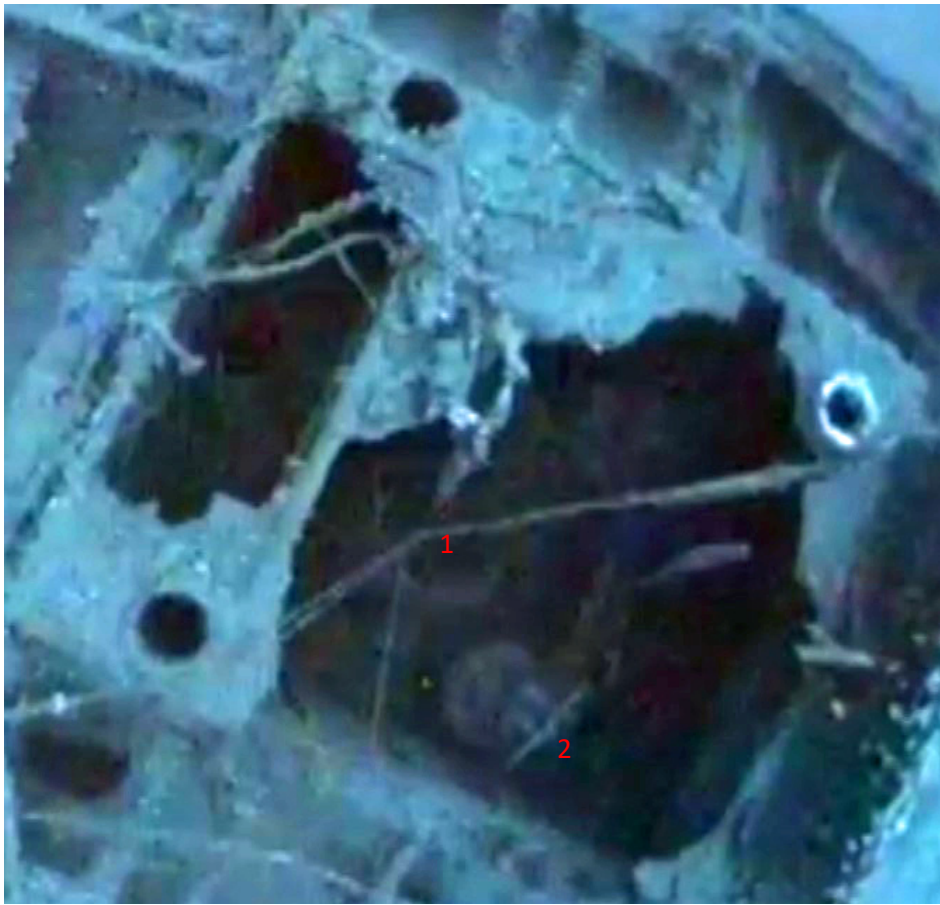
Figure 70: Closeup of midship section showing funnel air casing (1) and steam safety valve below the Casing (Image: CSIRO 2023 - 3061)

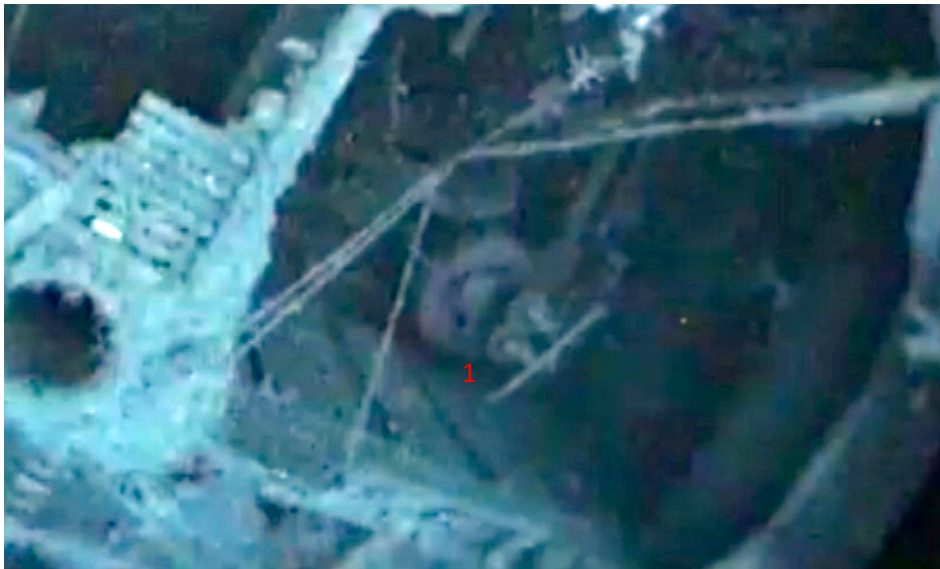
Figure 71: Closeup of Safety valve by side of funnel outlet (1) (Image: CSIRO 2023 - 3096)

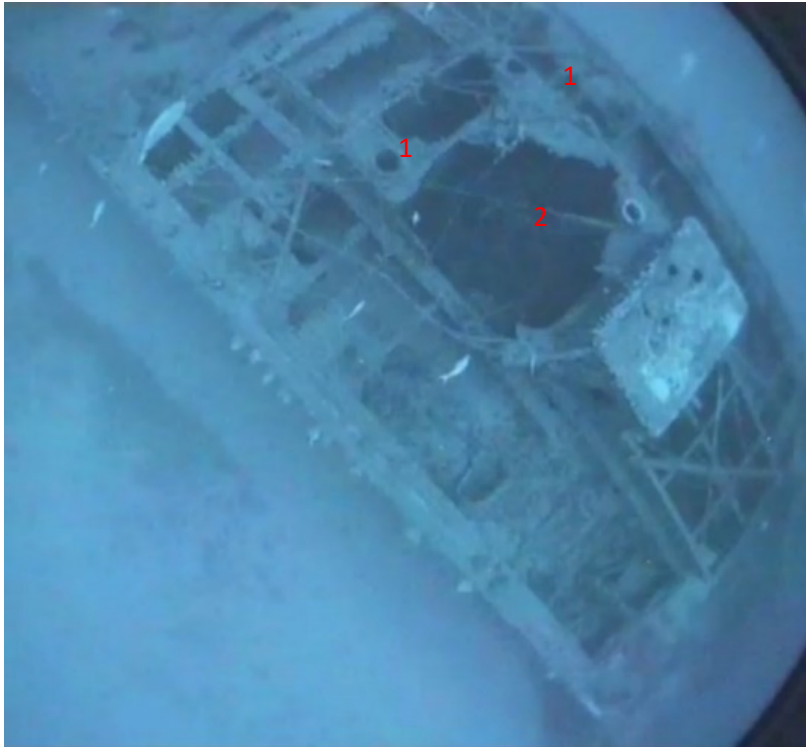
Figure 72: Stokehold ventilator tubes (1) and funnel air casing (2) locations on wreck (Image: CSIRO 2023 -)

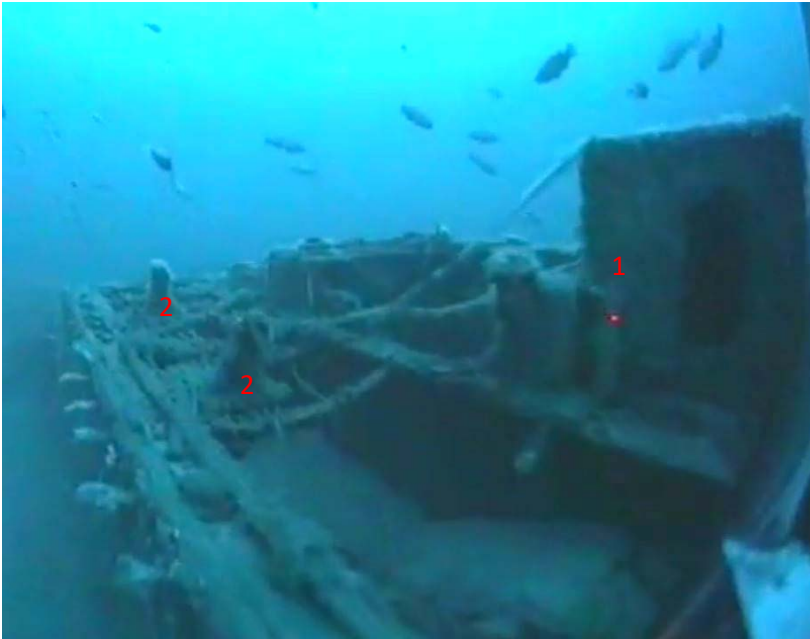
Figure 74: Port side looking forward from deck house (1) towards bridge. Note the raised remains of lifeboat davits (2) and stokehold ventilators (Image: CSIRO 2023 - Port Side drop Cam)

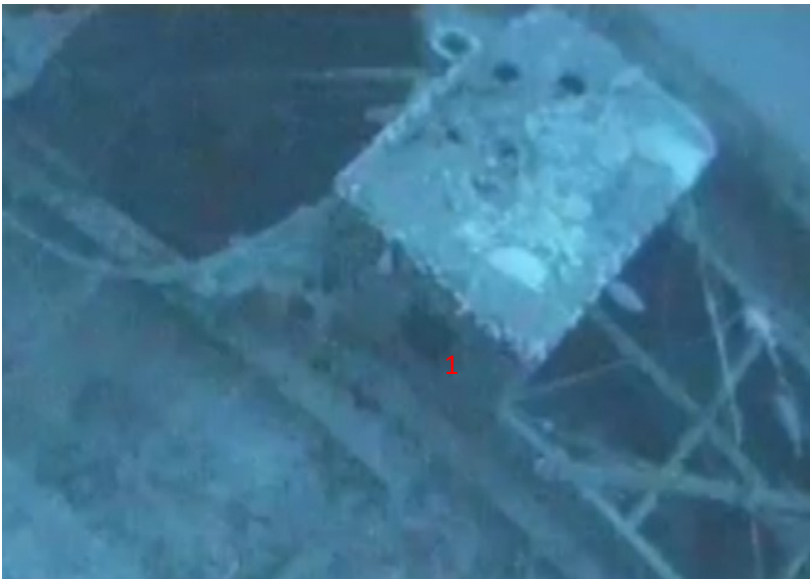
A small deck house is located aft of the funnel outlet. This structure is rectangular in transverse shape and has several circular outlets on the roof, possibly for small chimney outlet(s) and other ventilation requirements. A transverse rectangular doorway is visible on the port side of the structure and the roof projects c 30 – 50cm beyond the walls on all sides (Figure 74, Figure 76). The deck on either side of the deckhouse has collapsed exposing the coal bunkers below (Figure 76).

Figure 75: Top view of deckhouse showing multiple chimney or vent outlets on the roof and the port side window or door (1) (Image: CSIRO 2023 - deck house Drop camera side 02688).

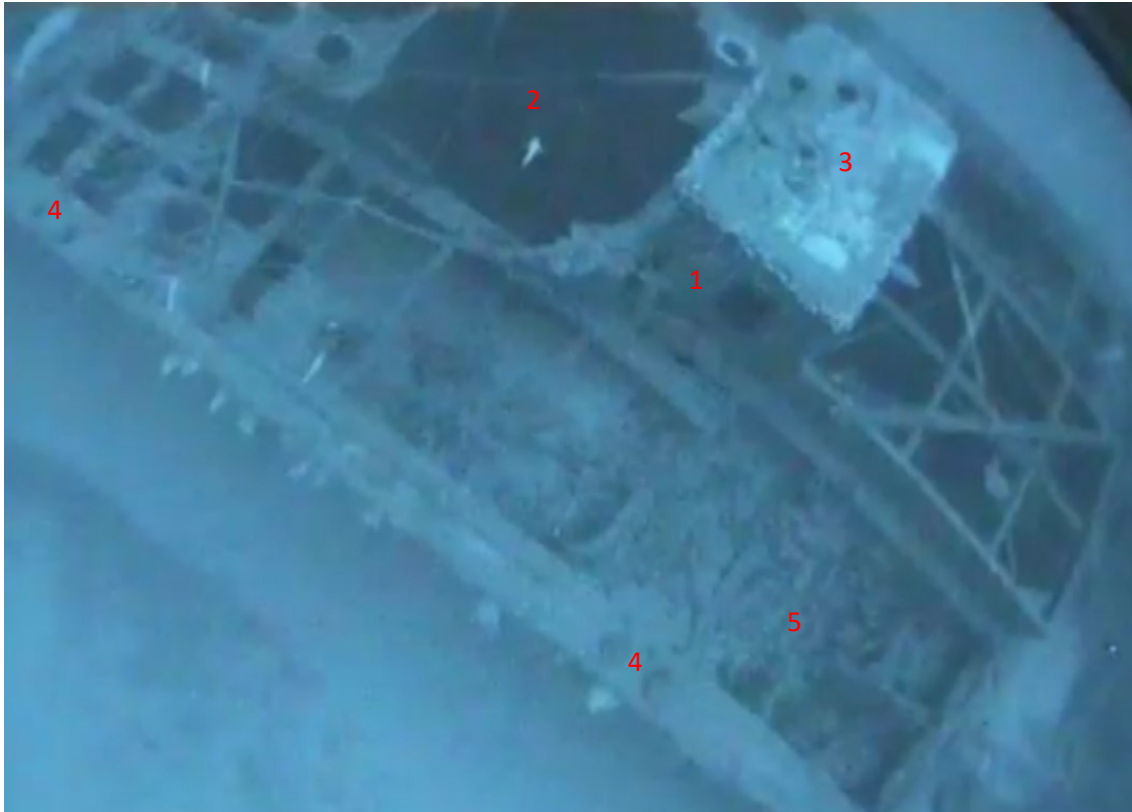
At least two sets of bitts are visible on the port side between the bridge and the deckhouse (Figure 76). These were probably used for mooring the vessel and/or for general maintenance.

Figure 76: Deckhouse structure (1) abaft the funnel (2). Note the outlets in the roof, probably indicative of ventilation or chimney/ exhaust outlets (3) bitts on port main deck (4); and coal in the coal bunkers under the main deck (5) (Image: CSIRO 2023 - 2715)

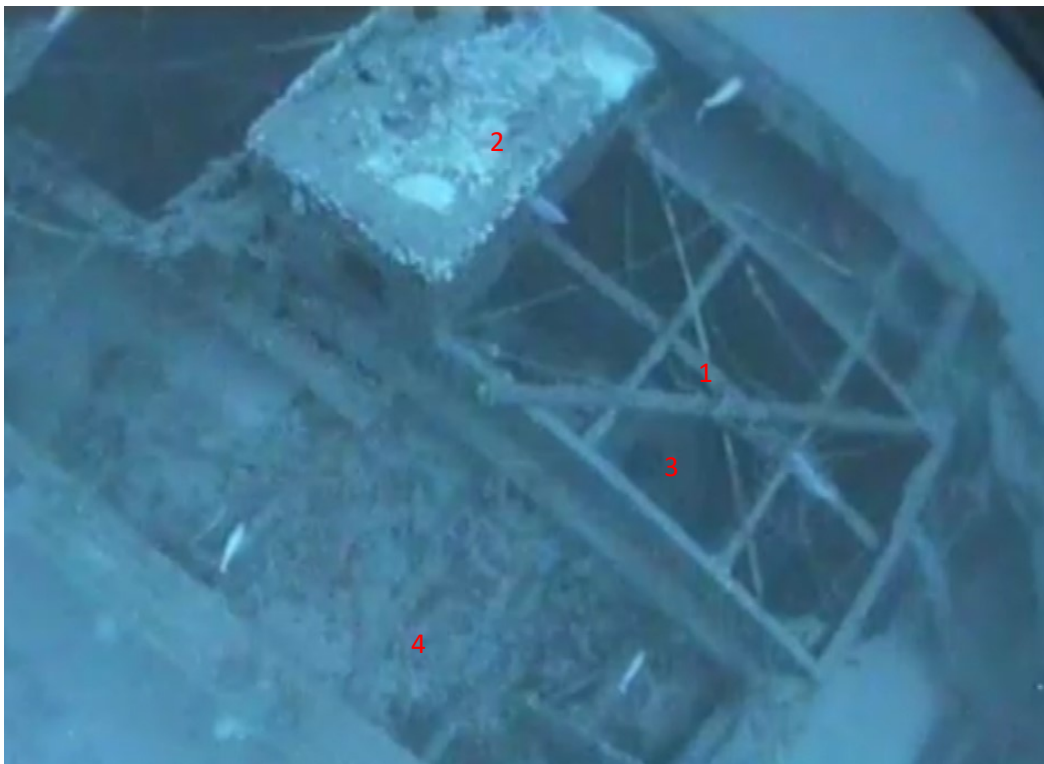
Figure 77: Engine room skylight (1) abaft deckhouse (2). Note the diagonal strapping supporting the coaming; the top of what appears to be a large engine cylinder (3) and possible coal bunker on port side (4) (Image CSIRO 2023 - 2659)

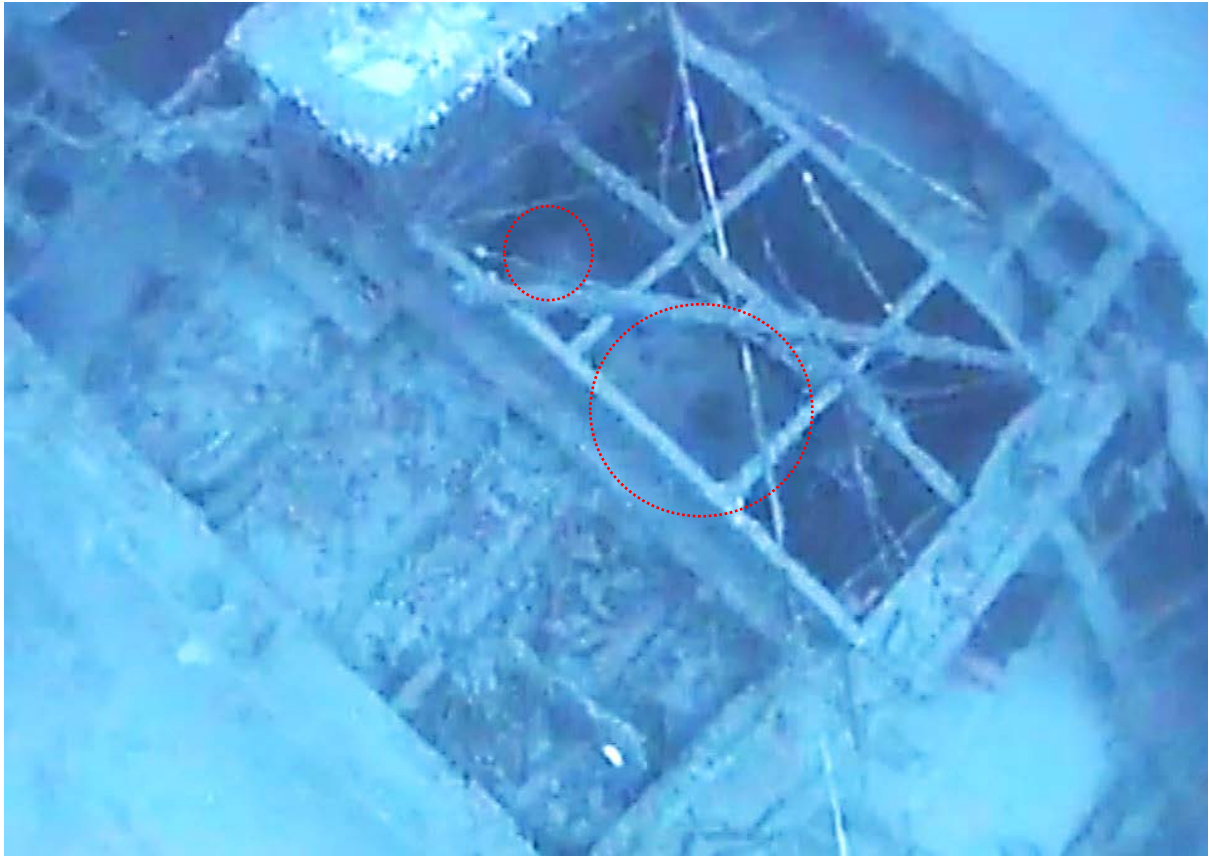
Abutting the rear of the deckhouse (and the same width of it) is a rectangular structure similar to a cargo hatchway coaming but with a central fore / aft beam and athwart two shifting beams. There are also two diagonal plates that cross from each corner of the coaming, but it is unclear if these are part of the structure or have fallen onto it (Figure 77). The top of the cylinder of what appears to be a large steam compound engine (or given its size: a triple expansion engine) is just visible through the skylight (Figure 78).

Figure 78: Closeup on engine room showing head of at least one cylinder (shown in red) with vertical tail rod or escape valve of a compound engine. (Image: CSIRO 2023 - Engine room cylinder Drop camera side02618).

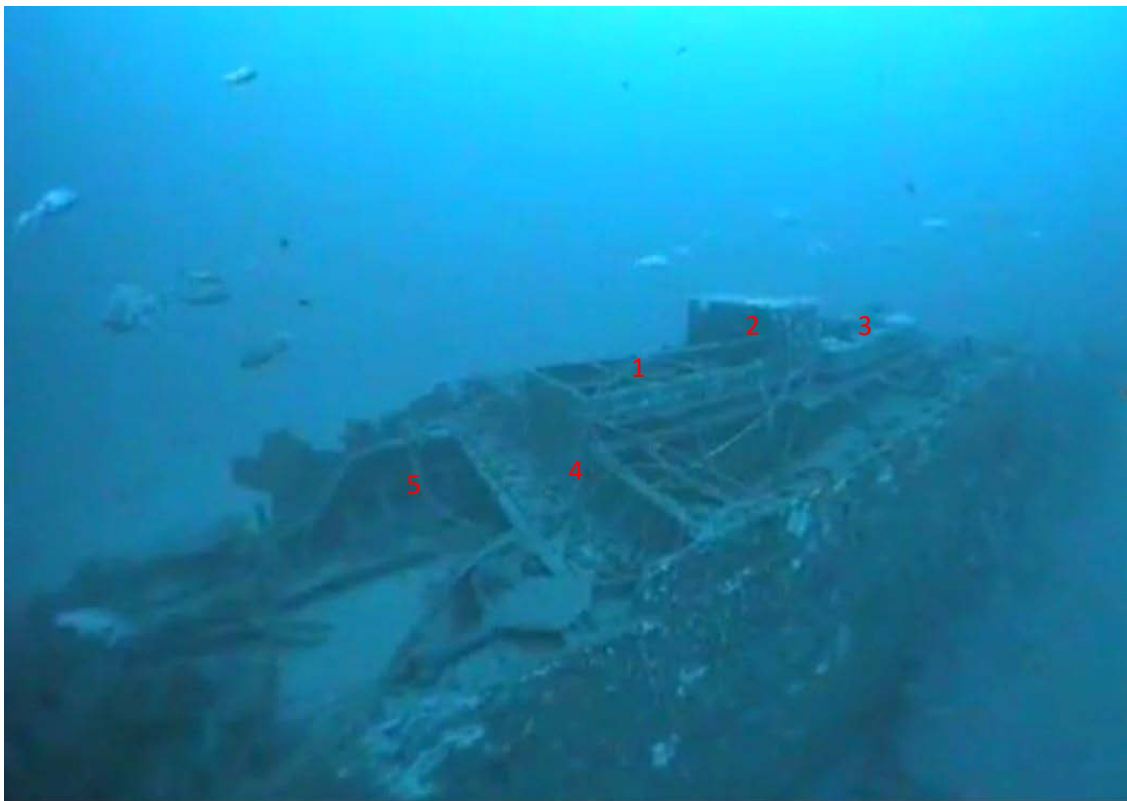
Directly behind this feature the bridge deck ends and drops down again to the main deck at the edge of the engine room bulkhead (Figure 79). This feature appears to be an engine coaming or skylight, a structure which allows natural light to enter the engine room (see schematic - Figure 80). Schematics of a compound and triple expansion engine are shown in Figure 81 and Figure 82 (respectively).

Figure 79: Rear view of engine coaming (1), deckhouse (2), boiler coaming (3), engine room bulkhead (4) and aft collapsed hatchway (5) (Image: CSIRO 2023 - Side cam)
