HMAS Australia (1)

Shipwreck 1924

Information Sheet - Heritage Branch

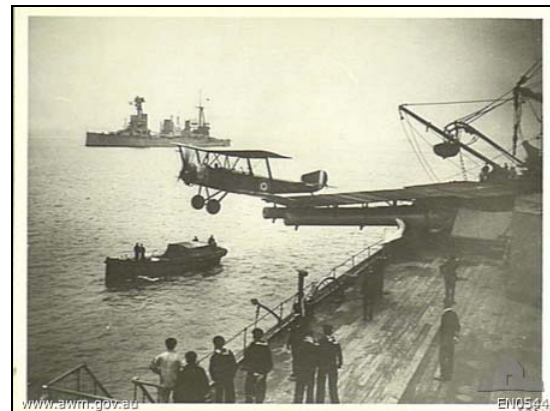
Members of the ships company watch as a two seater Sopwith 1 ½ strutter biplane takes off from the ships starboard gun turret (Photo: Australian War Memorial image # EN0544)

During the war, experiments were undertaken with mounting aircraft on her turrets, including Sopwith Strutter 1 ½ type. A Sopwith Camel was also later mounted. The success of these trials led to the widespread use of these aircraft throughout the British fleet.
