DUNBAR (1854-1857)

CONSERVATION MANAGEMENT PLAN

**Maritime Archaeology Program
NSW Heritage Office**

Prepared by David Nutley and Tim Smith

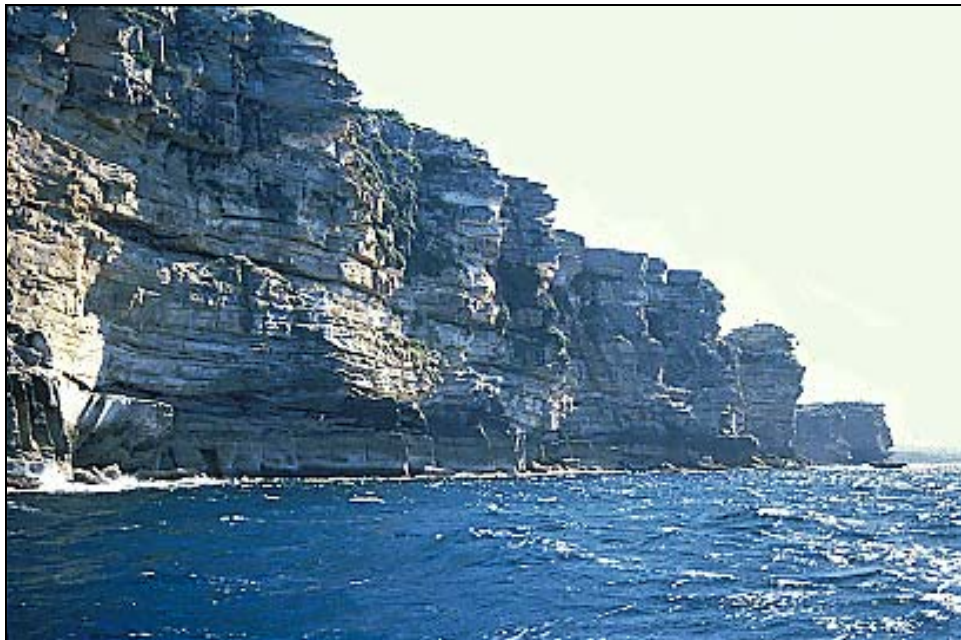
Figure 1: The South Head cliffs where the Dunbar struck in 1857. The wreck site lies in the water at left. Photo by David Nutley.

The wreck site is exposed to the majority of sea conditions with heavy storms periodically sweeping the site which lies at the foot of the outer South Head. These physical processes can impinge on site longevity and thus on the site's archaeological significance. Erosion of the wreck structure has been severe and the removal of exposed artefacts can lead to further reduction of site integrity.

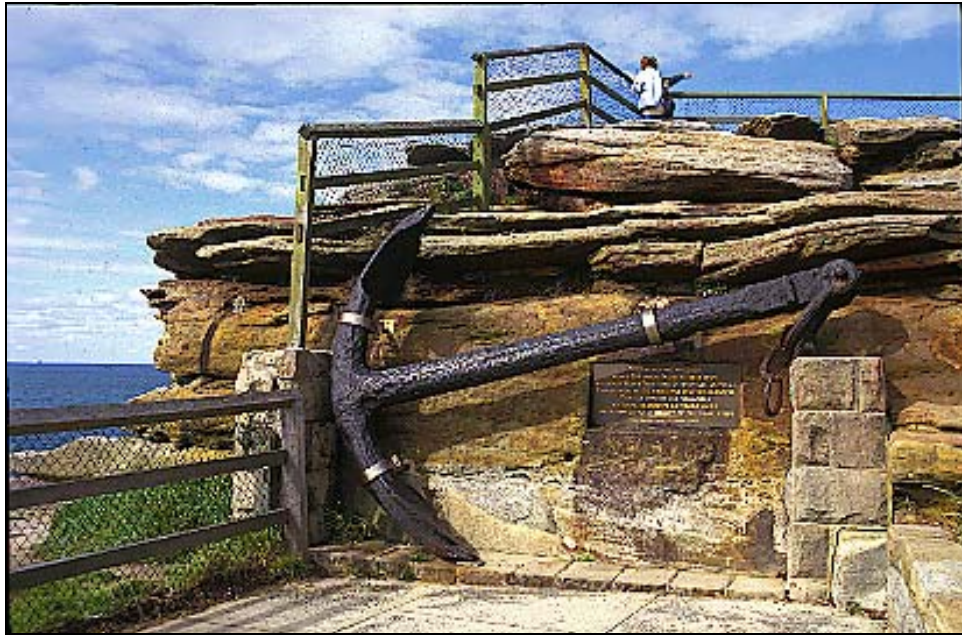
Figure 2: An Admiralty anchor recovered from the wreck site in 1910 and later displayed at The Gap as a permanent memorial to those lost in the tragedy. Photo: Mark Spencer.

Large quantities of material have allegedly been removed from the site since its rediscovery about 1955 and remain in largely unrecorded collections. A large Admiralty style anchor was removed from the wreck site in 1910 and put on permanent display at "The Gap" at South Head as a memorial in the 1930's (Figure 2).

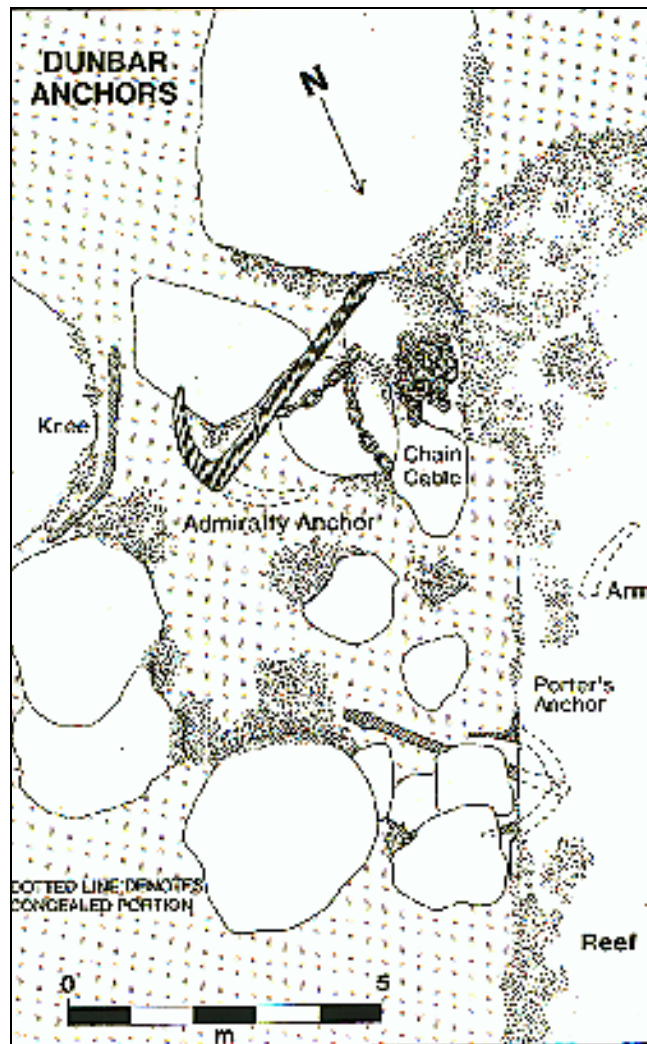
Figure 3: Plan of significant features at the northern extremity of the site. An Admiralty pattern anchor and a Porters Anchor. Drawing by Tim Smith.

The northern extent of the site (Figure 3) is marked by a Porter's anchor lying beneath a rock overhang. An Admiralty style anchor lies approximately four metres to the south. One arm of this anchor is broken and is located between the anchors. Near the western end of the Admiralty style anchor's shaft is an area of concretion which includes a substantial portion of chain cable and a brass fastening pin. It is likely that this concretion is a residue of the typical concretion present on the site prior to the advent of popular SCUBA diving. It is also likely to hold a variety of cultural remains in addition to the brass pin.
