NSW National Parks and Wildlife Service

Baliiga precinct plan (Never Never picnic area)

Dorrigo National Park

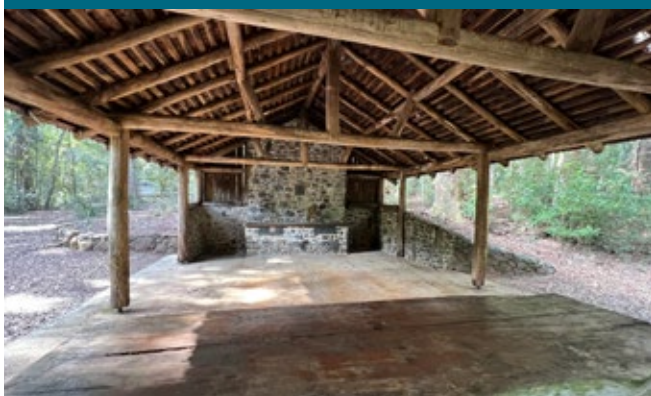
Never Never picnic shelter (Fisher Design + Architecture)

Built in 1975, the Never Never picnic shelter is considered an iconic part of the visitor precinct. The structure is currently in need of restoration works. The Never Never picnic area and picnic shelter have historical significance, reflecting important periods and events in the history of Dorrig National Park. The picnic area and shelter also have aesthetic and social significance, being highly valued by NPWS and the local community.

- replace the shingle roof with improved details
- repair the round timber-post roof frame
- repair the timber wall posts and the steel support brackets
- repair existing slab rot – cut back surfaces as required or replace the slab if too rotted
- investigate the extent of any earth build up on the eastern wall and remove earth buildup
- investigate the extent of drainage provided behind the lower section of this east wall of the shelter and the 2 curved stone retaining walls
- investigate the impact of tree roots behind the cracked curved retaining wall and identify any mitigative works required for these 2 defects

- provide a narrow full-length fixed skylight immediately to the south of the ridge line to heritage assessment recommendations
- provide gas barbecue cooking and the reuse of the fireplaces to recover their significance, but with an adaptation to provide for an enclosed fire place for warmth, while minimising risks from fire, to heritage assessment recommendations.

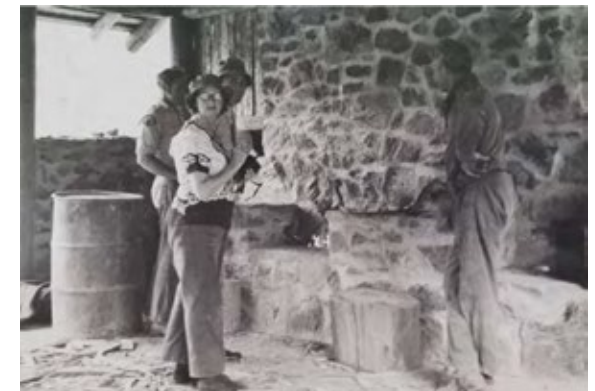
Testing the barbecue chimney before the opening of the picnic area in 1975 (Ruth Holmes)

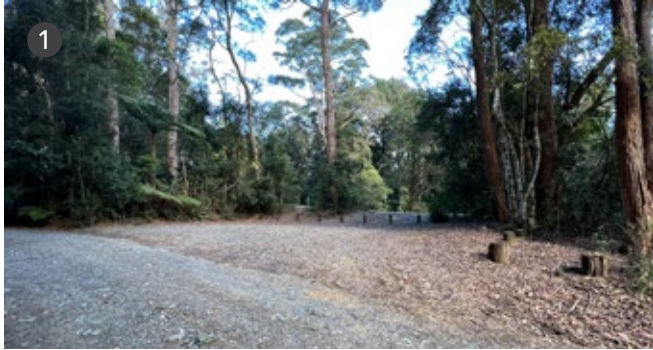
Entry and car parking area

- entry road in fair condition requiring minor upgrade, definition of roadside drainage, and filling of potholes
- need improved site orientation and information
- need formalisation of car parking areas for day use and camping, defined parking and turning
- bollards generally degraded and require replacement.

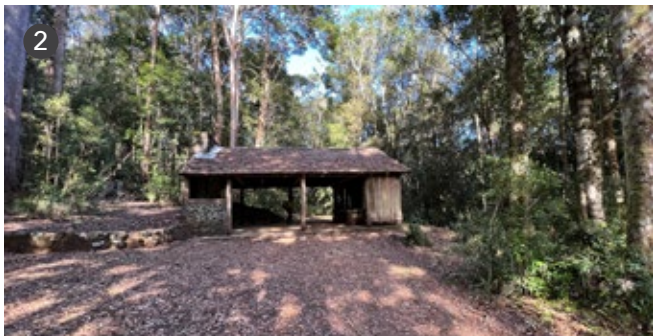
Heritage picnic shelter

- weathered and degraded due to ongoing deterioration of timber fabric from water damage and lack of maintenance.

Conservation works for the picnic shelter focus on the need for cyclic maintenance, a structural engineering assessment, and include plans to:

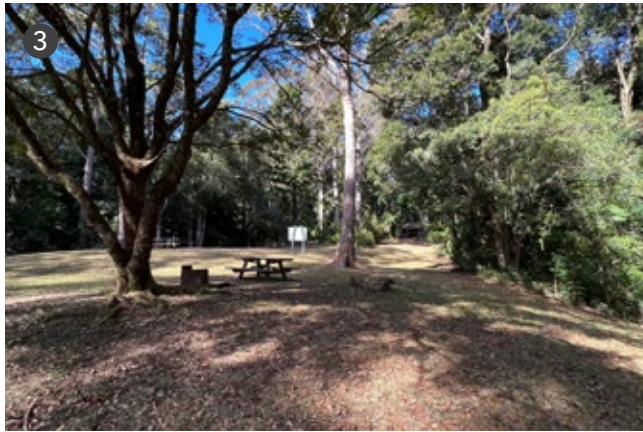
Day use area

- need definition of day use and camping areas
- loss of views around picnic area from vegetation growth
- abundance of fallen trees and debris
- poor layout and condition of picnic and barbecue settings.

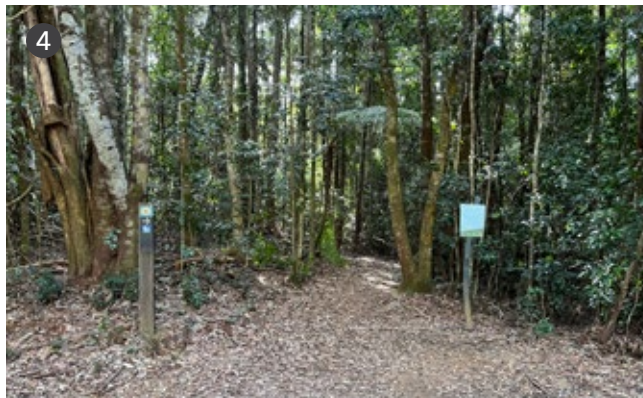
Track heads

- poor definition of tracks and trail heads
- inadequate trail head signage.

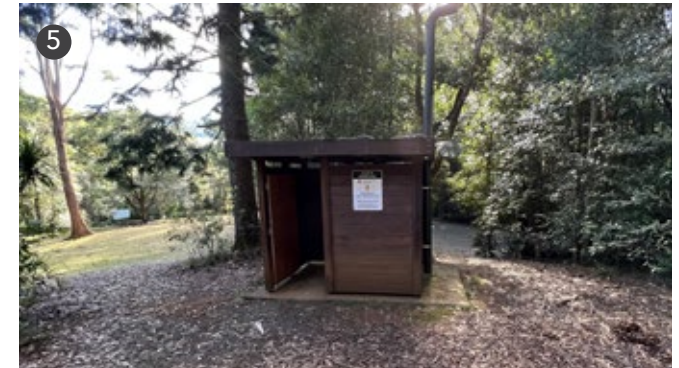
Amenities

- existing amenities tired and insufficient for future increased visitation
- accessible circulation requires upgrade.

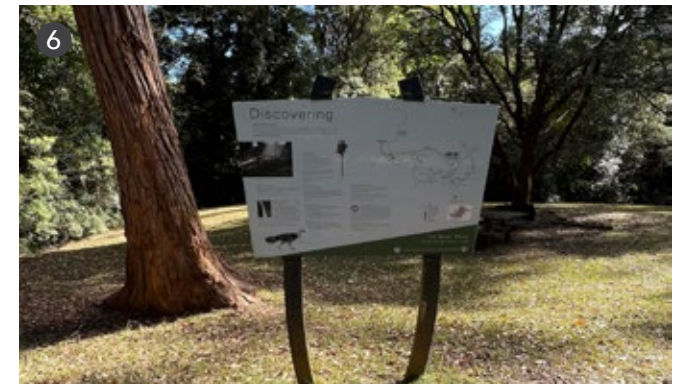
Signage

- interpretive signage poorly located and needs update
- precinct entry sign requires updated information – day use area, camping area, vehicle turning
- poor wayfinding signage
- need for new camp site sign posts to new layout.

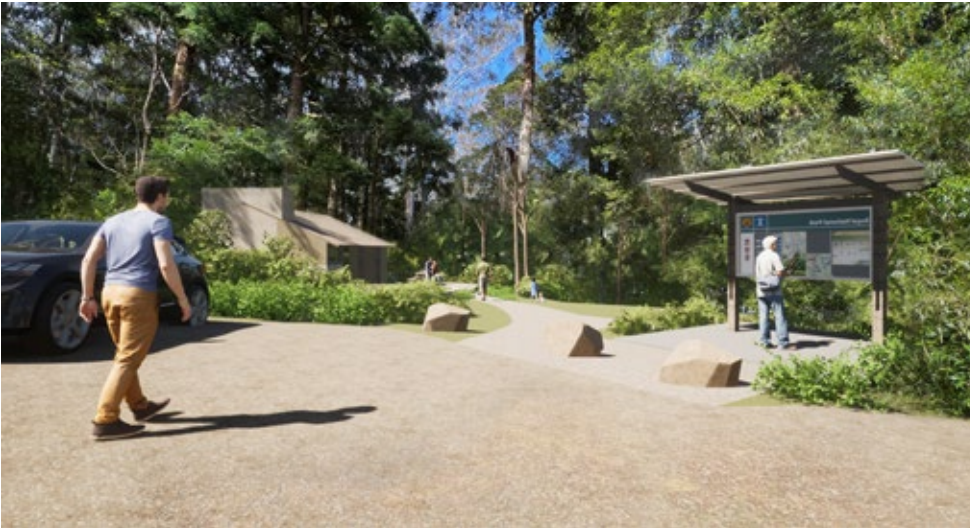
Artists impression: Day use area entry with increased parking capacity, new interpretation shelter and all-access pathway to picnic shelter

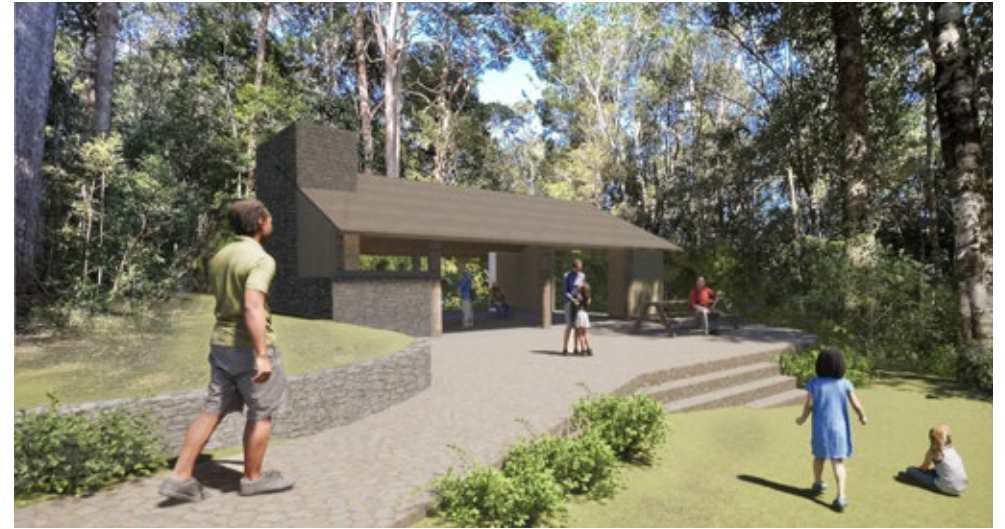
Artists impression: Renovated historic Never Never picnic shelter, new access pathway and paved level area outside

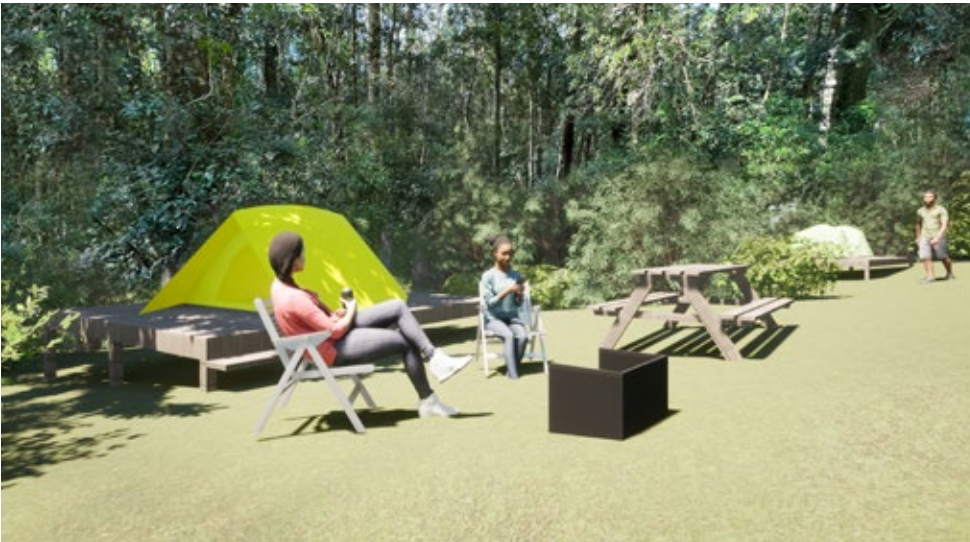
Artists impression: Camping platforms

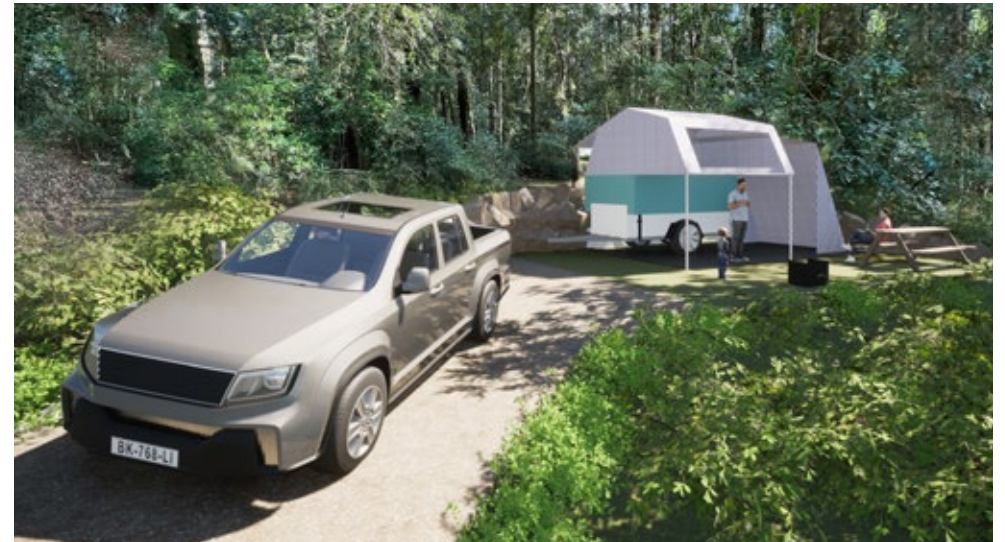
Artists impression: 3 new proposed vehicle camping sites on the lower section of the precinct
