# State of the beaches 2018-2019

Hunter region

Beachwatch

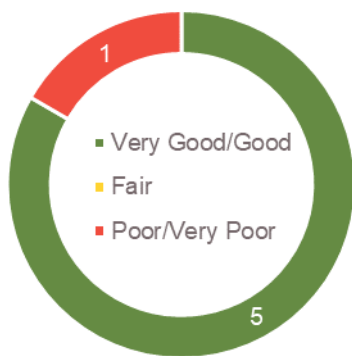
**Beach Suitability Grades for Port Stephens Council estuarine beaches**

Five of the six estuarine beaches in Port Stephens were graded as Good: Little Beach, Dutchmans Beach, Georges Reserve, Lemon Tree Passage Tidal Pool and Karuah Tidal Pool. Water quality at these sites is mostly suitable for swimming during dry weather conditions but may be susceptible to pollution for up to three days after rainfall.

Bagnalls Beach was graded Poor in 2018–2019, similar to previous years. While microbial water quality at this site has improved over the past five years, enterococci levels often exceeded the safe swimming limit in dry weather conditions and after low levels of rainfall. Swimming should be avoided at this site during and for at least three days following rainfall, or if signs of pollution are present such as discoloured water or flowing stormwater drains.

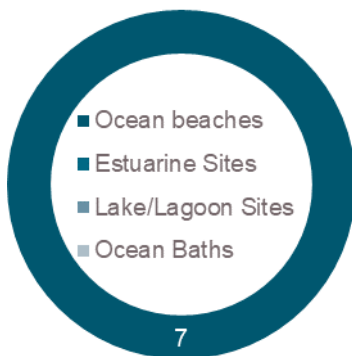
Site types in Newcastle City Council

Ocean beaches were the only site type monitored in the Newcastle region.

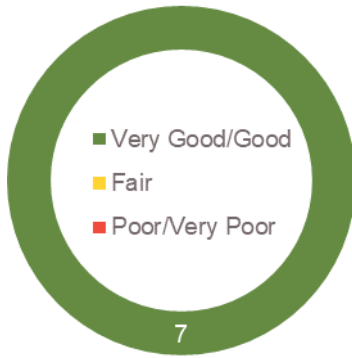
**Beach Suitability Grades for Newcastle City Council ocean beaches**

All seven ocean beaches were graded as Very Good: South Stockton Beach, Nobbys Beach, Newcastle Beach, Bar Beach, Merewether Beach, Burwood North Beach and Burwood South Beach. Water quality at these sites has been consistently excellent for many years and is suitable for swimming almost all of the time.

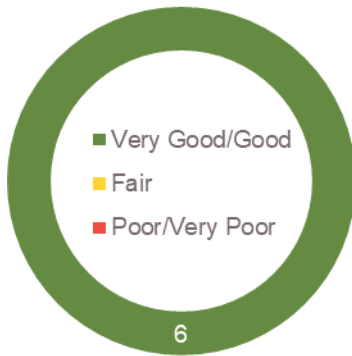
**Beach Suitability Grades for  
Lake Macquarie City Council  
ocean beaches**

Four of the six ocean beaches were graded as Very Good: Glenrock Lagoon Beach, Dudley Beach, Blacksmiths Beach and Caves Beach. The water quality at these beaches is suitable for swimming almost all of the time.

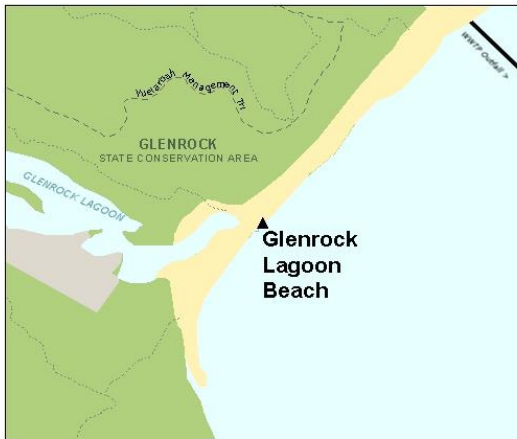
**Beach grade:**

Glenrock Lagoon Beach is 300 metres long and is located at the southern end of Burwood Beach. The beach is not patrolled by lifeguards.

The Beach Suitability Grade of Very Good indicates microbial water quality is considered suitable for swimming almost all of the time with few potential sources of faecal contamination.

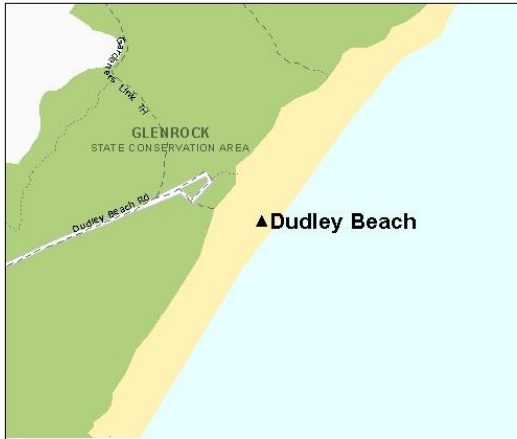
Beach grade: **VG**

Dudley Beach is one kilometre long and is not patrolled by lifeguards.

The Beach Suitability Grade of Very Good indicates microbial water quality is considered safe for swimming almost all of the time, with few potential sources of faecal contamination.

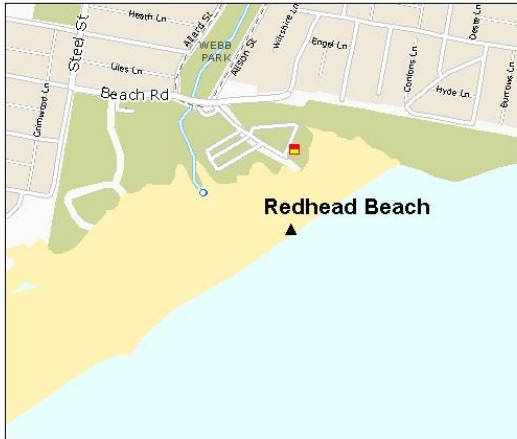
Beach grade: G

Redhead Beach is located at the northern end of a 10 kilometre stretch of beach and is patrolled between September and April.

The Beach Suitability Grade of Good indicates microbial water quality is considered suitable for swimming most of the time but may be susceptible to pollution after rain, with several potential sources of minor faecal contamination.

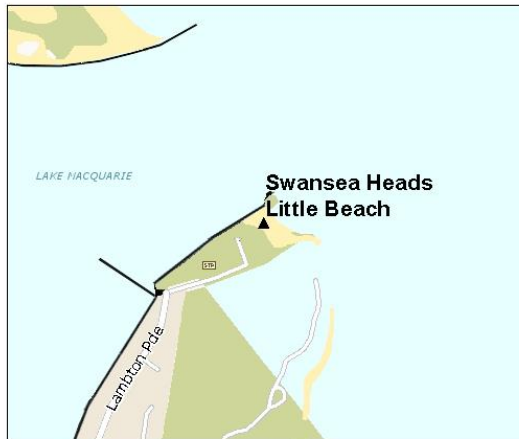
Beach grade: G

Swansea Heads Little Beach is 60 metres long and located on the southern side of the entrance to Lake Macquarie. The beach is patrolled from September to April.

The Beach Suitability Grade of Good indicates microbial water quality is considered suitable for swimming most of the time but may be susceptible to pollution after rain, from several potential sources of faecal contamination including outflow from Lake Macquarie.

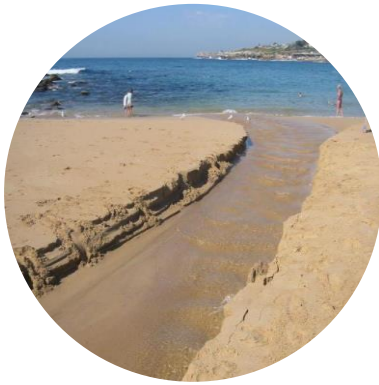
Stormwater at Coogee Beach  
Photo: Beachwatch/EES, DPIE

Stormwater in urban areas often contains sewage from leakages, overflows or sewer chokes when the sewerage system fails.
