DEPARTMENT OF PLANNING, INDUSTRY & ENVIRONMENT

State of the beaches 2019–2020

Statewide summary and how to read this report

Beachwatch

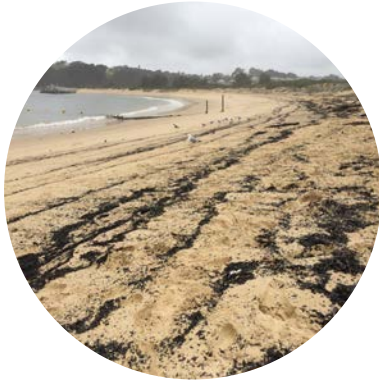
Bushfire ash and debris washed up at Wagonga Inlet on the South Coast
Photo: Adam Wethered/
EES, DPIE

Catastrophic bushfires affected many areas of New South Wales in 2019–2020, including the South Coast region between December 2019 and February 2020, and areas of the Southern Highlands in the Illawarra region between October 2019 and January 2020. Ash and debris from the bushfires was widespread and evident at many NSW beaches.

Ash fallout from bushfires can add chemical contaminants to waterways and beaches. Rainfall-driven runoff from burnt areas can also impact water quality by washing suspended solids such as ash, charcoal, debris and soil particles, pathogens and dissolved materials into dams, streams and waterways. Dissolved materials can include nutrients, metals and organic matter. Increases in nutrients including phosphorus and nitrogen in the waterways can promote algal blooms.

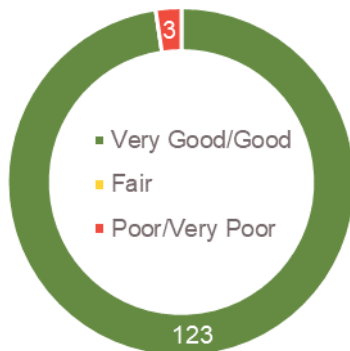
Beach Suitability Grades for monitored ocean beaches in NSW

New South Wales' open ocean beaches have excellent water quality with 98% of 126 monitored ocean beaches graded as Very Good or Good. This indicates they were suitable for swimming most or almost all of the time. This performance is similar to the 2018–2019 result, when 98% of 126 ocean beaches were graded as Very Good or Good.

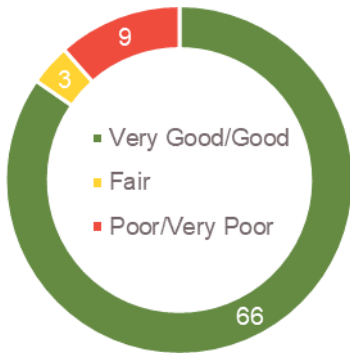
Beach Suitability Grades for monitored estuarine beaches in NSW

Sixty-six (85%) of the 78 estuarine swimming sites were graded as Very Good or Good, an improvement in performance on the previous year. While water quality at these sites was suitable for swimming most of the time, it was occasionally impacted by stormwater pollution following rainfall. These estuarine swimming sites are generally located in the well-flushed sections of the estuaries or had few potential sources of faecal contamination.

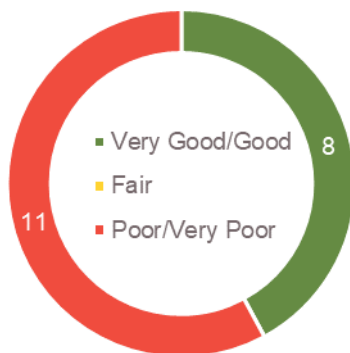
Beach Suitability Grades for monitored lake/lagoon swimming sites in NSW

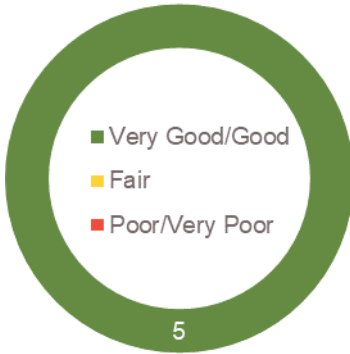
Beach Suitability Grades for monitored ocean baths in NSW

All five ocean baths were graded as Good in 2019–2020: Cabbage Tree Bay Rockpool, The Entrance Ocean Baths and Pearl Beach Rockpool on the Central Coast, South Maroubra Rockpool in Sydney and Big Blue Pool on the South Coast. While water quality at The Entrance Ocean Baths was generally suitable for swimming during dry and wet weather conditions, water quality at the other four ocean baths was mostly suitable for swimming after little or no rain, with elevated bacterial levels recorded following higher levels of rainfall.

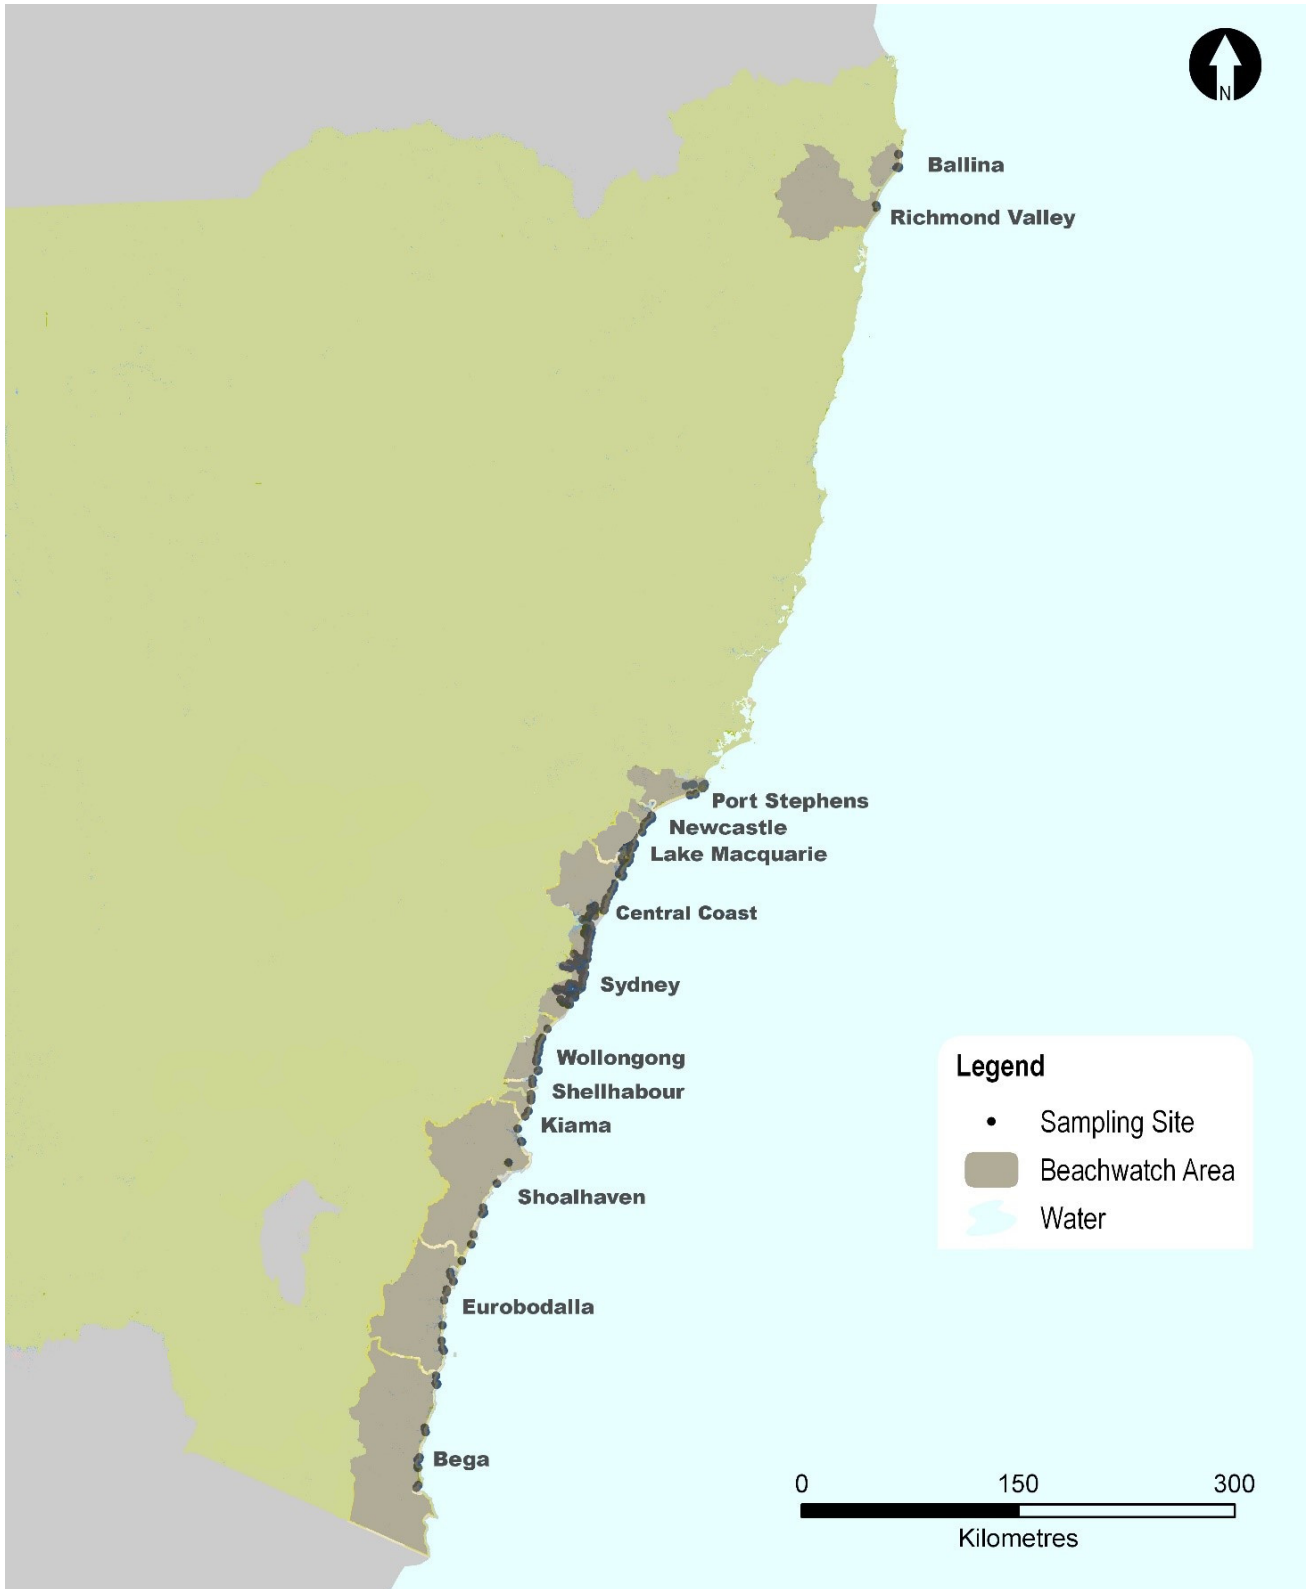
Sampling sites and areas monitored in New South Wales under the Beachwatch programs

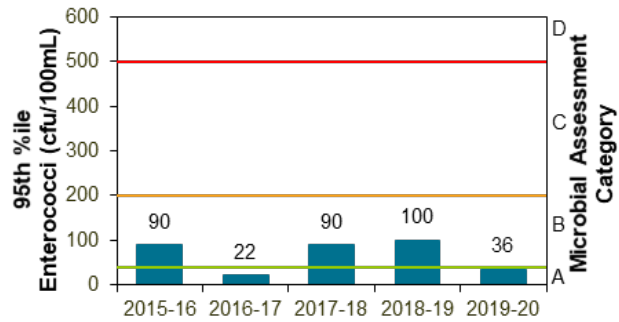
Sanitary Inspection Category (SIC) chart

The results of the sanitary inspection for each swimming location are presented in a radar pie chart. The chart shows the likelihood that each identified pollution source will contribute to faecal contamination at a swimming site, as indicated by the size and colour of the segment, ranging from very low (lightest colour) to very high (darkest colour) as shown below. The sum of these contributions is the overall likelihood, or Sanitary Inspection Category.

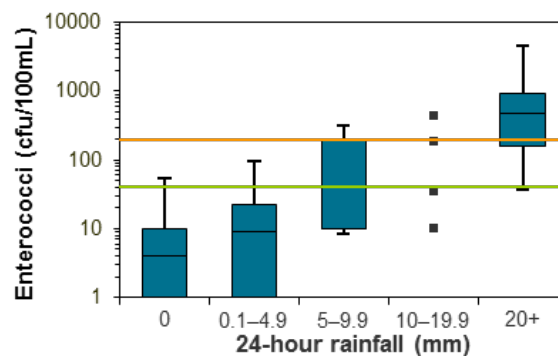
Trends in enterococci levels in response to rainfall are shown using a box plot. For reference, enterococci levels of 40 cfu/100 mL and 200 cfu/100 mL are indicated with a green and orange line, respectively. The 40 cfu/100 mL level is referred to as the 'safe swimming limit'. The enterococci data were obtained from the last five years of monitoring. Rainfall data were obtained from rain gauges situated close to the sample site and are 24-hour totals to 9am on the day of sampling. If there are fewer than five enterococci data points in a rainfall category, individual data points are presented instead of a box plot. At sites where many results are below the detection limit (1 cfu/100 mL), only the upper portion of the box plots will be visible.

Each part of the box plot represents a significant percentile value of the sample population:

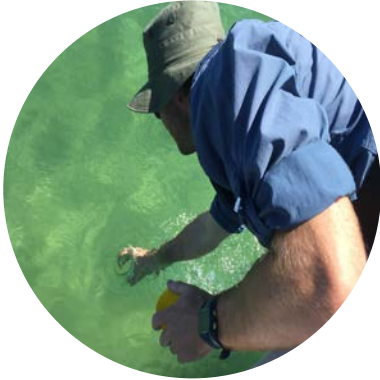
Water sample collection
Photo: Beachwatch/EES,
DPIE

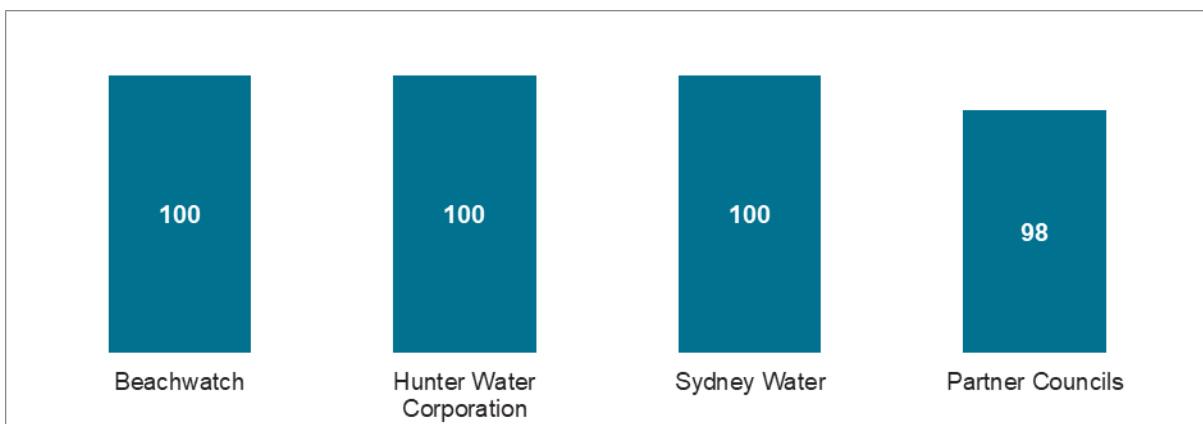
Figure 1 Percentage compliance with Beachwatch sampling protocols in 2019–2020

Sample collection by Beachwatch, Hunter Water and Sydney Water complied well with established sampling protocols, with a compliance of 100%. Councils in the Beachwatch Partnership Program achieved an overall compliance of 98% with Beachwatch sampling protocols.

Minor non-compliance was noted during the field audits of two partner councils, which did not include checks of esky temperature while sampling or detailed field observations. While the temperatures of the samples are checked by the laboratory before testing, regular checks of esky temperature during a run will alert the sampler to quickly resolve any issues if temperature for sample storage and transport is outside of ideal range. Recording detailed field observations

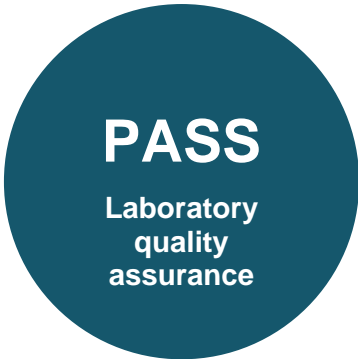
Figure 2 Distribution of duplicate enterococci (cfu/100 mL) results for the contracted laboratory, May 2019 to April 2020

To assess the reliability of laboratory data, Beachwatch sends duplicate water samples to our contracted microbiological laboratory, which is accredited by the National Association of Testing Authorities (NATA). Duplicate samples are collected from the same site at the same time and the laboratory is unaware that the samples are collected from a single location. The results are expected to be similar.

Due to the inherent variability of bacterial levels in environmental samples, duplicate results that are within 0.3 log-units of each other (equivalent to a halving or doubling of density on a linear scale) are considered to be acceptable. Most duplicate samples were within the acceptable limits; however, some enterococci results were outside this range, with most of these at very low bacterial densities that were below the safe swimming limit. Where values were outside this range, the site result was more often higher than the replicate, indicating that results were rarely underestimated.

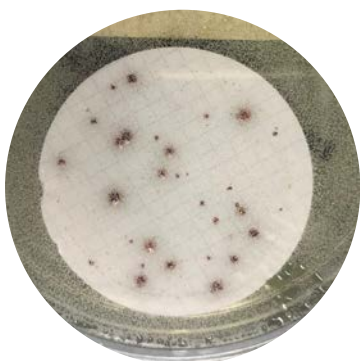
Confirmed colonies of
enterococci on plate
Photo: Silliker Australia

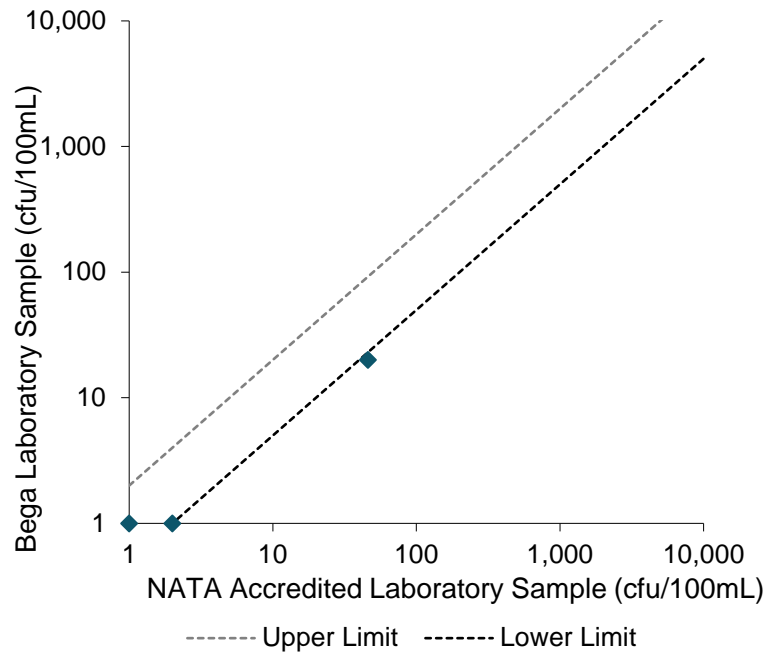
Figure 3 Distribution of duplicate enterococci (cfu/100 mL) results for Bega and NATA accredited laboratories

Bega Valley Shire Council collected duplicate samples on three occasions during the summer season. Bega laboratory analysed one sample while the duplicate was sent to a NATA accredited laboratory for testing. Comparison of results showed four of the six samples were within the acceptable limits. Three of these are not shown in Figure 3 as the values were less than one colony forming unit per 100 millilitres. Bega laboratory reported two results outside the lower limit, and slightly lower than the bacterial count reported by the NATA accredited laboratory (Figure 3), with one outlier well below the safe swimming limit, and one just above the safe swimming limit. Bega laboratory microbial analysis has continued to show much improvement in performance over the last four years, and confidence can be placed in data reported for council's swimming sites.

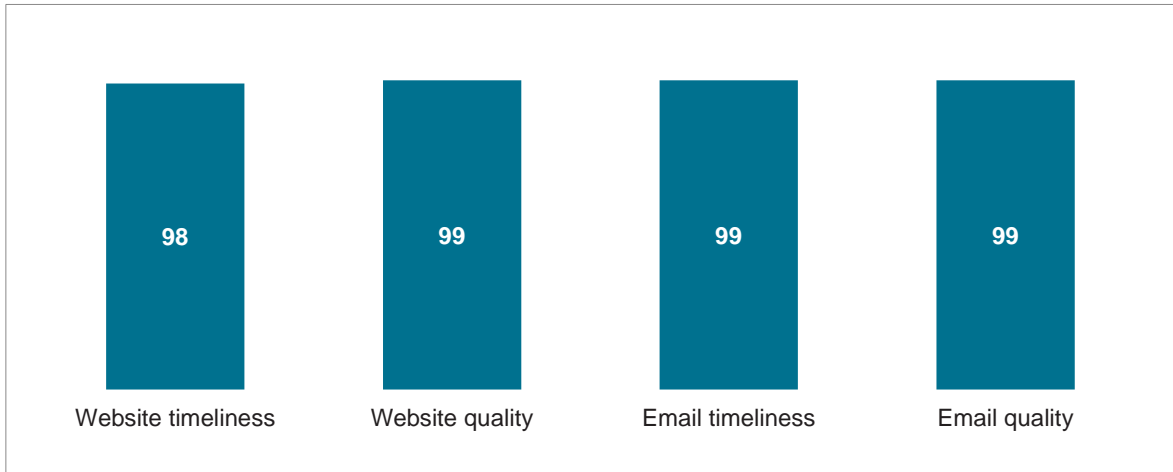
Figure 4 Percentage compliance with beach pollution forecast reporting protocols in 2019–2020

Forecast reports are audited weekly to assess the quality and punctuality of information issued on the Beachwatch website and in emails:
