Beachwatch

State of the beaches 2021–22

Mid-North Coast Region

Mid-North Coast region summary 2021–2022

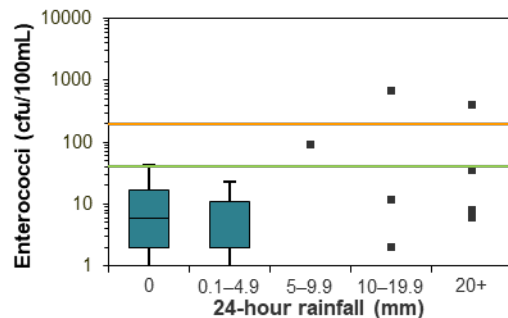
Water quality in response to rainfall

Enterococci levels increased slightly with increasing rainfall, occasionally exceeding the safe swimming limit after no rain, and after 5 mm or more of rain.

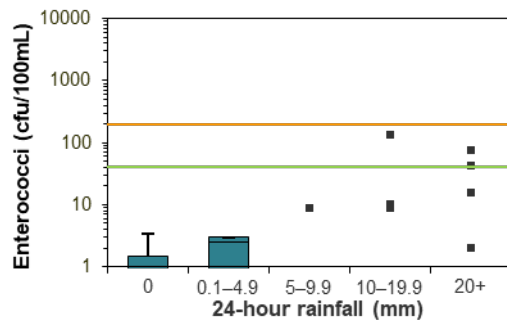
Water quality in response to rainfall

Enterococci levels increased slightly with increasing rainfall, occasionally exceeding the safe swimming limit after 10 mm or more of rain.
