Beachwatch

State of the beaches 2023–24

Mid-North Coast region

Department of Climate Change,
Energy, the Environment and Water

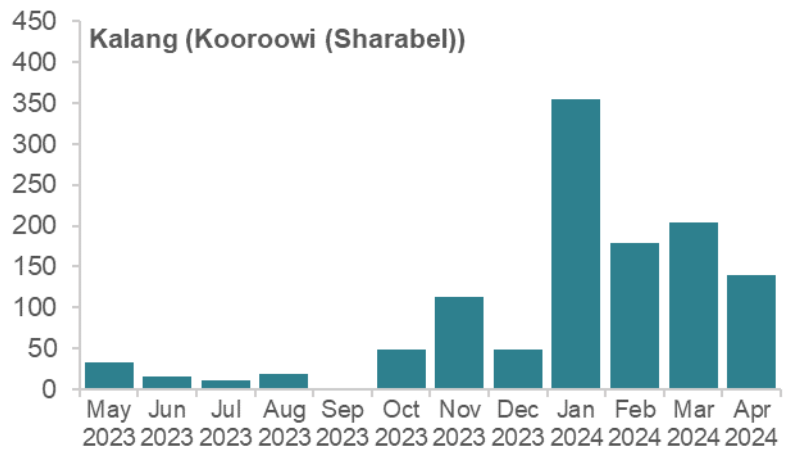
Mid-North Coast region rainfall

Rainfall on the Mid-North Coast was below the long-term monthly averages from May to September 2023. Monthly rainfall totals were much higher than the previous 6 months across the region between October 2023 and April 2024, with January 2024 notably wet. Coffs Harbour recorded more than two and half times the long-term January average rainfall.

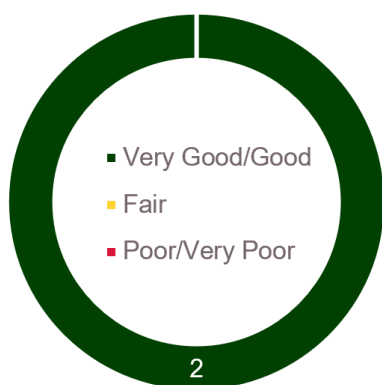
Beach Suitability Grades for Bellinghen Shire Council ocean beaches

Hungry Head Beach and North Beach were graded as Good in 2023–2024. Hungry Head Beach improved to Good from Poor in the previous year. Water quality at these beaches was suitable for swimming most of the time, with 83% and 94% of dry weather samples within the safe swimming limit at Hungry Head Beach and North Beach respectively.

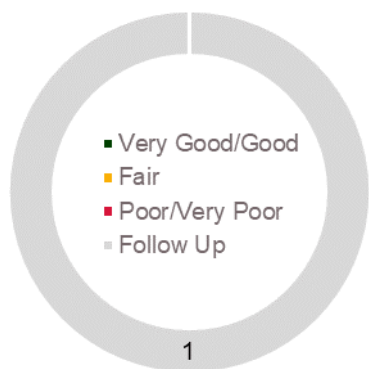
Beach Suitability Grades for Bellingen Shire Council lagoon site

Dalhousie Creek was graded as Follow Up in 2023–2024, due to incongruent results from the sanitary inspection and microbial water quality. While this grade is provisional, microbial water quality was mostly suitable for swimming during dry weather conditions, with 74% of dry weather samples within the safe swimming limit. Elevated bacterial levels increased with increasing rainfall, and frequently exceeded the safe swimming limit after moderate rainfall.

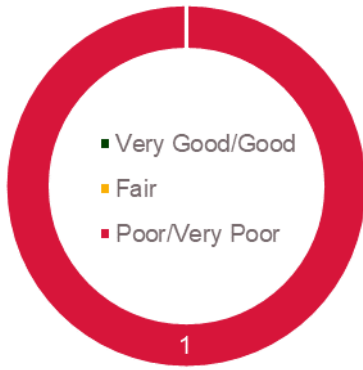
Beach Suitability Grades for Bellingen Shire Council freshwater site

Arthur Keough Reserve was graded as Poor in 2023–2024, similar to the previous year. This grade is provisional and subject to change as data available for the microbial assessment is incomplete.

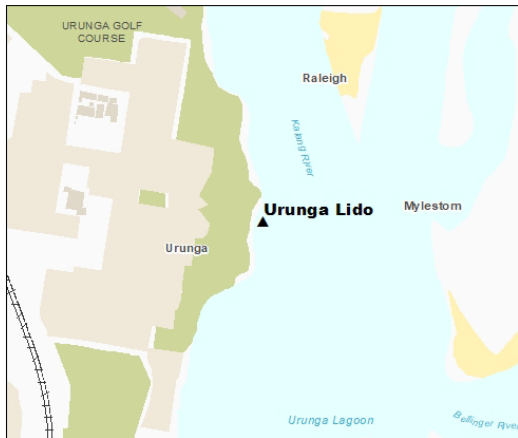
Urunga Lido is a sandy beach with calm waters located in the Kalang River Estuary. The beach is backed by a holiday park and features a recently upgraded boardwalk.

The Beach Suitability Grade of Poor indicates microbial water quality is susceptible to faecal pollution, particularly after rainfall, with potential contamination from Urunga Lagoon and river discharge.

Enterococci levels increased slightly with increasing rainfall, often exceeding the safe swimming limit in dry and wet weather conditions.

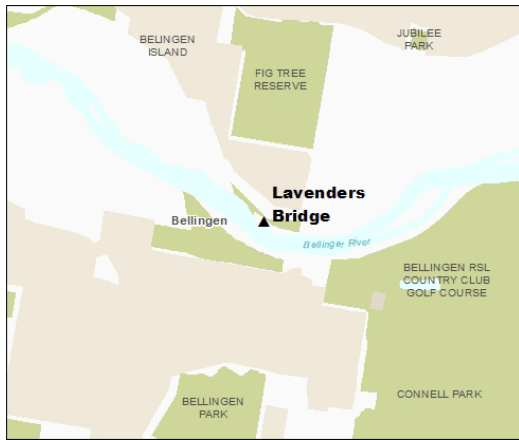
Lavenders Bridge is a riverside beach in the Bellingher River in the centre of Bellingen.

The Beach Suitability Grade of Poor indicates microbial water quality is susceptible to faecal pollution, particularly after rainfall and occasionally during dry weather conditions, with potential faecal contamination from upstream sources in Bellingher River and bathers.

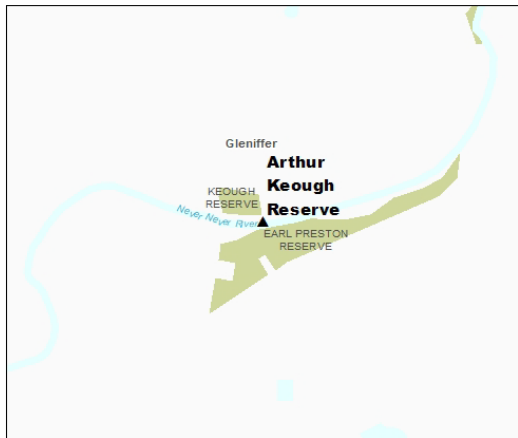
Arthur Keough Reserve is a riverside picnic spot offering space for recreation and relaxation along the Never Never River.

The Beach Suitability Grade of Poor indicates microbial water quality is susceptible to faecal pollution, particularly after rainfall and occasionally during dry weather conditions, with potential faecal contamination from bathers and onsite systems.

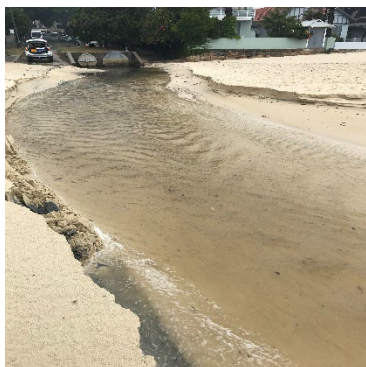
Stormwater drain flow

Stormwater in urban areas often contains sewage from leakages, overflows or sewer chokes when the sewerage system fails.

Sewage overflows can occur in wet weather when the network has exceeded capacity due to rainwater entering the system. The mix of sewage and rainwater discharges from designated overflow points and drains to waterways, usually via the stormwater system. Overflows from the sewerage system can also occur in dry weather due to mechanical failure or power outage.

Sewer chokes occur due to blockages in the pipes usually due to tree roots, oil, grease or debris. This causes sewage to back up and escape via sewer inspection points, designed overflow structures or cracks in the pipes, then drain to waterways, usually via the stormwater system.
