30013602

19 January 2024

RE: Terania Street Bridge – Structural soundness following impact

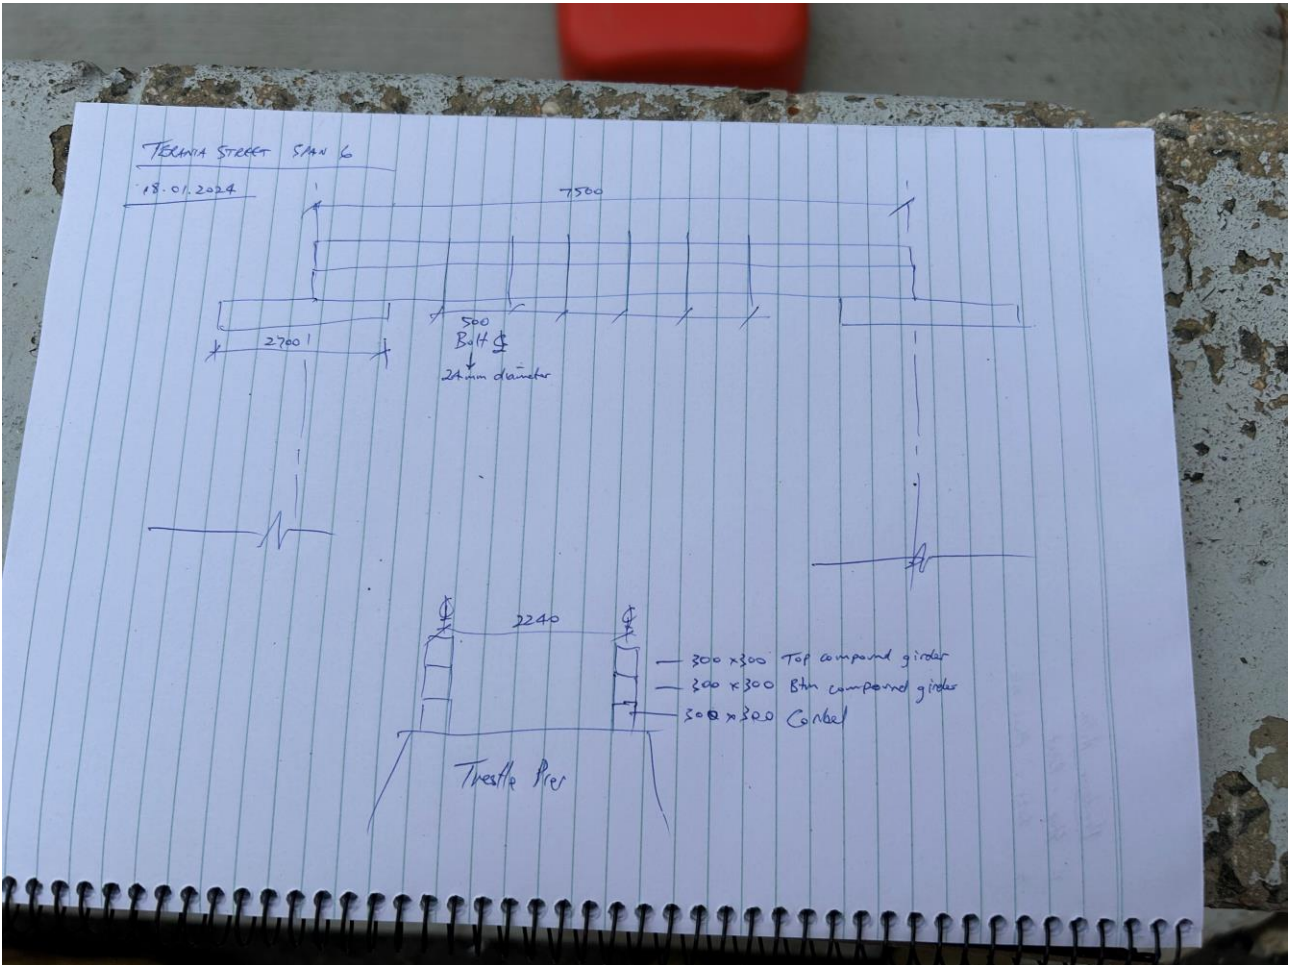
Attachment 1 – Dimensions

- Dimensions taken by TfNSW on site on 18/01/24 (attached)
- F22 timber grade (as recommended by the RTA timber bridge manual)
- Damaged beam assumed to be dead load only and not contributing to the capacity.
- Loads considered were – self weight of beams, sleepers, steel angles, steel rails. No live load considered as access to the top of the bridge is blocked.
- Load factors were as per AS5100.2.
