GOAT ISLAND

Conservation Management Plan

Volume 4

Appendices

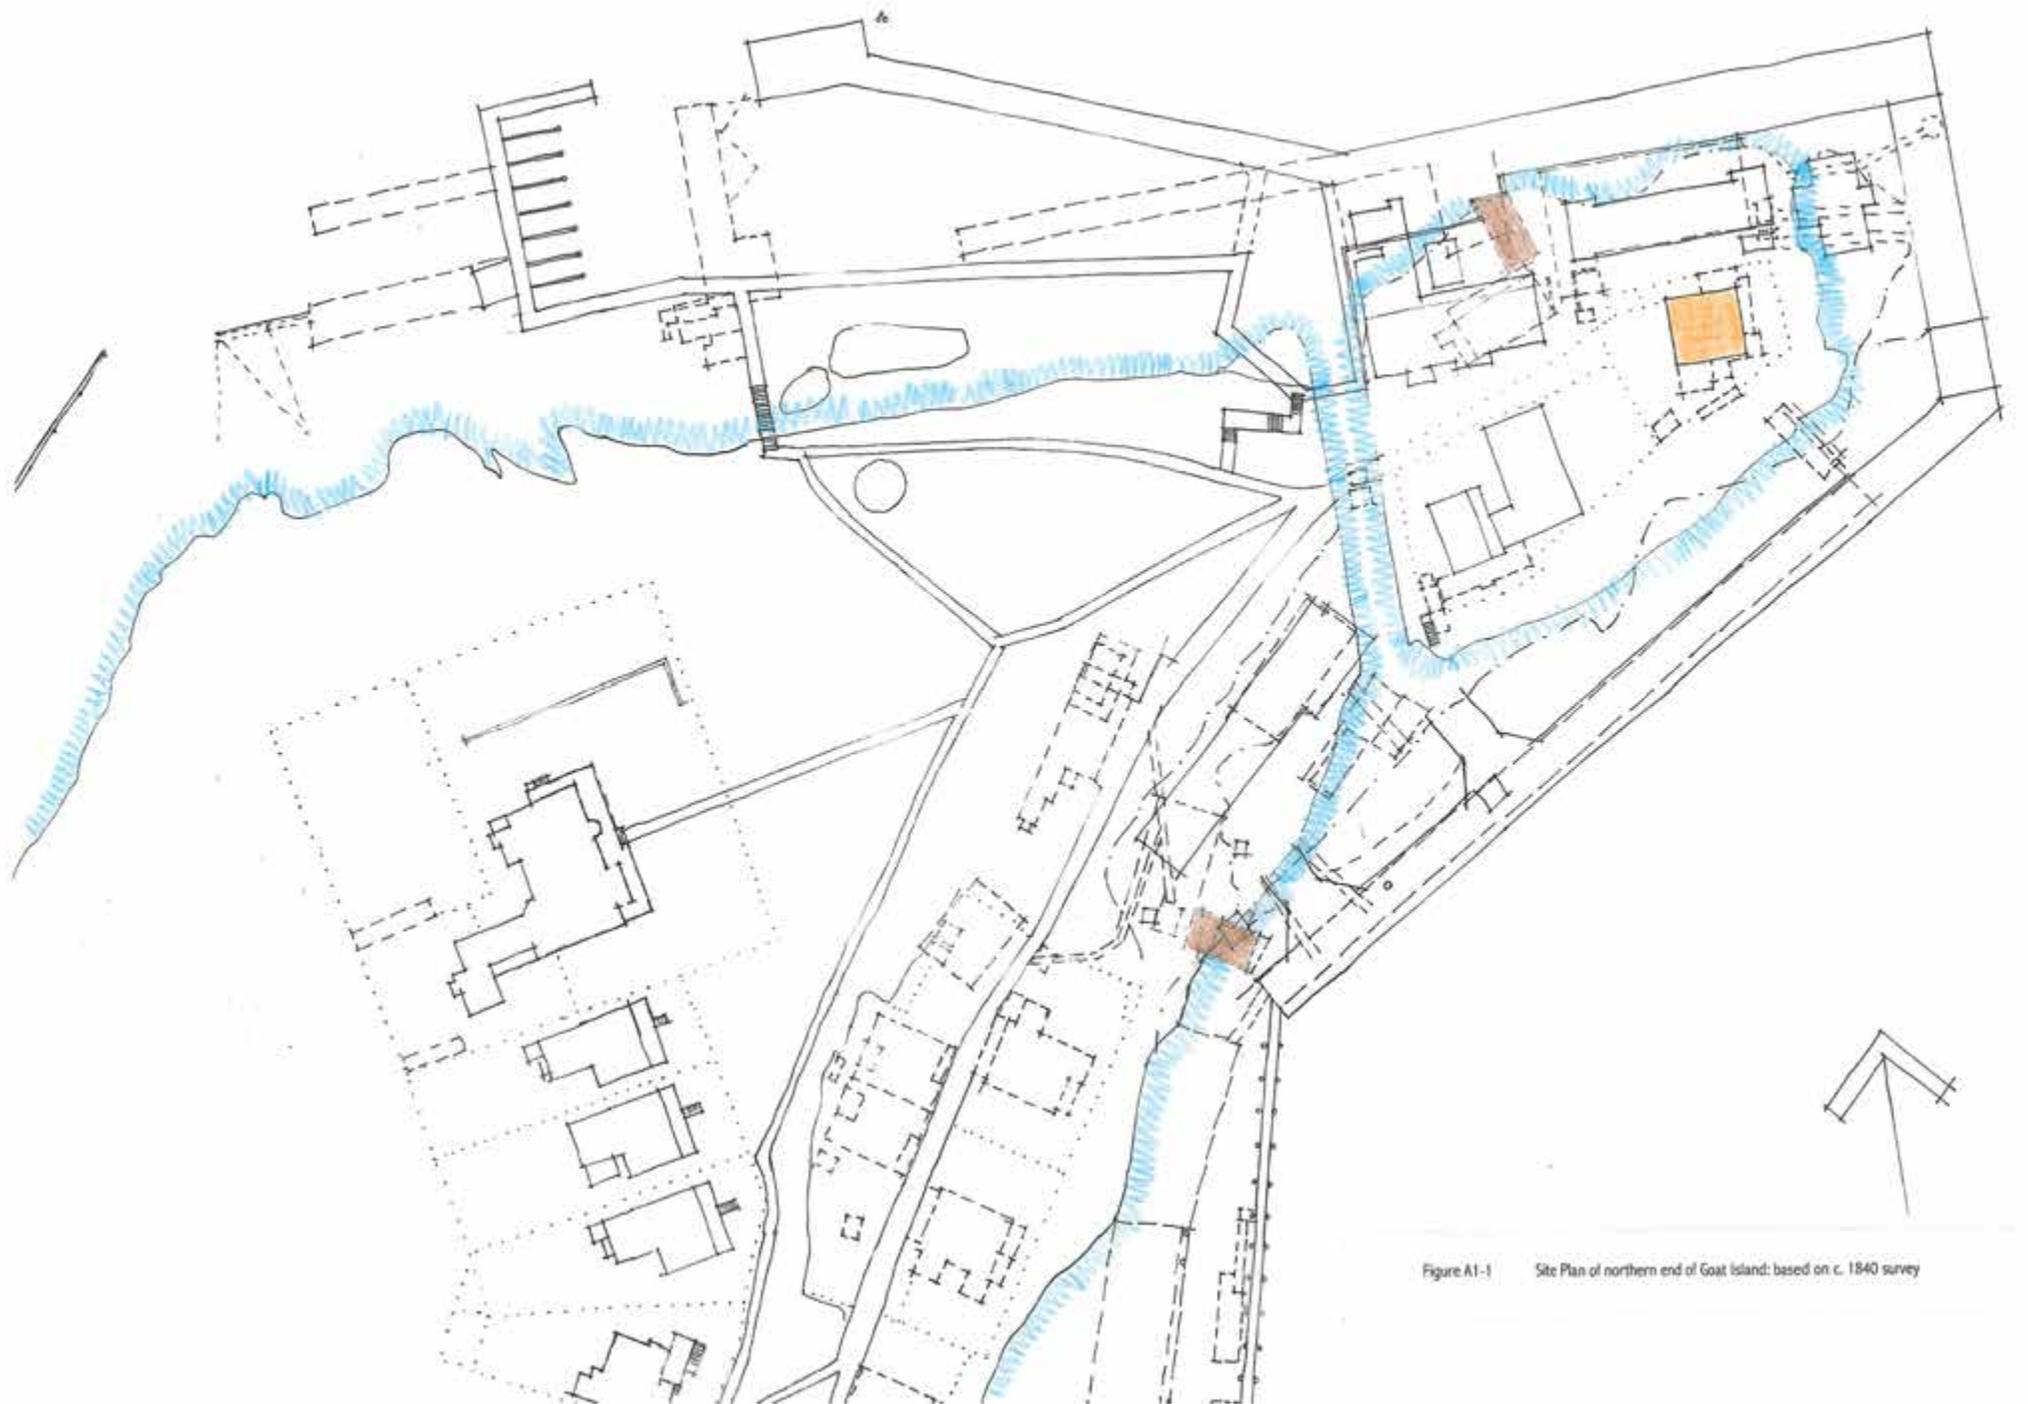
Figure A1-1 Site Plan of northern end of Goat Island: based on c. 1840 survey

The extant buildings at the plan dates are shown in orange, with extant wharves in brown. Extant shorelines at the plan dates are shown in blue.

These plans are provided to demonstrate the layering of the site, the location of earlier site elements in relation to the current structures, site features and landforms and to illustrate how the edges of the island and the shoreline development have evolved.

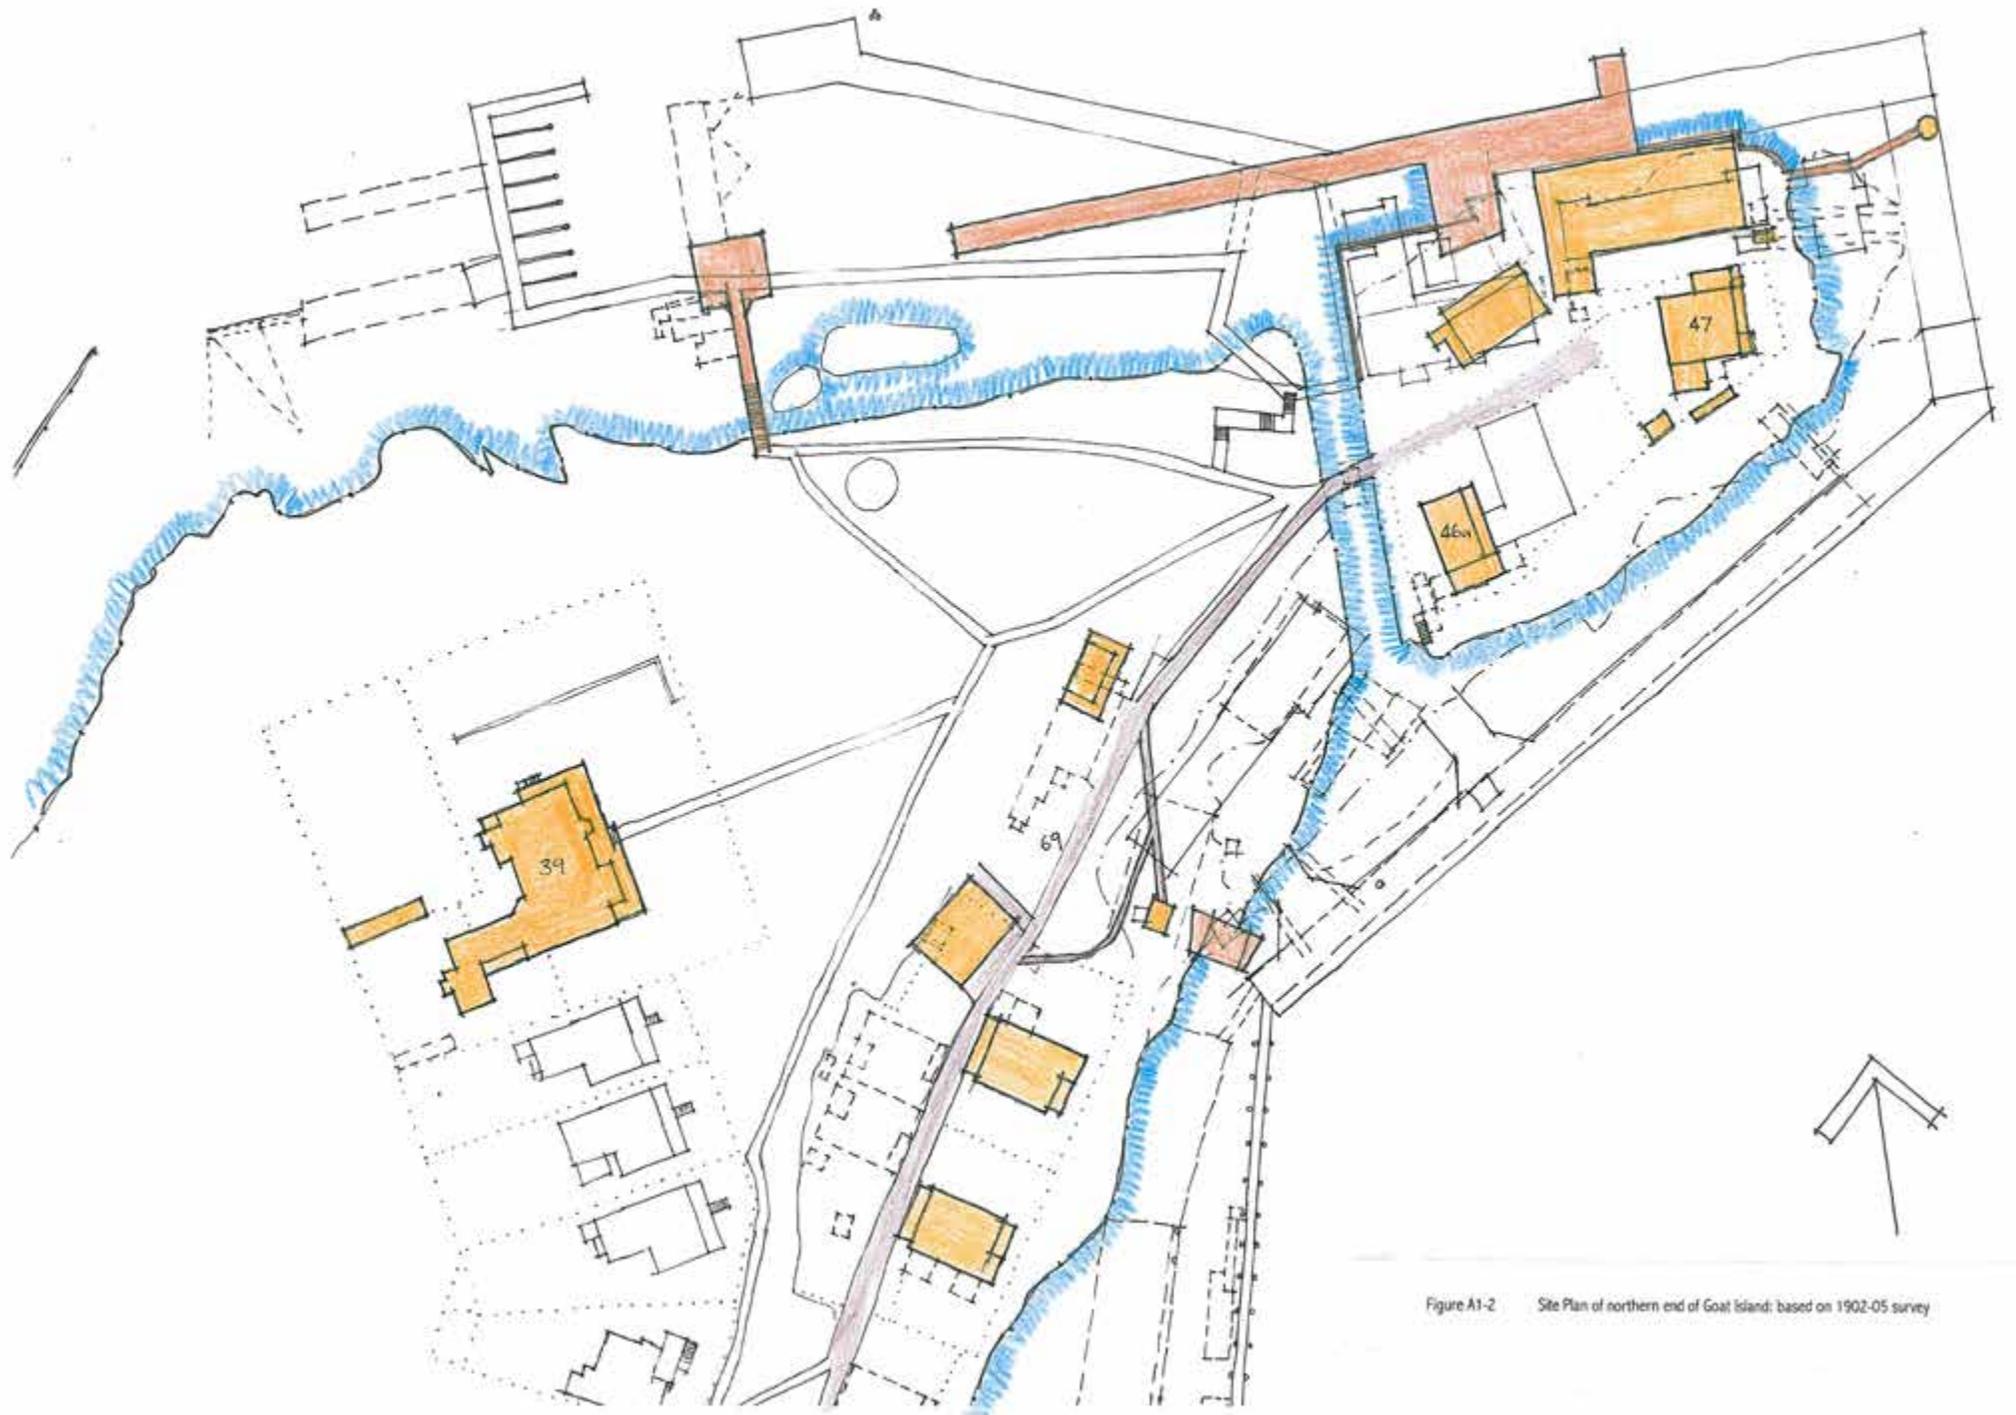
Figure A1-2 Site Plan of northern end of Goat Island; based on 1902-05 survey

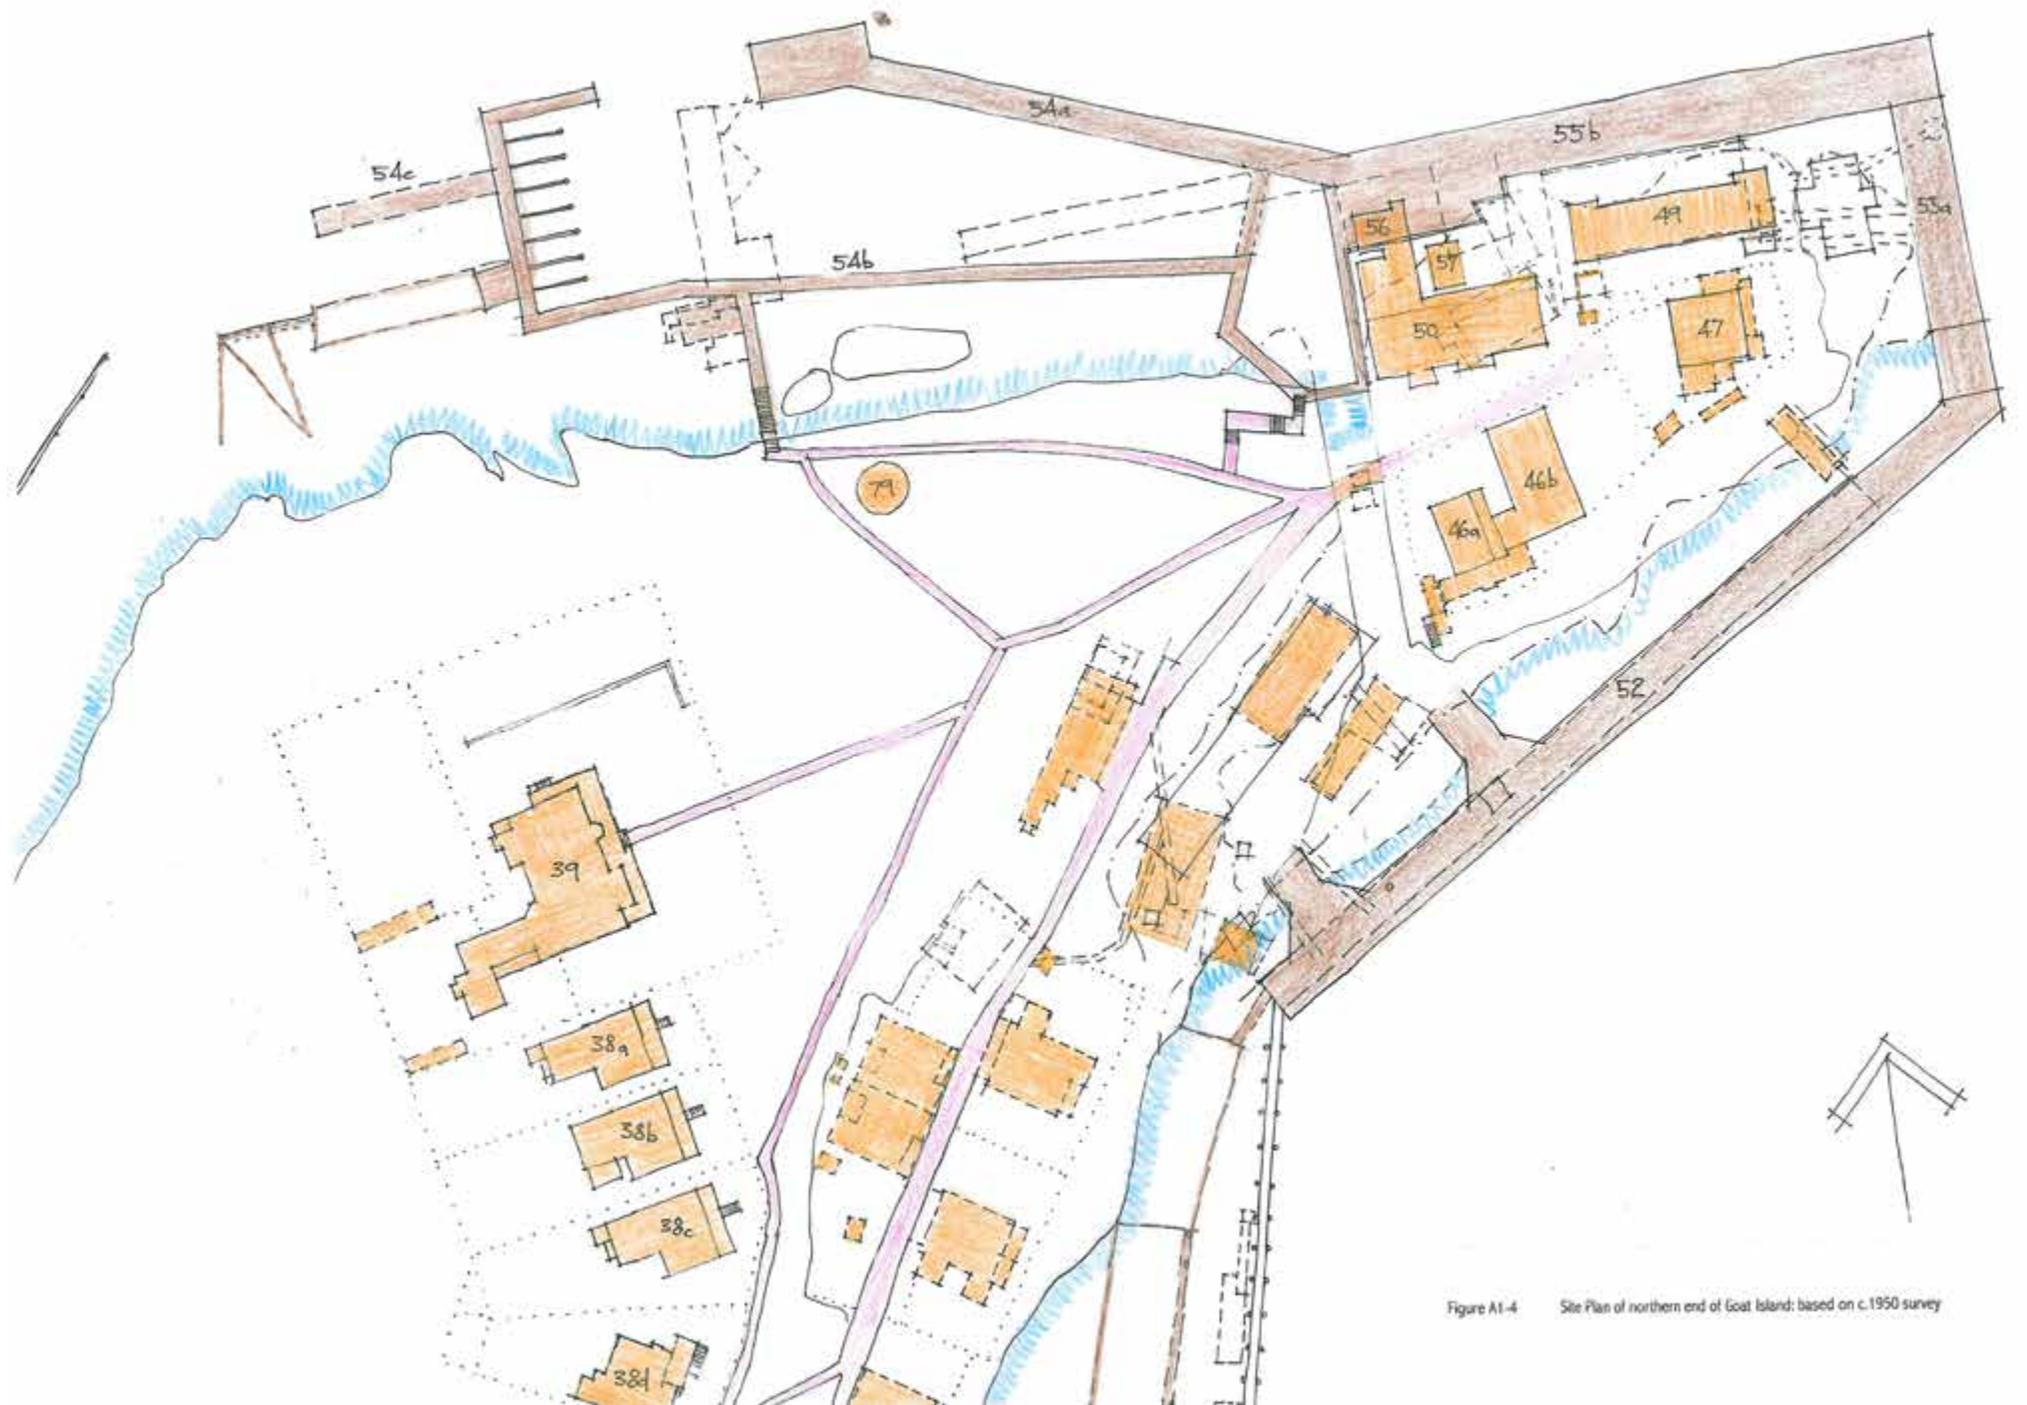
Figure A1-4 Site Plan of northern end of Goat Island: based on c.1950 survey

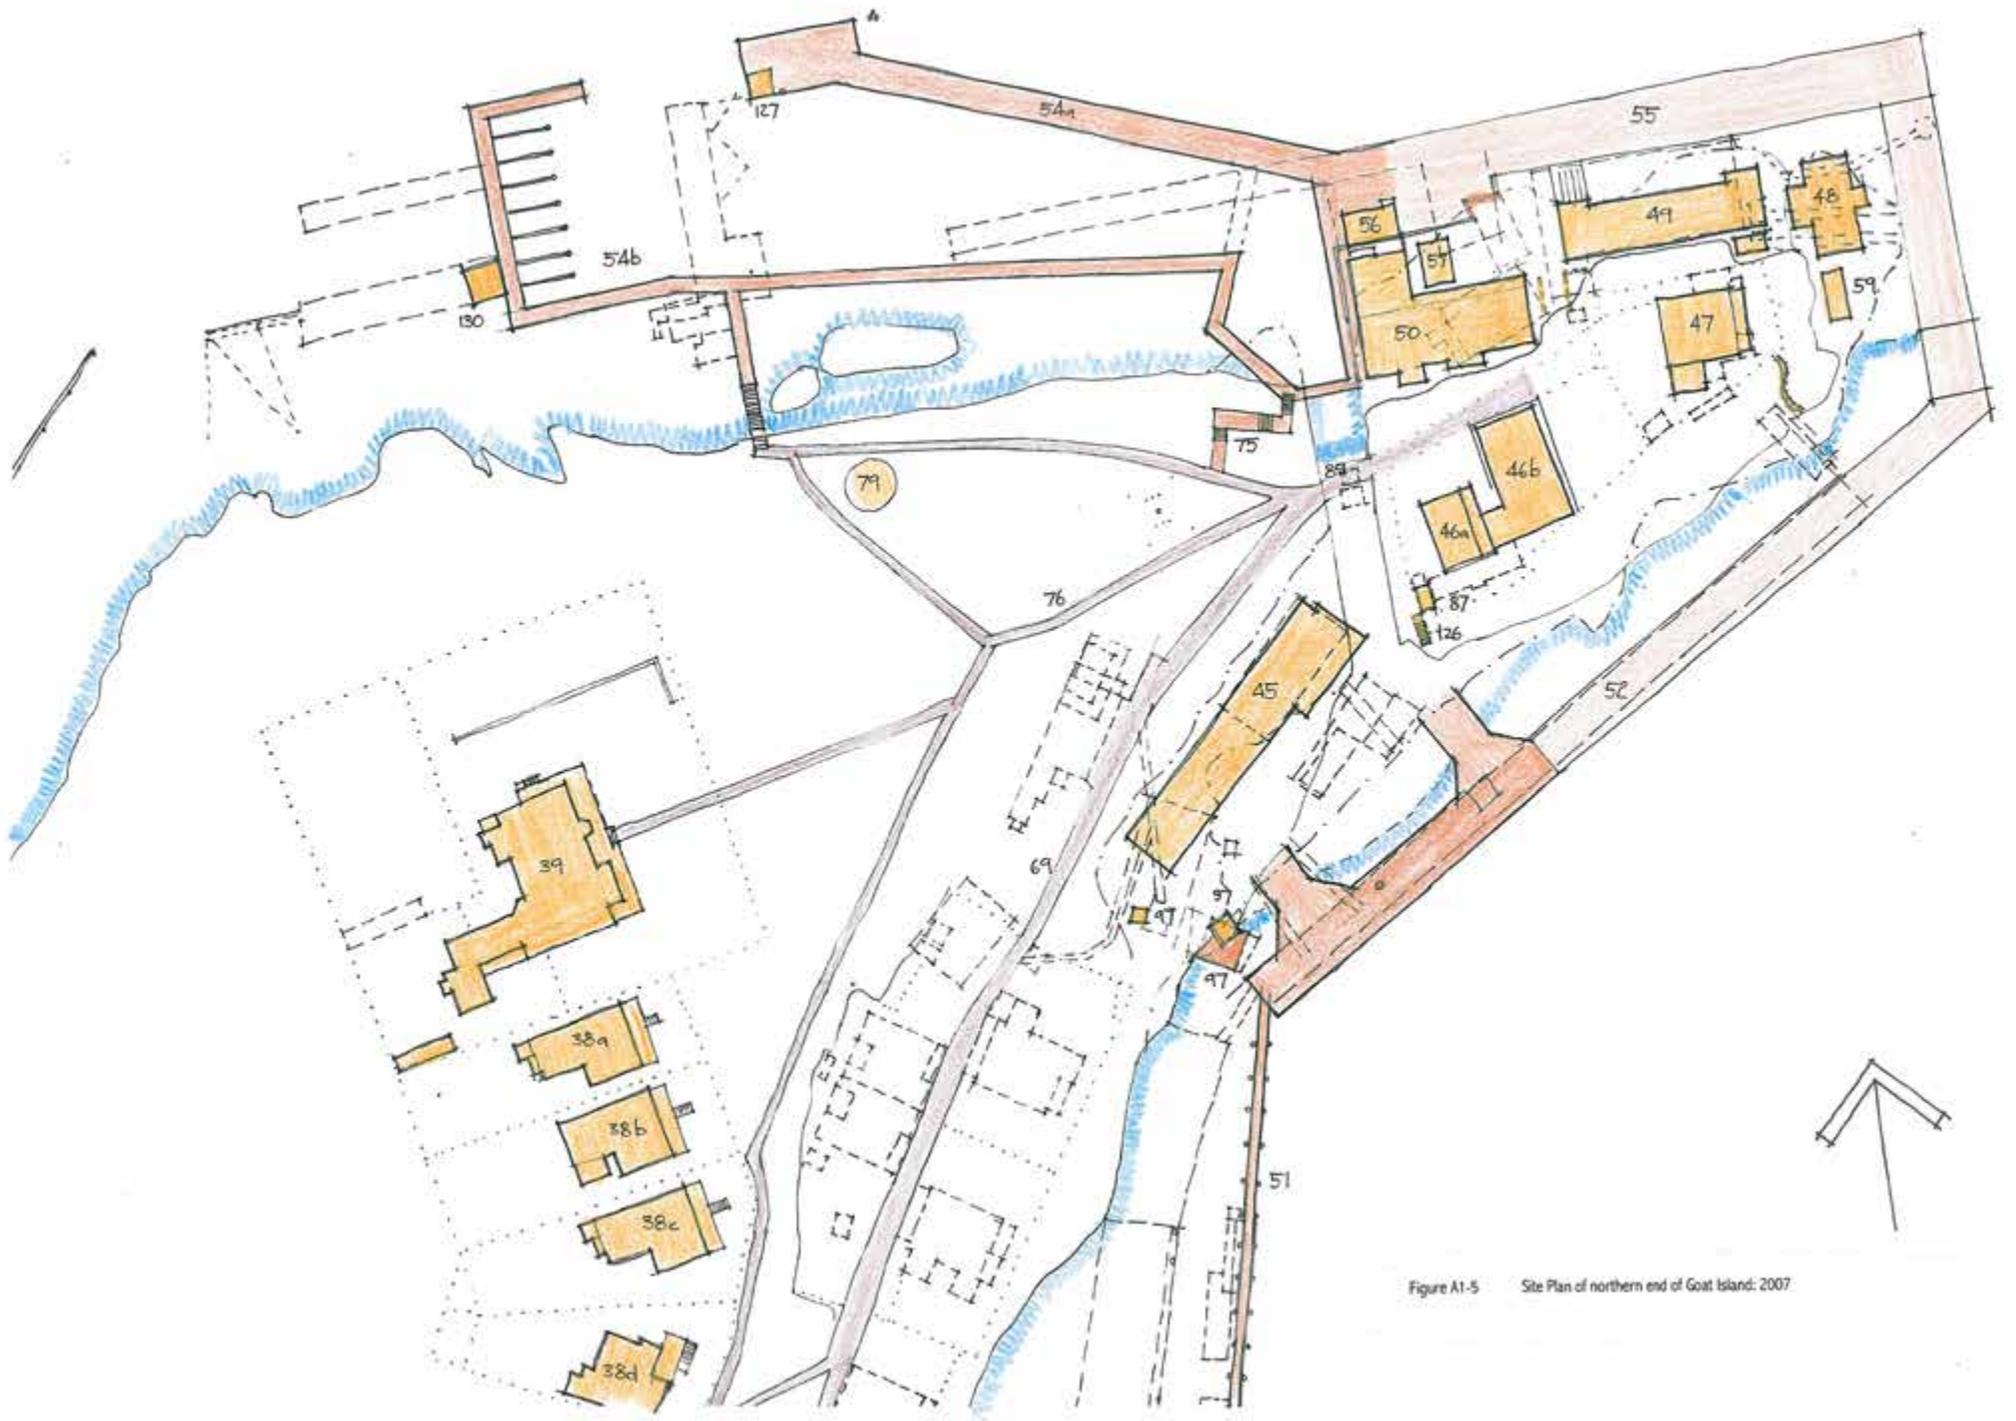
Figure A1-5 Site Plan of northern end of Goat Island: 2007

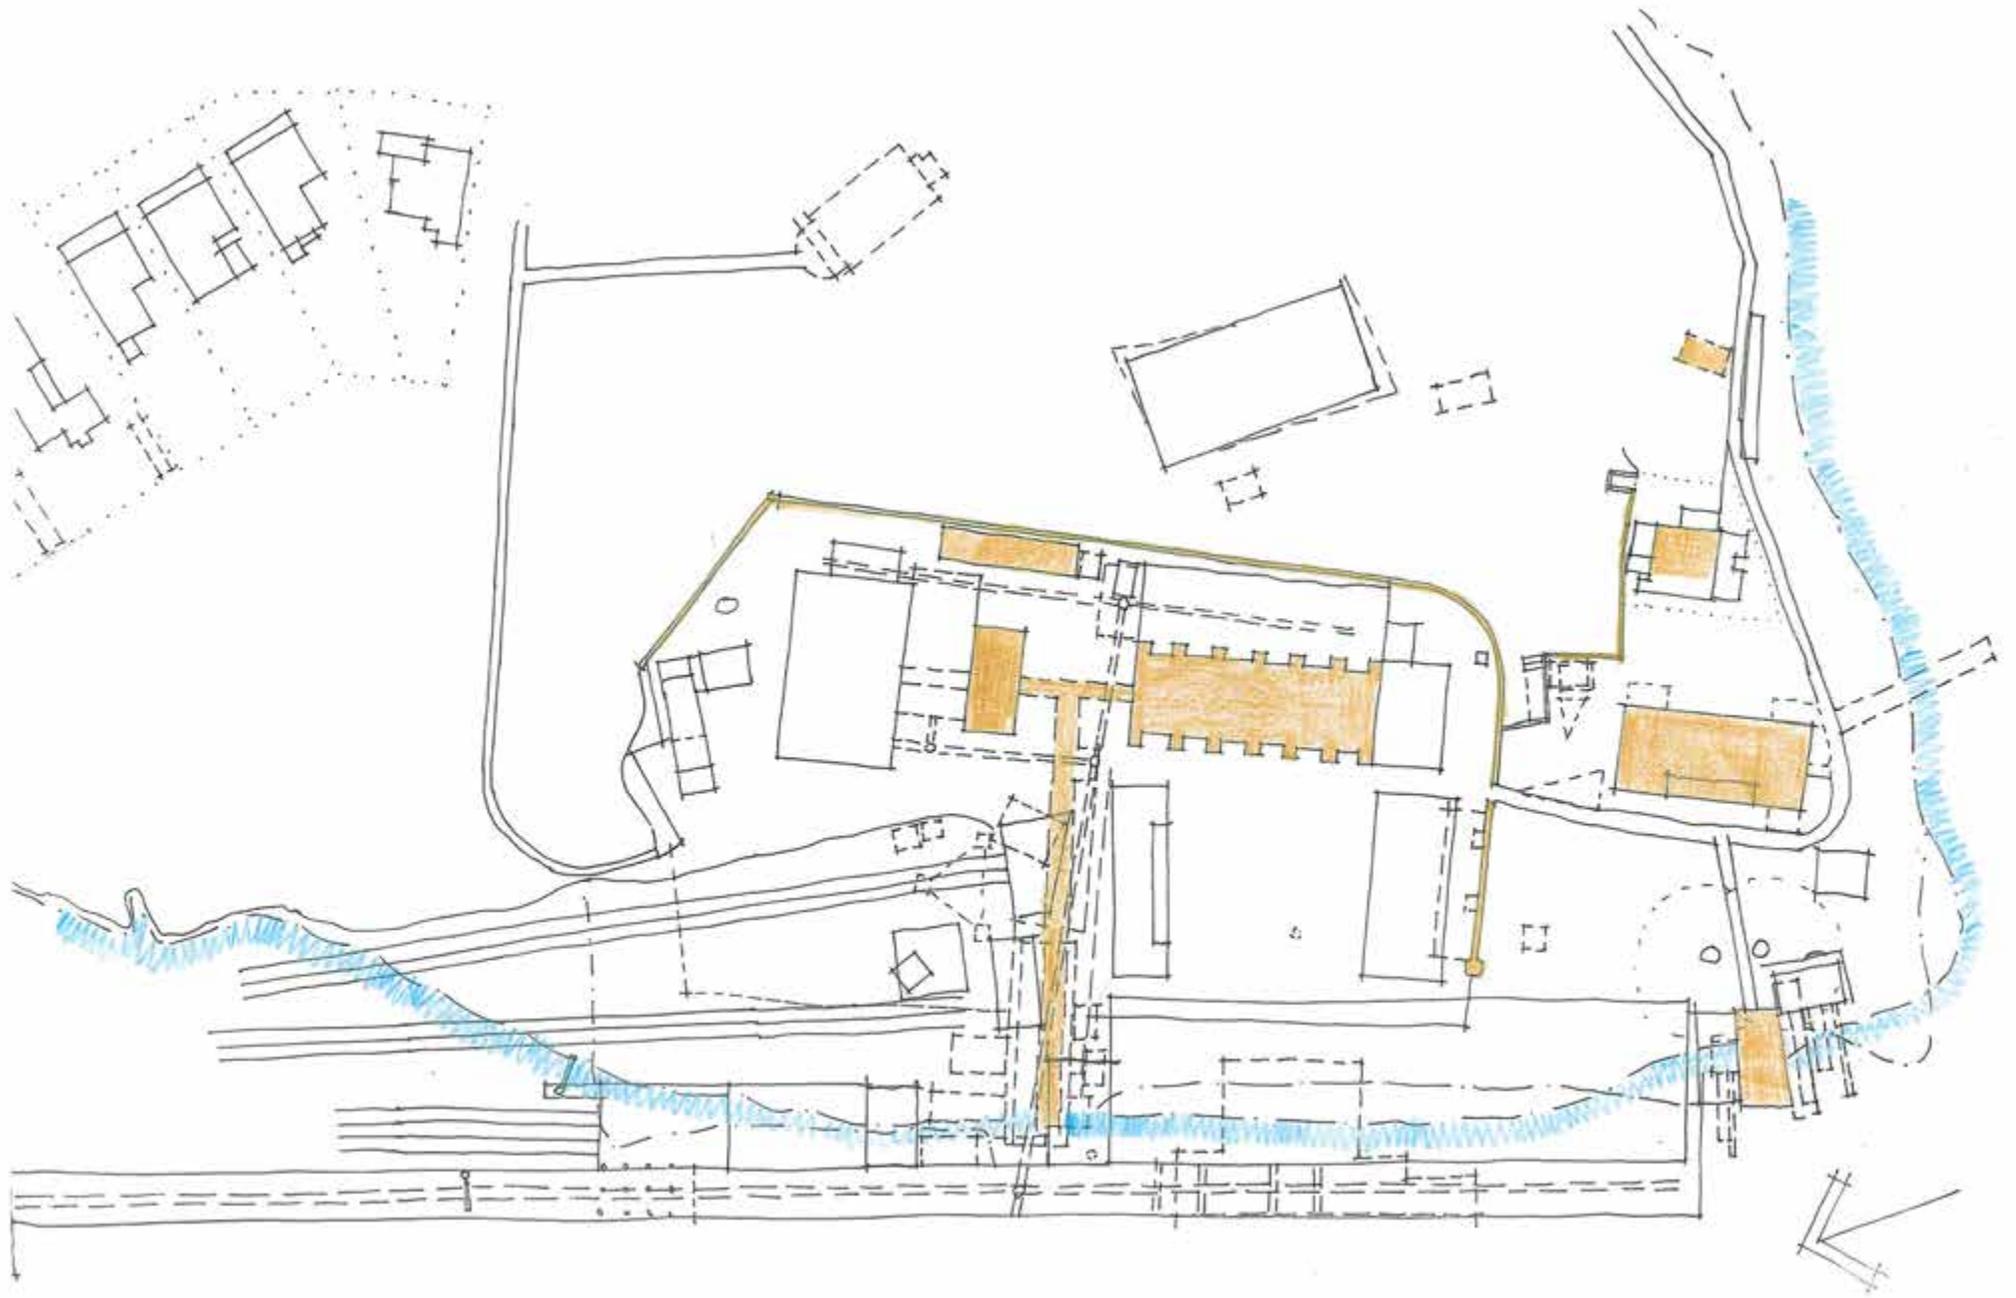
Figure A1-6 Site Plan of southern end of Goat Island: based on c. 1840 survey

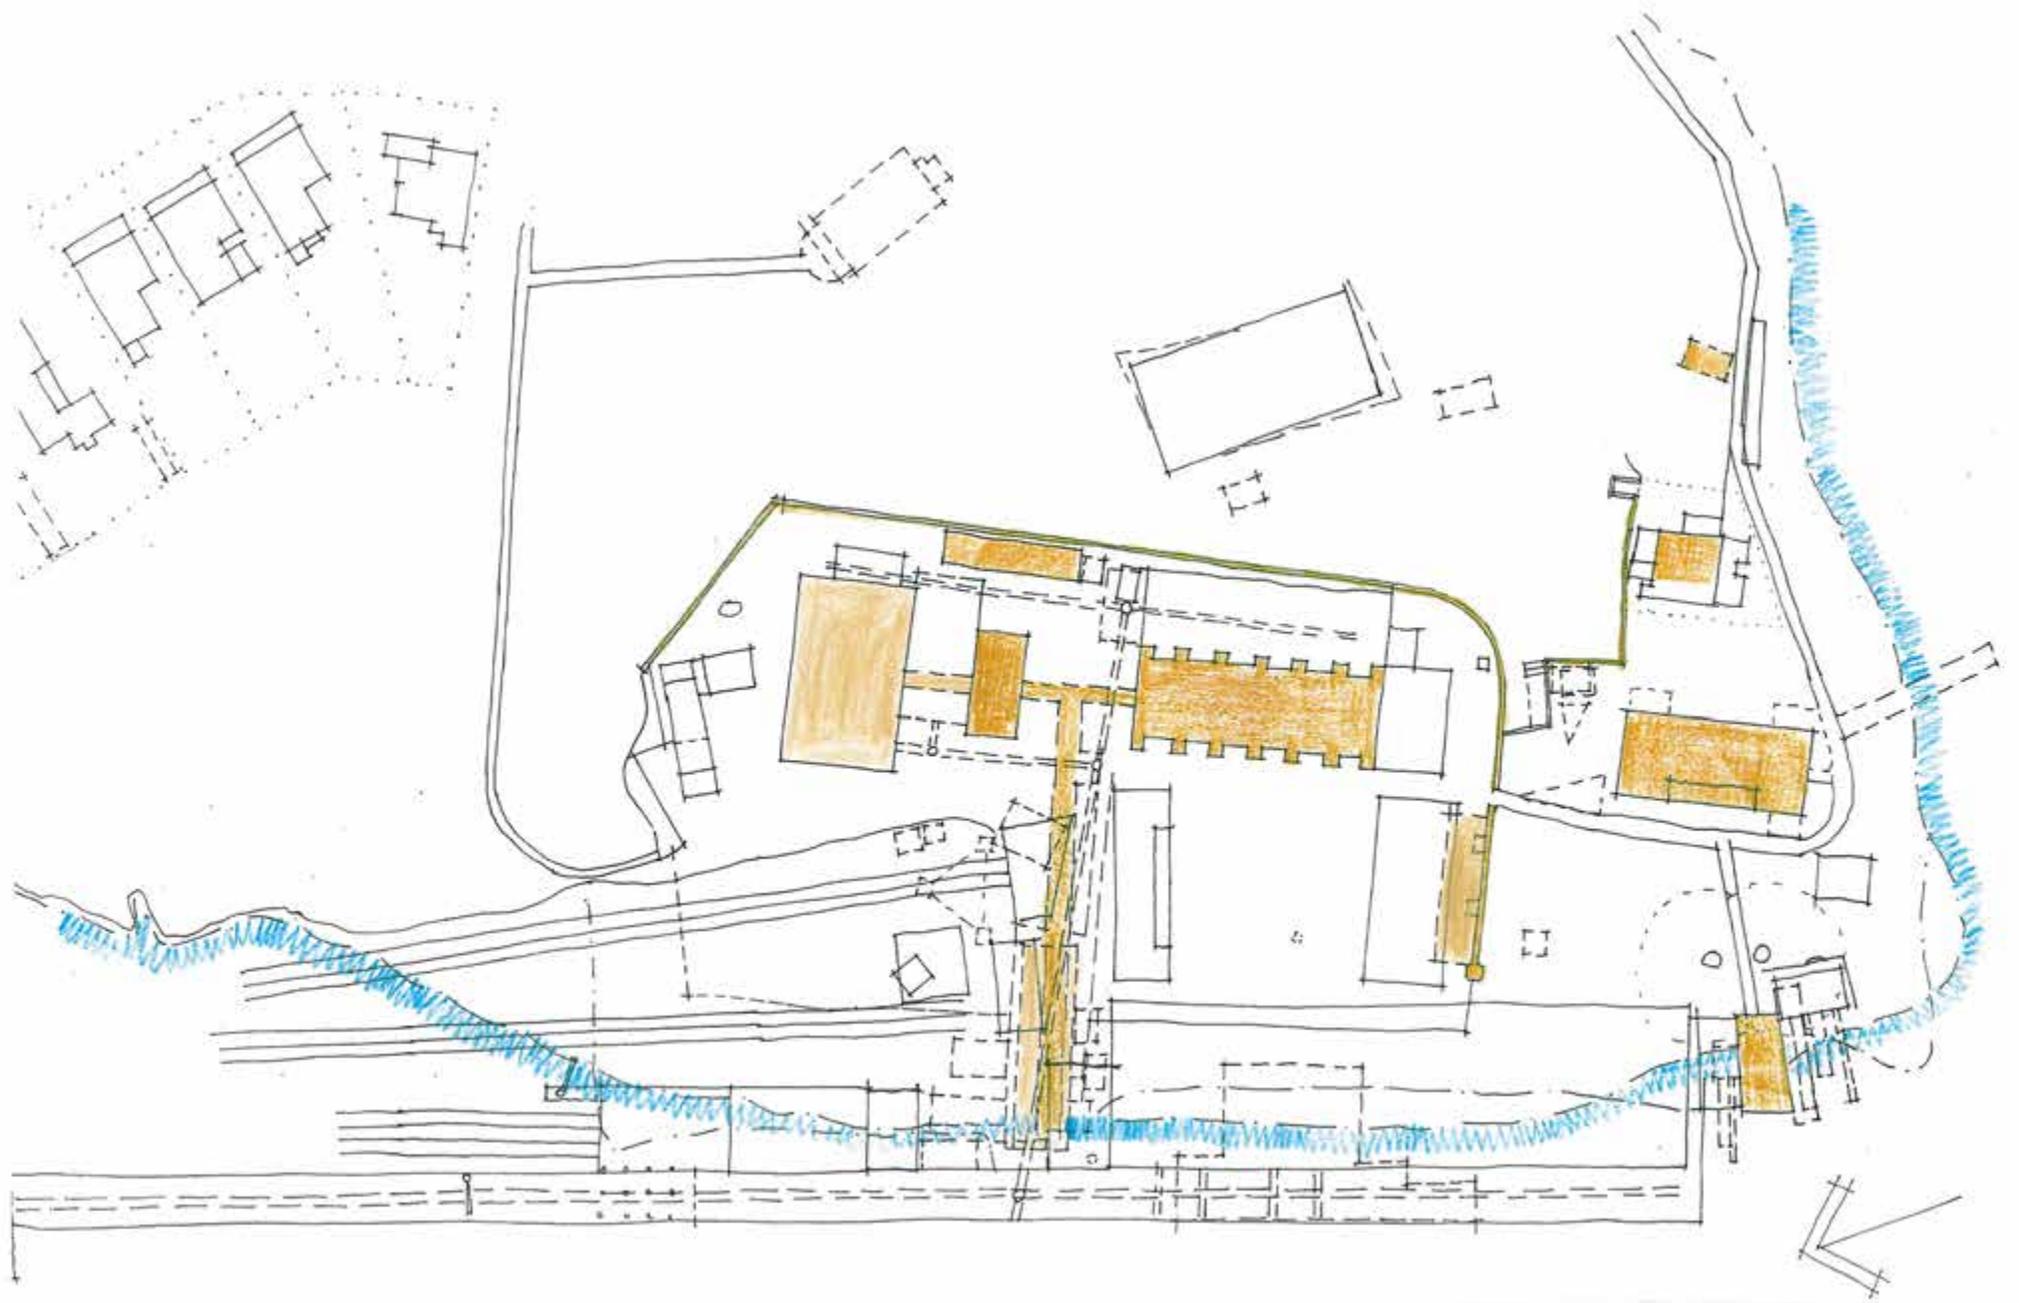
Figure A1-7 Site Plan of southern end of Goat Island: based on 1902-05 survey

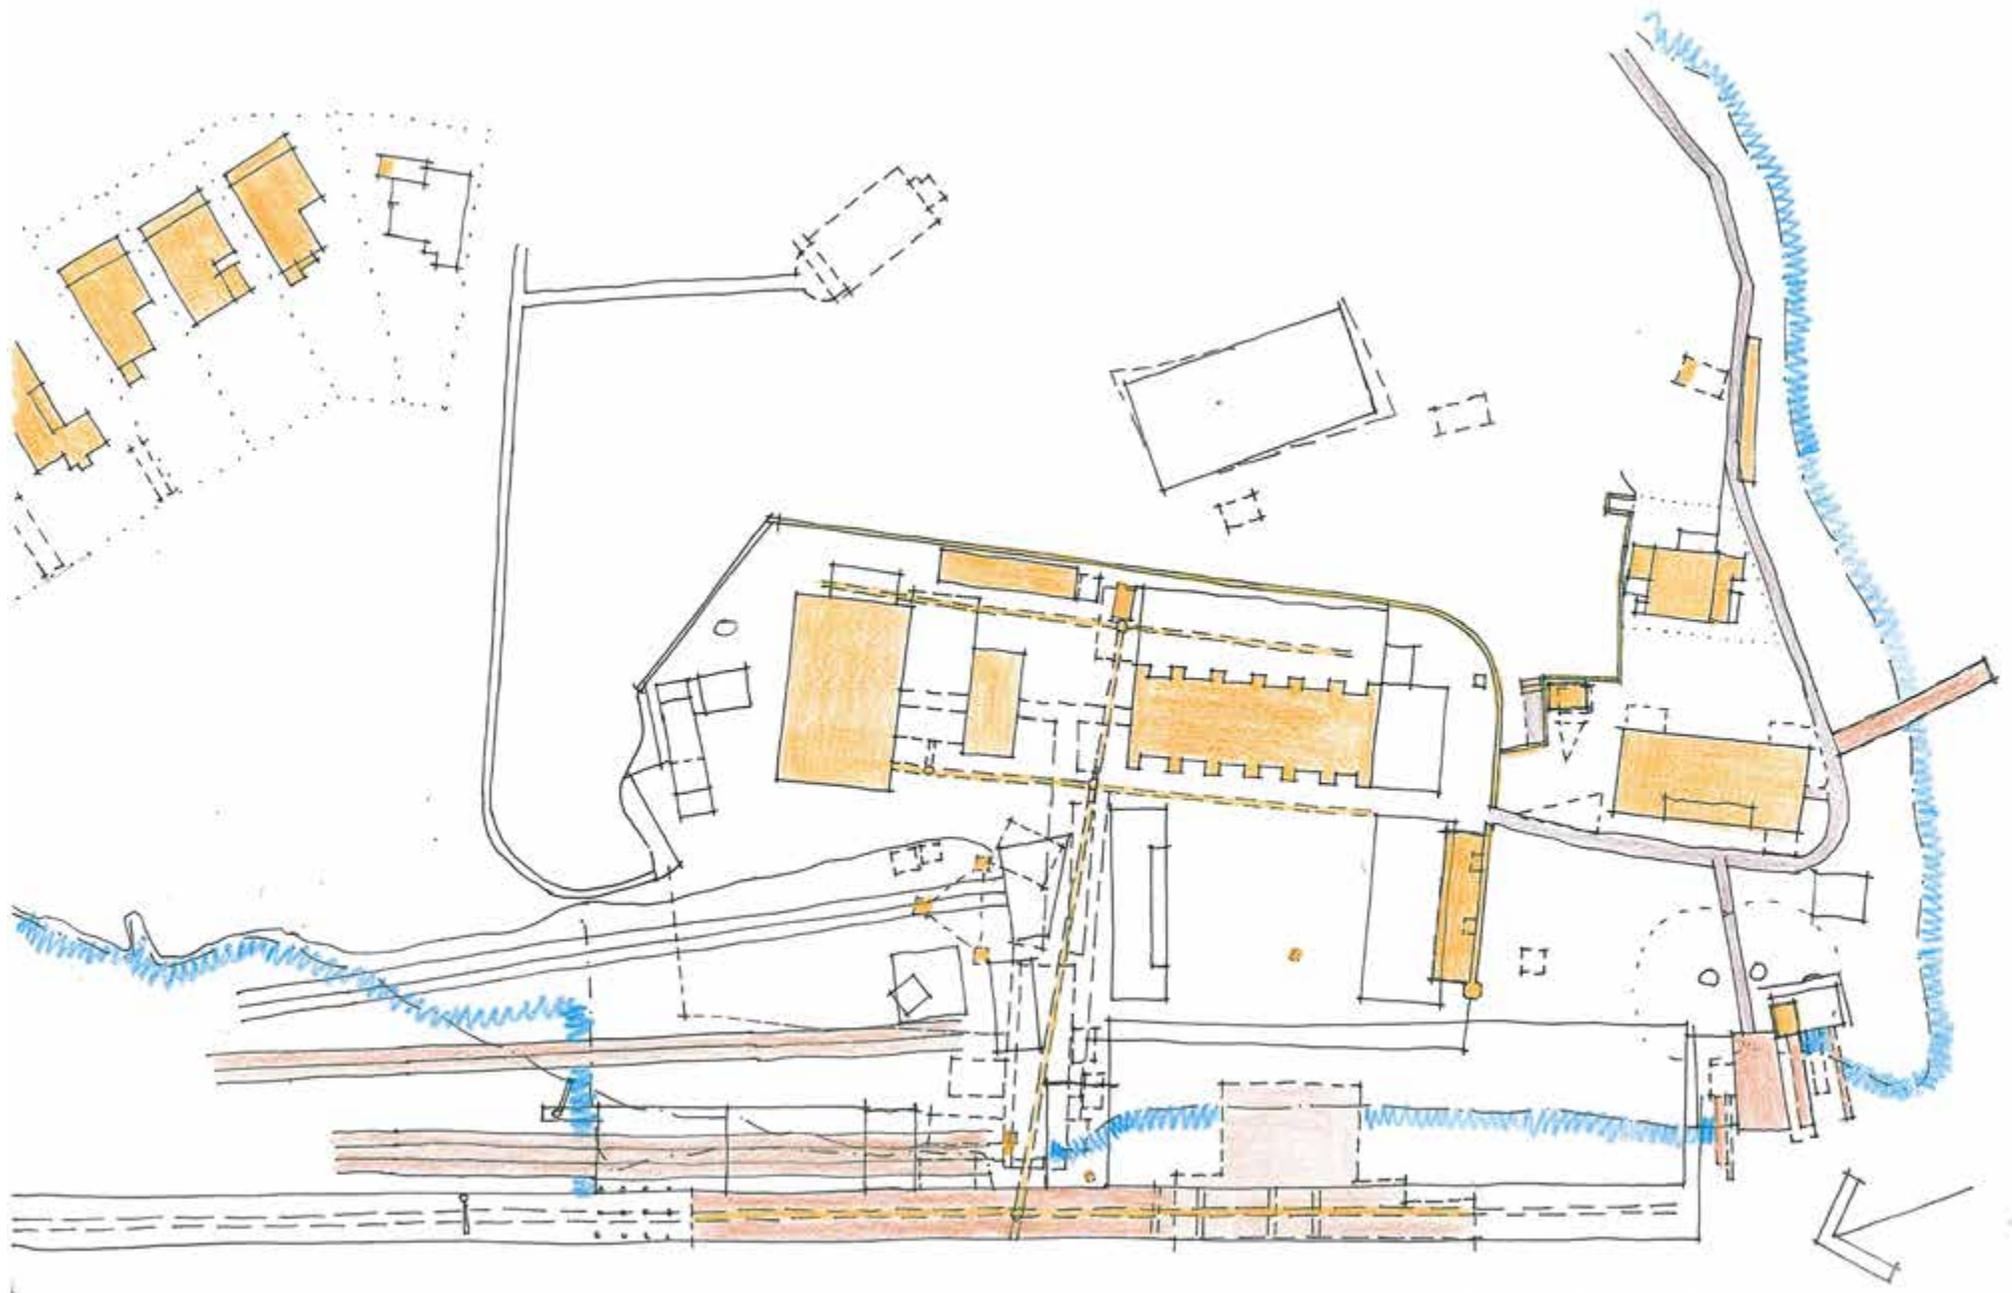
Figure A1-8 Site Plan of southern end of Goat Island: based on 1929 survey

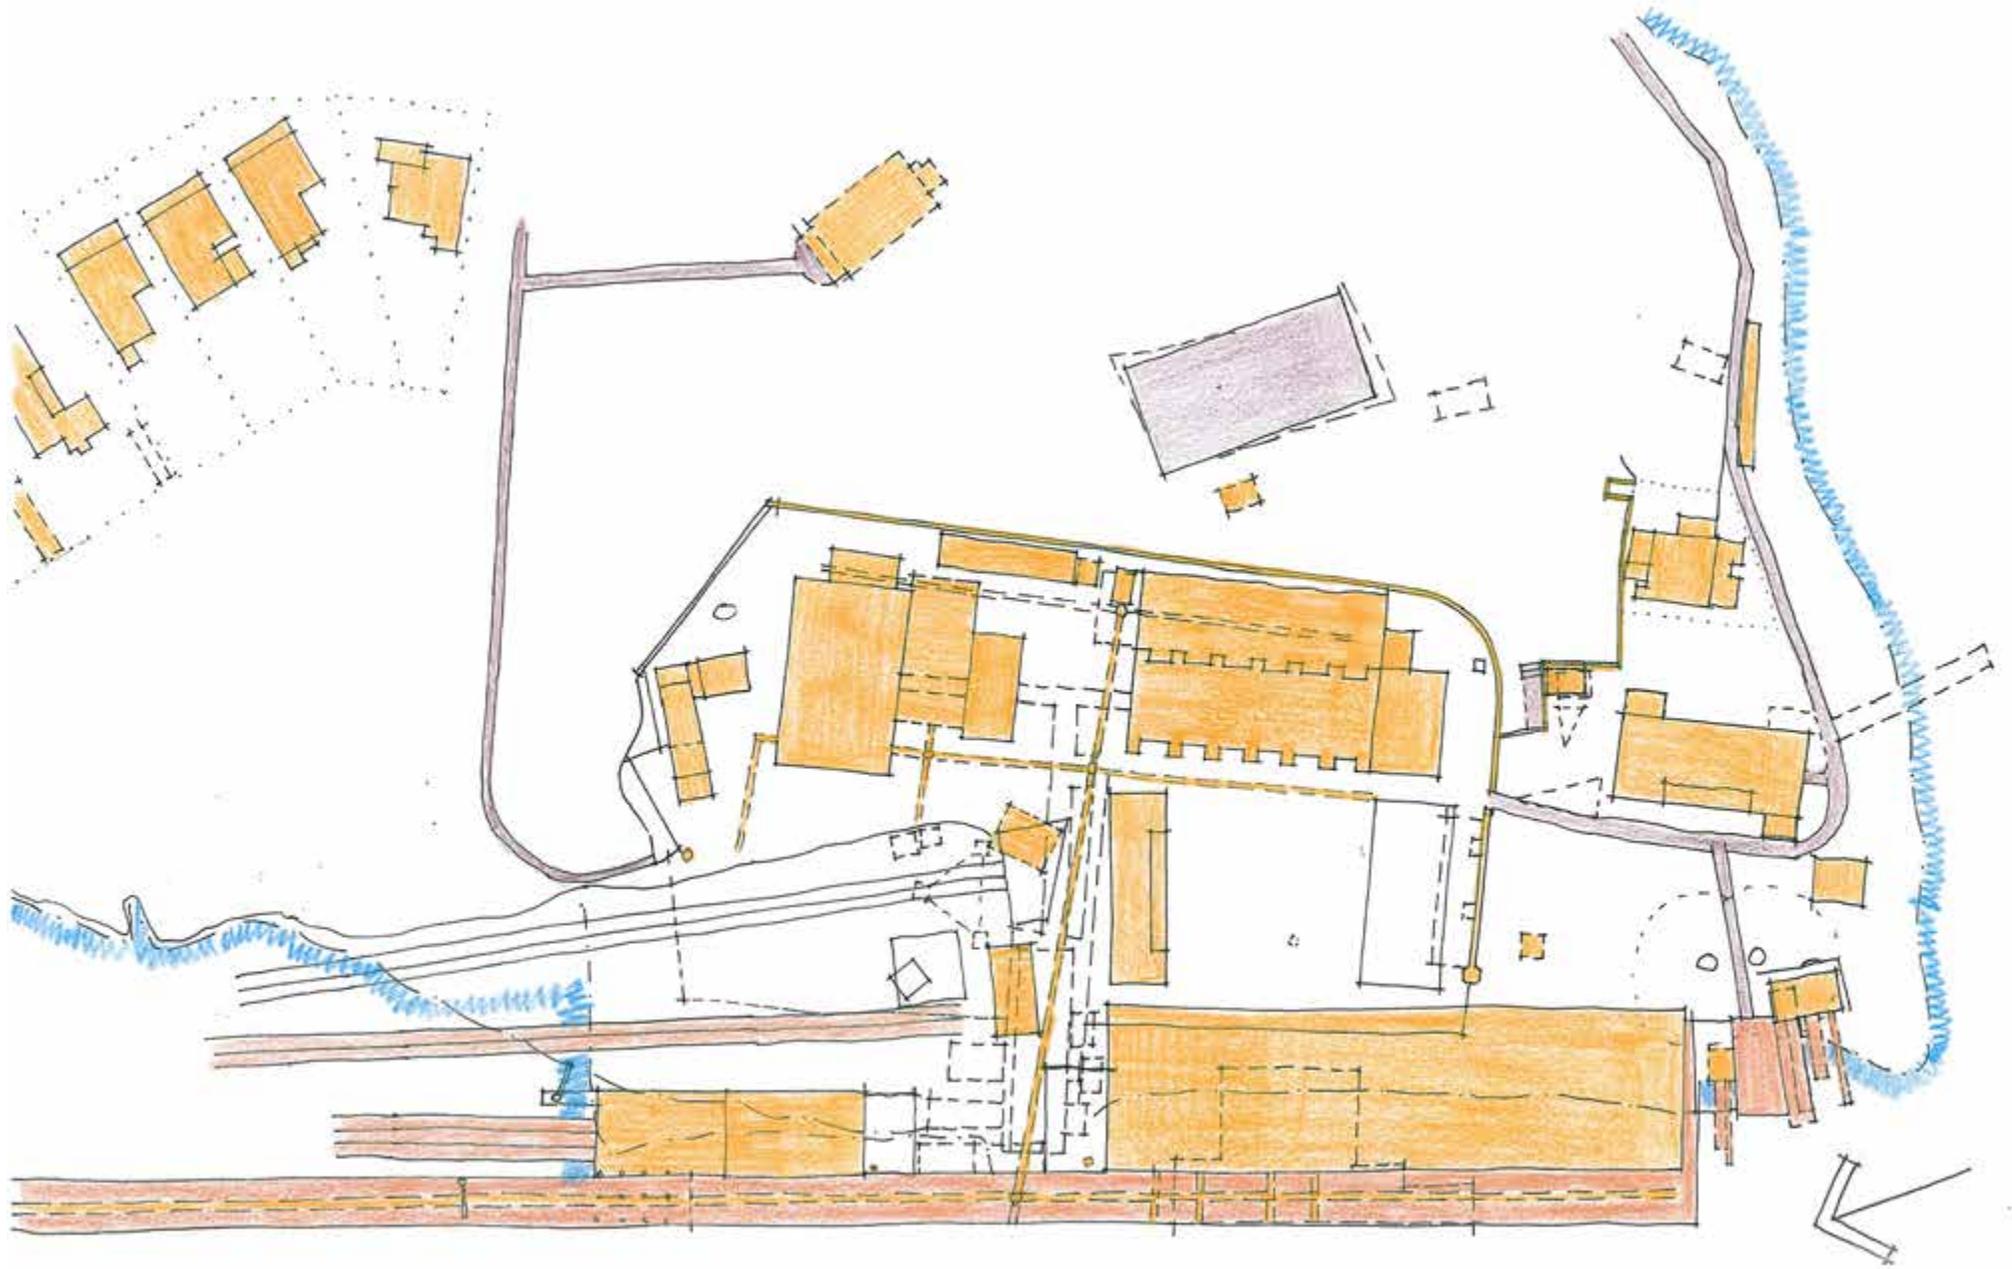
Figure A1-9 Site Plan of southern end of Goat Island: based on c.1950 survey
