GOAT ISLAND

Conservation Management Plan

Volume 4

Appendices

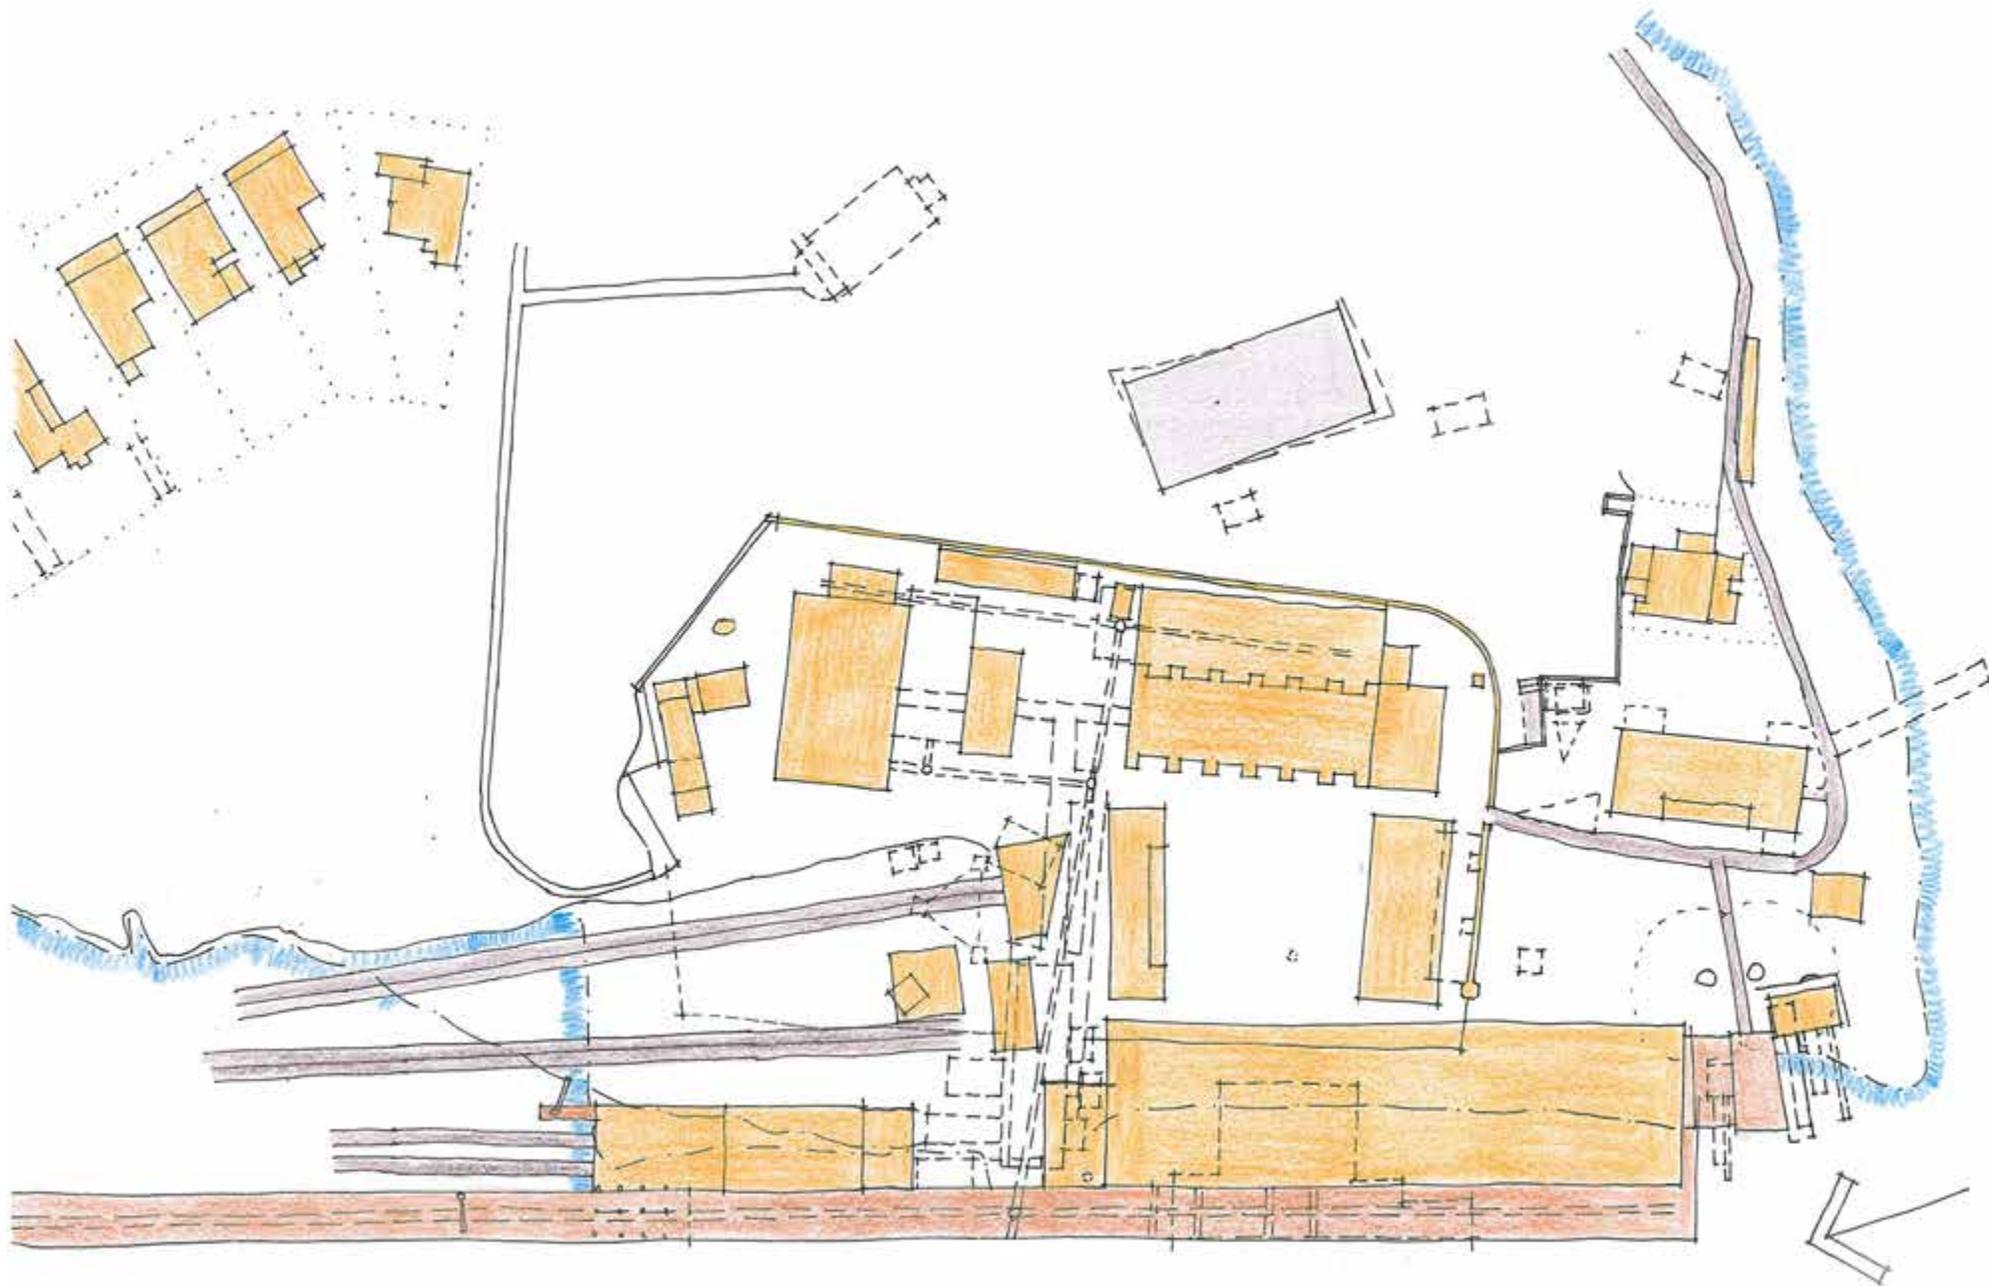
Figure A1-10 Site Plan of southern end of Goat Island: 2007

The extant buildings at the plan dates are shown in orange, with extant wharves in brown. Extant shorelines at the plan dates are shown in blue.

These plans are provided to demonstrate the layering of the site, the location of earlier site elements in relation to the current structures, site features and landforms and to illustrate how the edges of the island and the shoreline development have evolved.

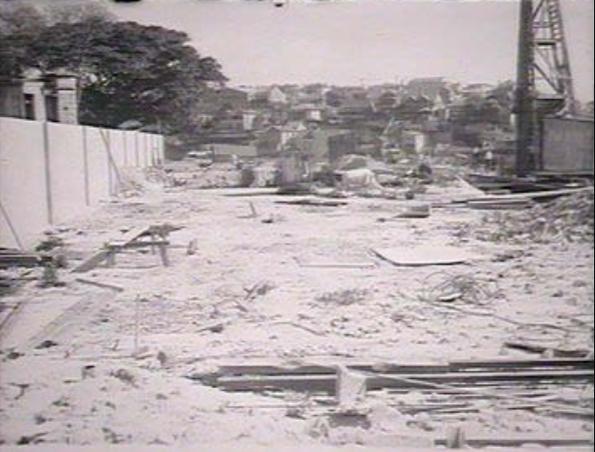
State Library	d1_10116. 1946 photo of construction site of the Ship Repair Workshop on Goat Island

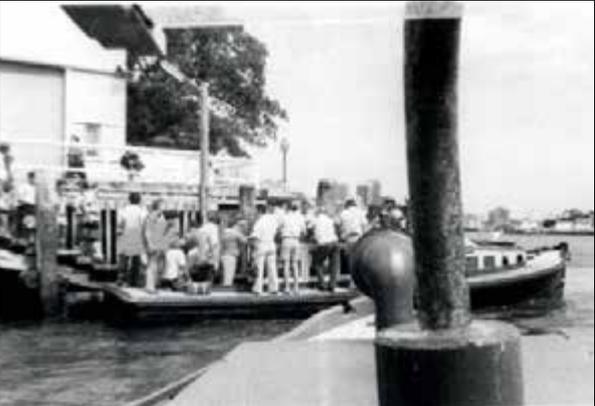
LIBRARY/ ARCHIVE	IMAGE DETAILS	IMAGE
State Library	d1_10060/ GPO 1 - 10060 1955 launch of the hopper barge "Nyawi" and the slipways on Goat Island

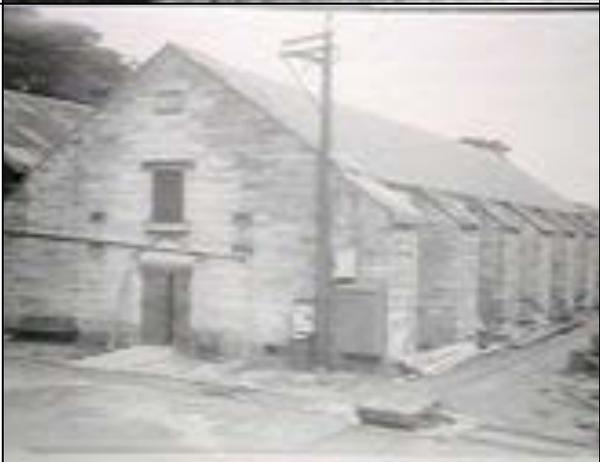
LIBRARY/ ARCHIVE	IMAGE DETAILS	IMAGE
State Library	d1_10037/ GPO 1 – 10037. 1923 image of Queen's Magazine south elevation and south elevation of Cooperage, single storey explosives magazine (1885?) built against the fortified wall.

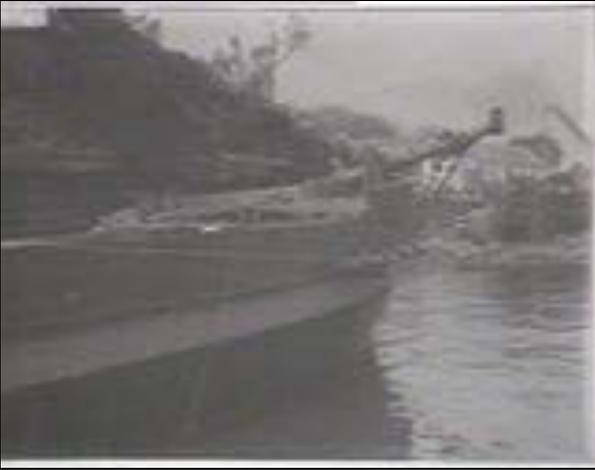
State Library	d1_10263/ GPO 1 – 10263 Replica "Supply" under construction at Goat Island shipyard, August 1937

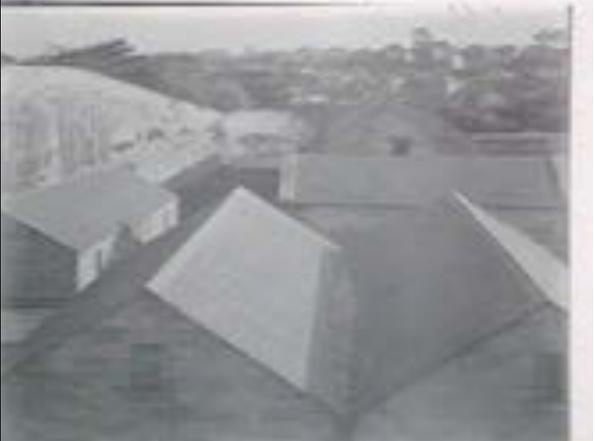
A black and white aerial photograph showing several large, rectangular buildings with gabled roofs. The buildings are arranged in a cluster, with some showing signs of age and wear. The surrounding area appears to be a flat, open space, likely a magazine or storage area.
State Library	d1_10041. 1943 photo of 1838 Barracks on Goat Island

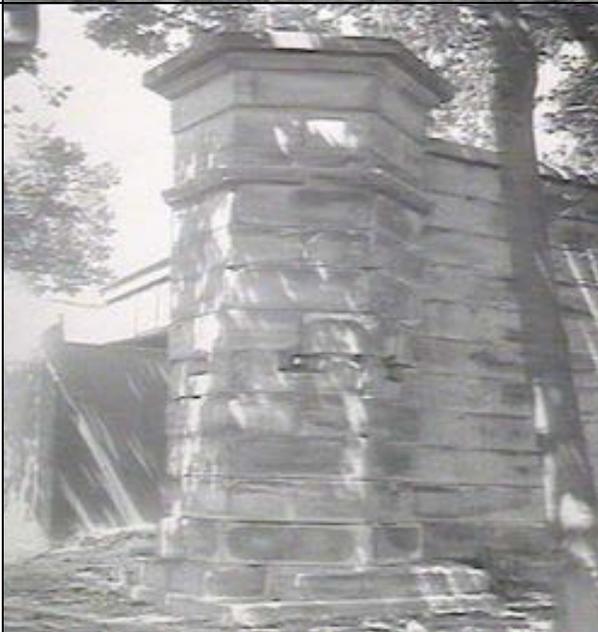
LIBRARY/ ARCHIVE	IMAGE DETAILS	IMAGE
State Library	d1_10047. 1940 photo of gate in Fortified Wall showing original timber entry gates.

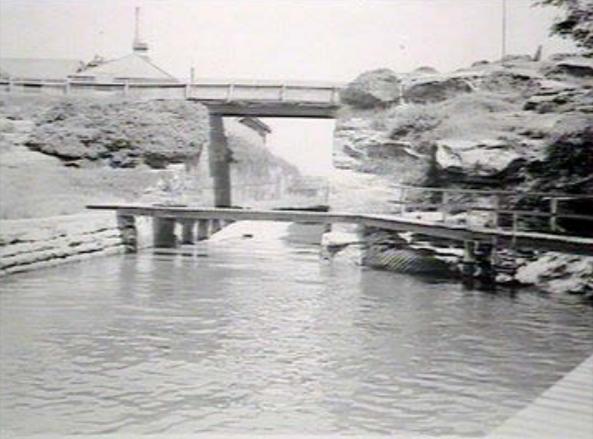
LIBRARY/ ARCHIVE	IMAGE DETAILS	IMAGE
State Library	d1_10050. 1953 photo of Goat Island slipways

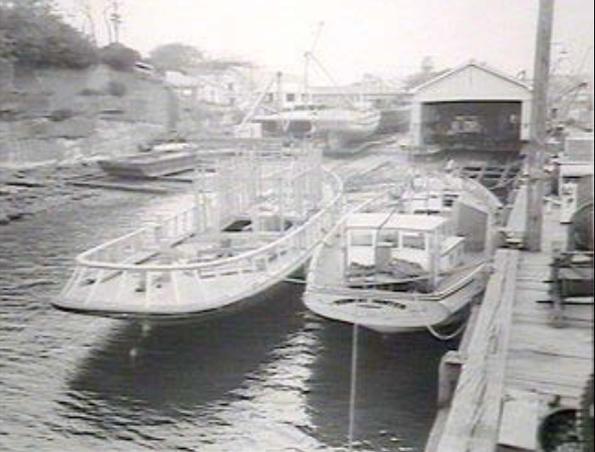
State Library	d1_10058. 1966 photo of Goat Island slipways with Hammerhead Crane

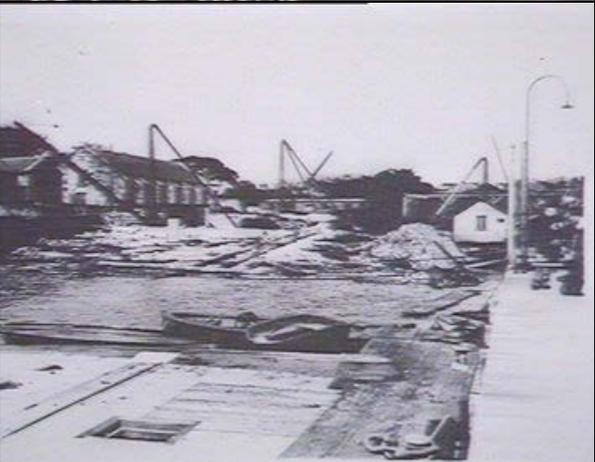
LIBRARY/ ARCHIVE	IMAGE DETAILS	IMAGE
State Library	d1_25000. 1956 photo of Goat Island slipways

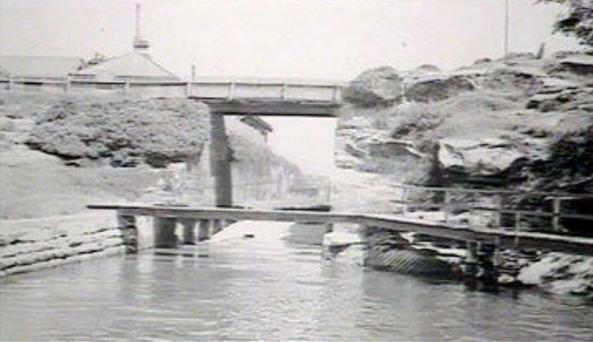
State Library of NSW	GPO 1 – 10134 (MSBL1450), July 1946: Goat Island fitters shop & wall, Goat island

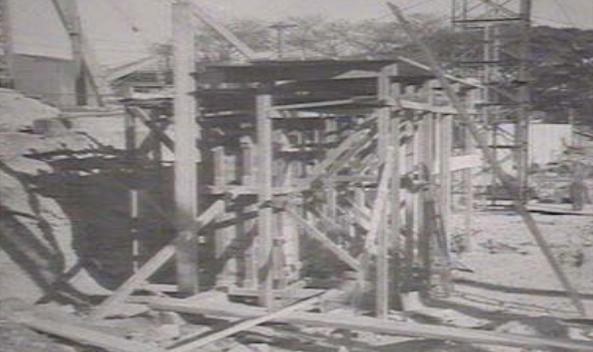
State Library of NSW	GPO 1 – 10054 (MSBL958), 1947: Building construction: Goat island

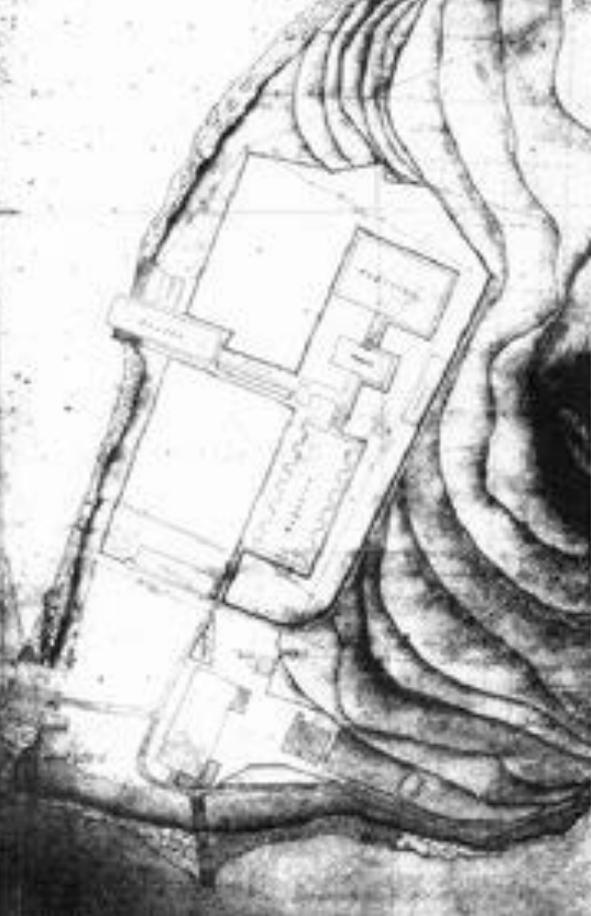
LIBRARY/ ARCHIVE	IMAGE DETAILS	IMAGE
Lands Dept	<p>The 1891 plan of the north-east end of the island. The buildings evident in this plan are the former 1838 Water Police Building by this stage with additions and outbuildings, the 1865 cottage and the 1875 magazines and store building. There is a stone wharf to the north of the water police station and the cut are both clearly shown as is the original shore line with its rocky outcrops.</p> <p>This jetty is now behind the sea wall and fill area. It is likely that it remains in situ and it may form part of the current sea wall. A second small jetty is on the southern side of the island, below the later magazines and with a small store building and possibly of timber construction. It was removed in the early years of the twentieth century and there is some evidence of its location on the cliff face. The plan also shows a bridge over the cut (probably at lower level than the present bridge based on site inspection) the main path connecting to the magazine precinct (Magazine Walk) and ancillary paths and fences. Interestingly the change of alignment in the walk adjacent to the larger magazine is still evident in the path alignment.</p>

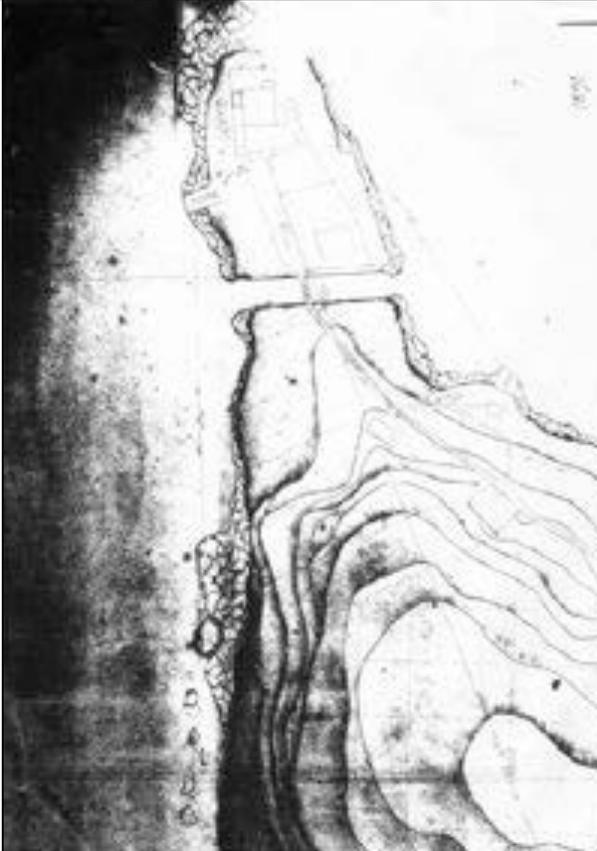
Lands Dept	<p>An informative 1924 plan of the island showing the extent of the Harbour Trust development just prior to their redevelopment of the magazine precinct. The Trust added the various residences on the ridge and to the east, the fire brigade barracks, workshops and stores along the northern shore and converted the barracks and kitchen and used the water police building for residential use. Many of the buildings built in this phase have been removed including the workshop and stores buildings and six of the residences.</p> <p>The wharves at this time comprise: the early stone jetties and wharves to the magazine precinct, an area of fill near the magazine in preparation for the new wharf construction, the first north wharf and ferry jetty, located with a parallel outer face, the stairs and jetty for the Harbour Master, the rough eastern wharf located off the shore line and several skeleton wharves further south braced off the cliff face. The only wharf elements remaining from this period are the stair to the residences and the alignment of the north wharf however both elements have been rebuilt.</p> <p>This plan also shows the privy (94) and the small stores building (109) located near the barracks.</p>

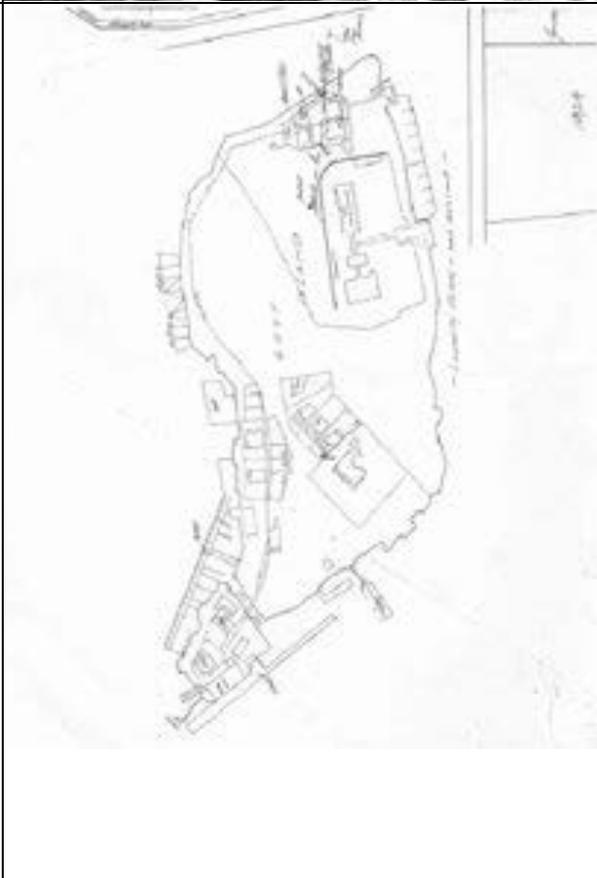
LIBRARY/ ARCHIVE	IMAGE DETAILS	IMAGE
Lands Dept	<p>A detailed plan from 1929 (part of plan of whole island), nearing the end of the Harbour Trusts tenure of northern area of the island showing more detail of the layout of the buildings and wharves. It is interesting to observe the range of small buildings, sheds, boatsheds and ramps around the edge of the water, the full length of the cut that was modified around 1960, the fence line of the Harbour Master's residence and what appears to be the incorporation of one of the magazine buildings from 1875 into the residence visible in the centre of the drawing.</p> <p>The stone seawall immediately to the north of the cut returning to the east appears to date from around 1901 and also appears to remain intact as the face of the current wharfage.</p>

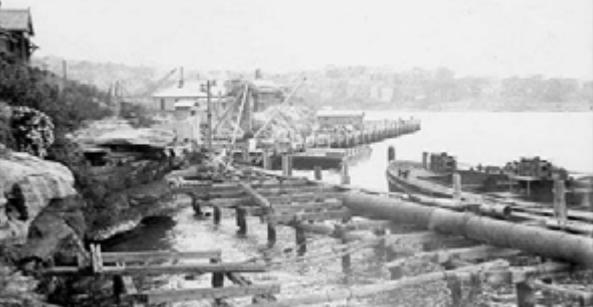
SLNSW GPO1-19371.	<p>Wharf construction c1940. This picture has been attributed to the 1920 period but the ferry wharf was not angled until reconstruction in c1945. The pool area is visible to the left of the frame. The shed to the west of the pool seems to have been moveable – it appears in a number of locations in various photographs as construction works are carried out. This also shows the wharf at approximately half its current length suggesting that the photo was taken during construction. There is no documentary evidence that this wharf was built in stages.</p>

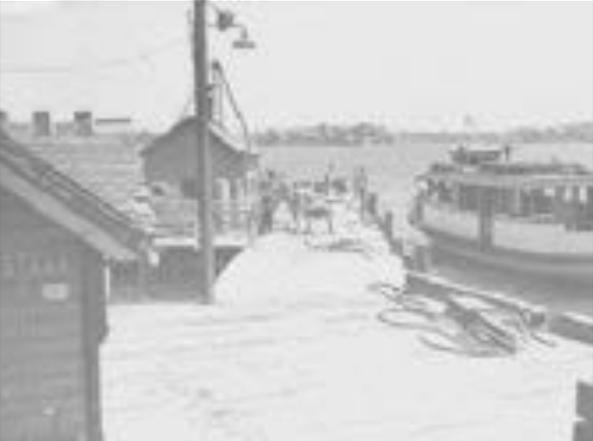
SLNSW GPO 1-07969	<p>Construction of the ferry wharf. Undated Most likely 1944 after the addition to the end of the wharf was complete.</p>

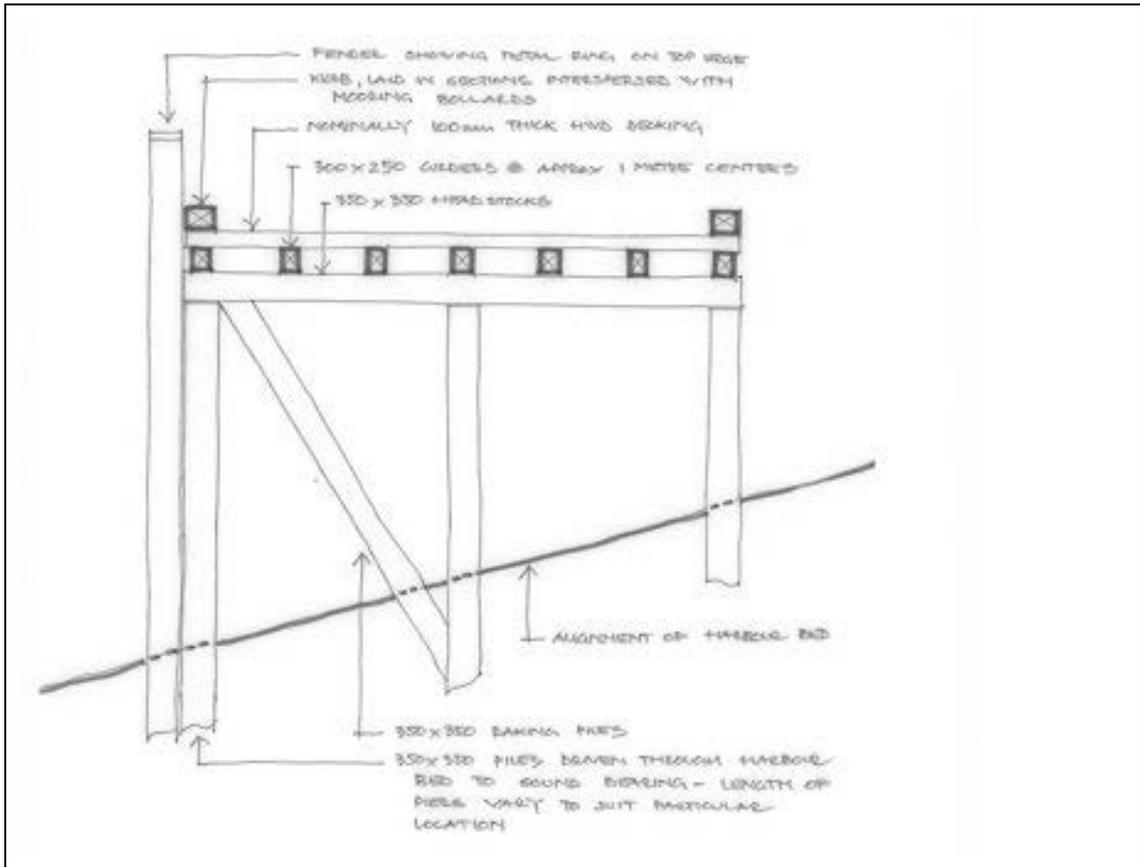
The Figure below shows the principal wharf elements and a typical layout. This layout is taken from the free-standing eastern wharf at Goat Island but applies generally around the island.

Typical Section through a timber Wharf showing component parts, this section is based on wharf 52a, a freestanding wharf.

All timber (and steel) wharves around the Harbour have similar base construction with usually only minor variations depending on where they are located, the tidal and water conditions in the area and the nature of the loading or vessels to be moored against them. To provide clarity in terminology, to understand how wharves are constructed and to provide a basis for considering if any aspects of the wharves on Goat Island are unusual or of particular significance the following drawing and description is of a typical wharf at Goat Island and across Sydney Harbour.

Decking is either timber boarding or concrete. Concrete was introduced in the second half of the twentieth century and as seen at Goat Island replaced timber decking on some wharves, other wharves such as the coal loader (wharf 5) appear to have had concrete from their construction.

Headstocks and girders generally fail at the point of connection between members where water is trapped between timber surfaces. Examination of timbers after decking removal shows clearly the failure of the upper face of girders and the intersections of girders and headstocks as well as deterioration of the end of the members and around the major fixing points.
