Metalwork

Introduction

This information sheet deals with the care and conservation of metals used in building, including cast and wrought iron as fencing and decorative panels, steel-framed windows and roof plumbing. For further information refer to the references at the end of the sheet, and to the separate information sheets on *Corrugated Roofing*, and *Slating, Tiling and Roof Plumbing*.

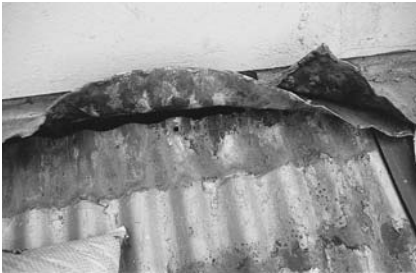
Galvanic corrosion of original corrugated metal sheeting.

The further apart two metals are on the series, the greater will be the galvanic reaction. Combining two distant metals in a damp environment will lead to rapid corrosion of the less noble metal. This is why metals such as zinc (or galvanised steel) and copper should never be used together. Lead flashings and cappings, traditionally used in conjunction with galvanised steel roofs, can cause corrosion if the roofing is replaced with modern steel sheeting coated with a zinc–aluminium alloy.

Even if the two metals are not touching, corrosion can still occur. Water can provide an electrical bridge, or carry in solution a small amount of the nobler metal to the other, where it precipitates or plates out and causes corrosion. Thus, water running off a copper roof into galvanised gutters will lead to rapid corrosion of the zinc galvanising and then the steel of the gutters.

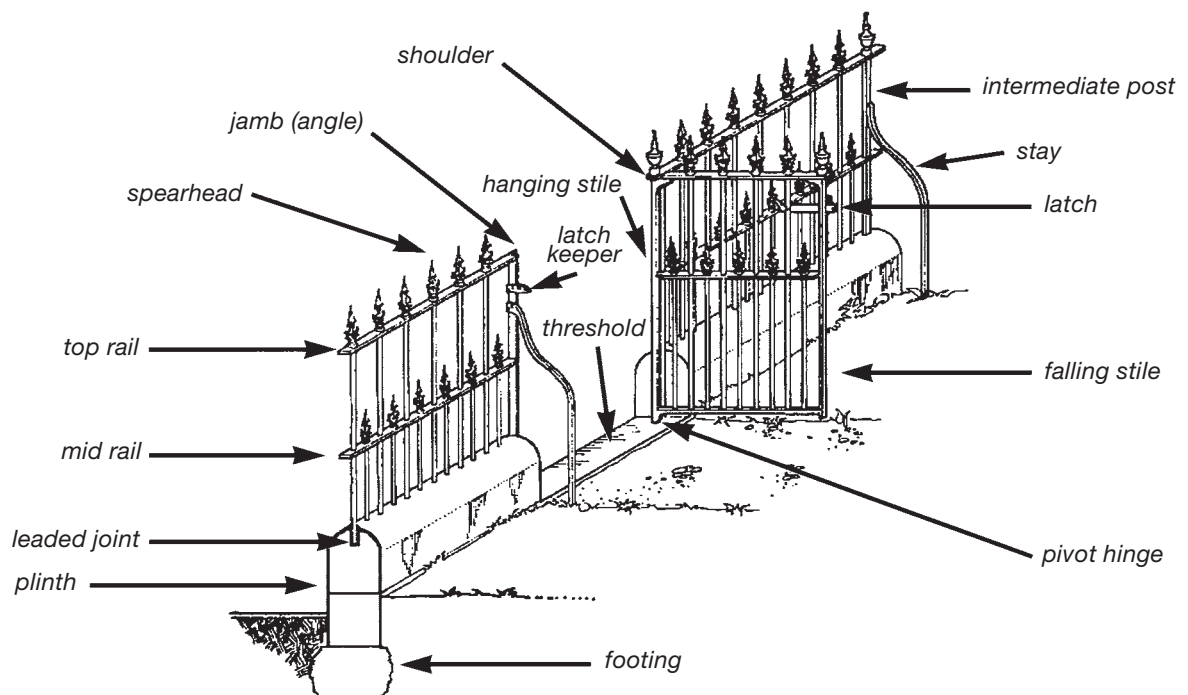
Iron Palisade Fence Construction

Crevice corrosion can occur where the shafts penetrate the rails, and also between the spearheads and the top rail. Careful filling and painting of these areas is required to eliminate crevices where corrosion may occur.

The problem with such fixings is that repeated thermal cycling creates a very small gap between the iron and the lead, allowing water entry and consequent crevice corrosion. Severe corrosion of the iron can result in rupturing of the masonry base as the rusted metal expands.

- removing the shafts, treating them for rust, and replacing them according to traditional practice with molten lead;
- removing the shafts, treating them for rust, and replacing them with a modern packing such as expansive tape;
- cutting off the corroded base and welding on a new base of mild steel, galvanising the whole shaft, and resetting it in lead;
- cutting off the corroded base and welding on a new base of stainless steel, which is then set in lead or in expansive tape. If lead is used it will be the less noble metal and will therefore corrode;
- cutting off the corroded base to a stump and fastening a new base of stainless steel tubing over the stump using epoxy adhesives. The outside diameter of the tubing must match that of the shaft. The tubing can then be set in lead or in expansive tape;
- replacing the entire palisade in new galvanised steel painted an appropriate colour.
