# Old Great North Road

Dharug National Park

Maintenance Plan

March 2007

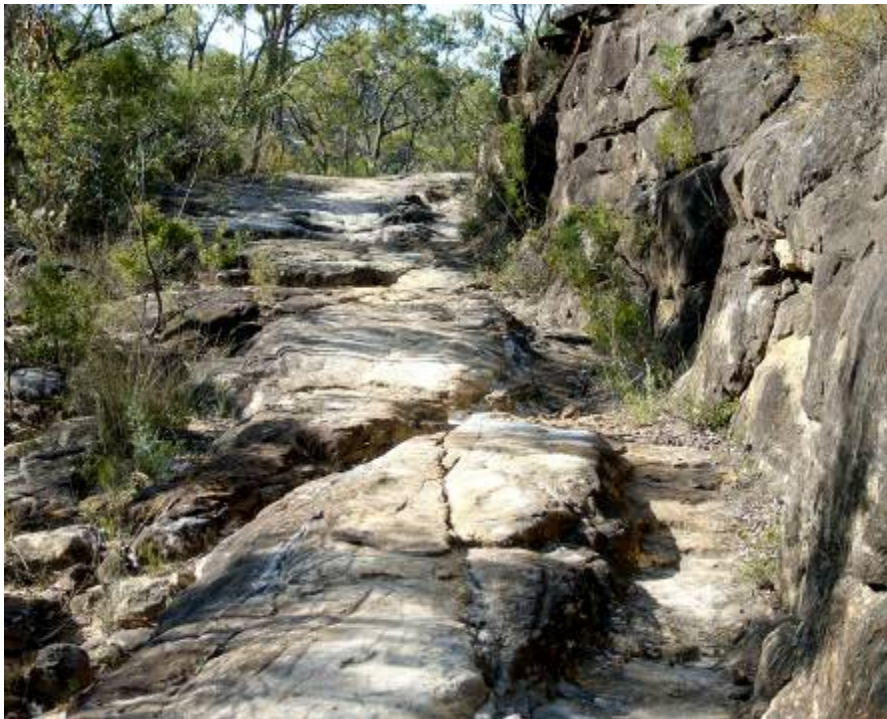
Figure 1  
Baseline management will include controlling access and vegetation impinging on the road corridor. Precinct 5.

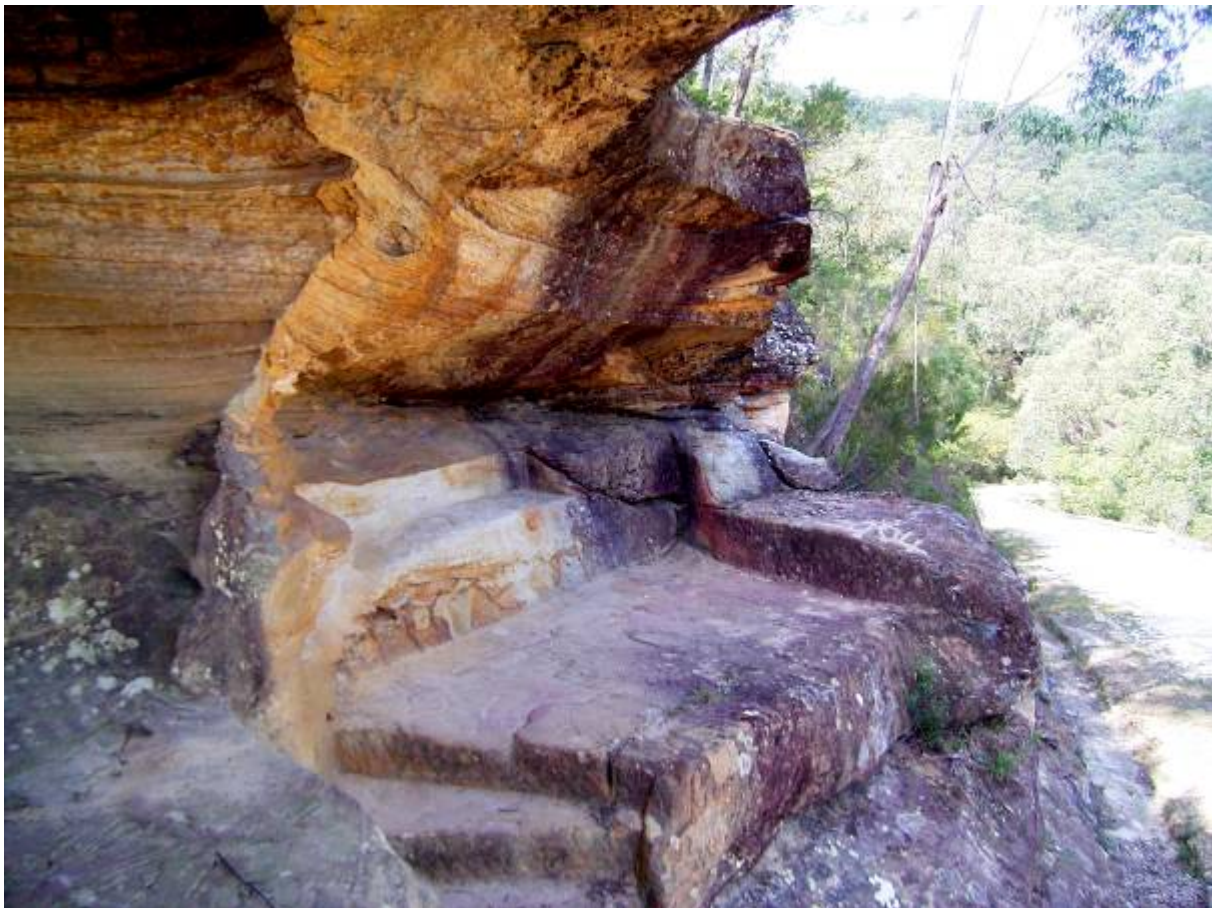
Figure 2

Hangman's Rock, Devine's Hill ascent. The CMP envisages a masonry conservation strategy to investigate longer term stone conservation issues, such as decay of the light-coloured bench at centre left, that are not dealt with in this maintenance plan.

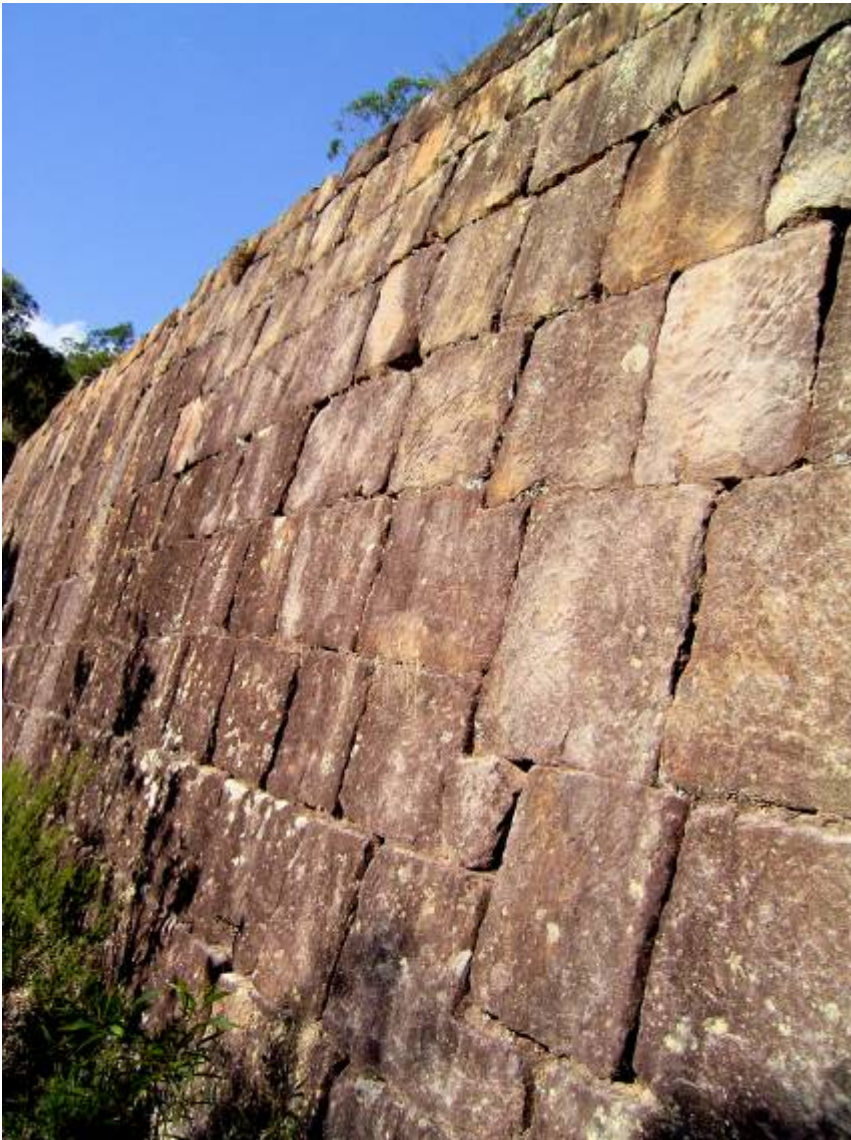
Figure 3  
Remarkable quality drystone retaining walls are a feature of the Devine's Hill ascent (Precinct 1).

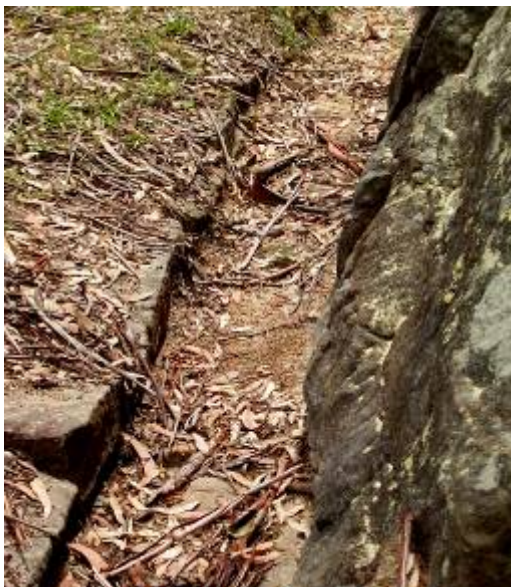
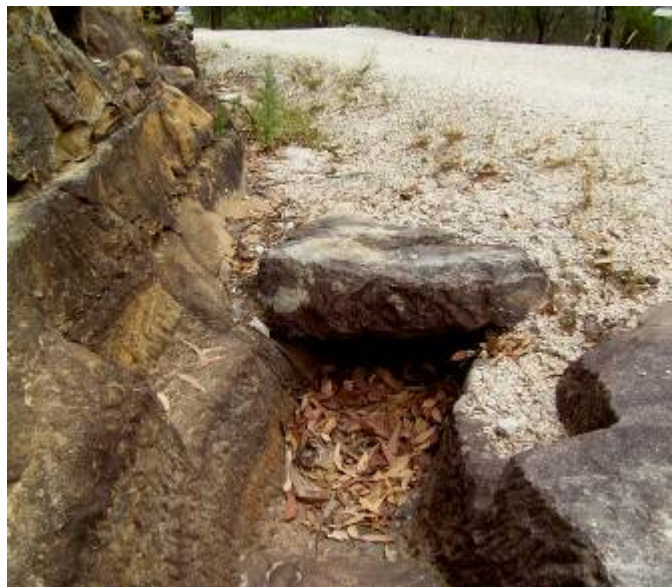
Figures 4 & 5

Accumulation of leaves bark and other tree litter in drains leads to the risk of blocked culverts, with potentially serious damage to the road structure. Note that the culvert on the right is missing its original entrance cover: recesses cut into the sandstone bedrock indicate where it was positioned.

Figure 27 Sandbagging of drain to catch silt run off from recent (2006) resurfacing of portions of the Devine's Hill ascent. This silt is collected and disposed of. Sandbags should be removed once the amount of run off has stabilised. Like the culvert in Figure 4 this one is missing its original entrance cover: recesses in the sandstone bedrock on either side show where it was fitted.

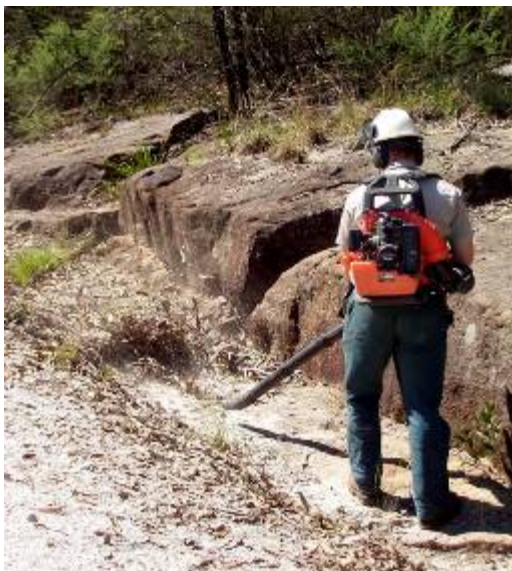
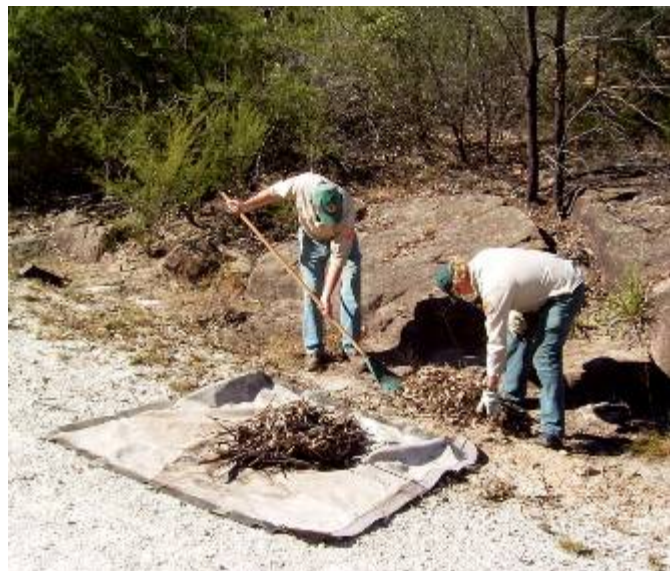
Figures 6 & 7

Use of a powerful blower to move tree litter to stockpiles along the drain. The stockpiled waste is then collected using plastic rakes and a tarpaulin for transfer to a vehicle for disposal.

4.1.3.2 The drains are then swept of accumulated leaves, twigs, bark and other debris using the blower (see Figure 6) to progressively build piles at intervals along the drains. To minimise any 'sandblasting' effect, do not concentrate the blower jet on any one spot for any length of time. When the heap of debris becomes too large to move with the blower, plastic rakes (see Appendix 3) and shovels should be used to gather the material, either onto tarpaulins (see Figure 7) or into plastic rubbish bins. The debris is then placed in utility vehicles for disposal. Experiments with a vacuum type blower showed that it had insufficient 'suck' to be effective on sand, small stones and twigs. However, it may be useful for collection of lighter material such as sawdust generated during removal of fallen trees.

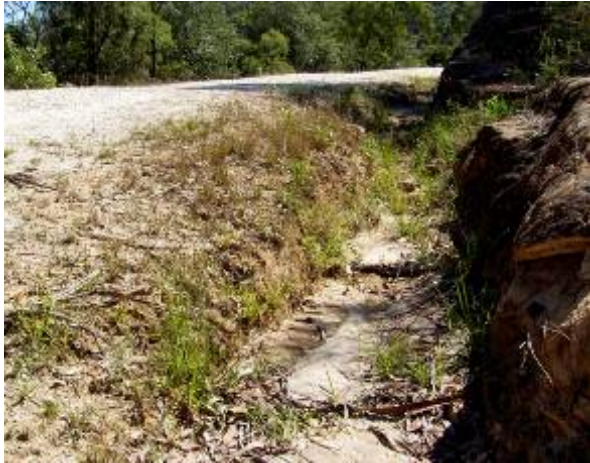
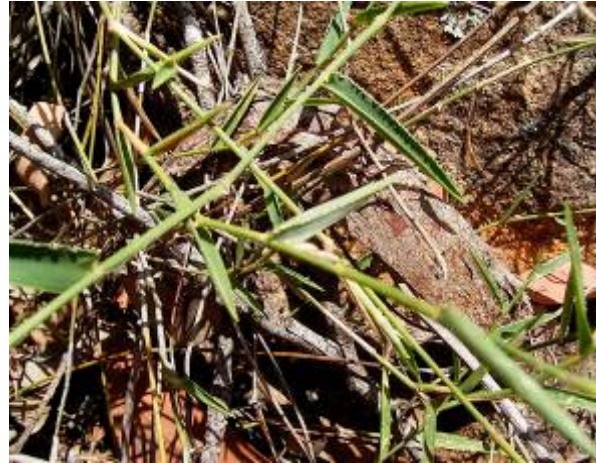
Figures 8 & 9

Spraying grasses and weeds growing in the drains is part of ensuring good drainage. However the drain on the left depends on the grasses to support the drain edge (kerb) and contain the road pavement. In a case like this no spray should land within 100 mm of the kerb. On the right *Ancistrachne maidenii* a threatened species, has been found growing in the drains and on the rock faces above. Prior to any spraying activity, the Ranger should inspect for threatened species and use tags to indicate spray and no-spray zones

4.1.3.8 Weeds, mostly in the form of grasses, grow in the drains and trap silt and sand leading to blockages. Weeds should be sprayed on an annual basis and in accordance with PWD Job Safety Analysis (JSA) procedures. Minimum concentrations of glyphosate poison should be used. Spraying should be limited to the floor of the drain and 100 mm up the wall on either side, except where the kerb wall is root bound soil (see Figure 8). In this case spraying should be controlled so that no spray lands within 100 mm of the kerb edge.

Special considerations should apply where threatened flora species occur. For example, *Ancistrachne maidenii* (Figure 9) has been found colonising areas disturbed by road construction in precinct 1. Operations involving spraying of drains and trimming along drains and the base of walls need to be amended in areas where these species have been identified (see Threatened species management, Section 4.3). The Ranger should inspect for threatened species and use tags to indicate spray and no-spray zones prior to any spraying activity.

There are extensive areas with no surviving kerb stones. As we cannot be sure about their form, or even existence, these areas are best left alone with no kerb. Some areas show good growth of grasses whose roots help to bind and retain the road surface (Figure 8). In these areas it will be important to avoid any weed spray coming in contact with the grasses.

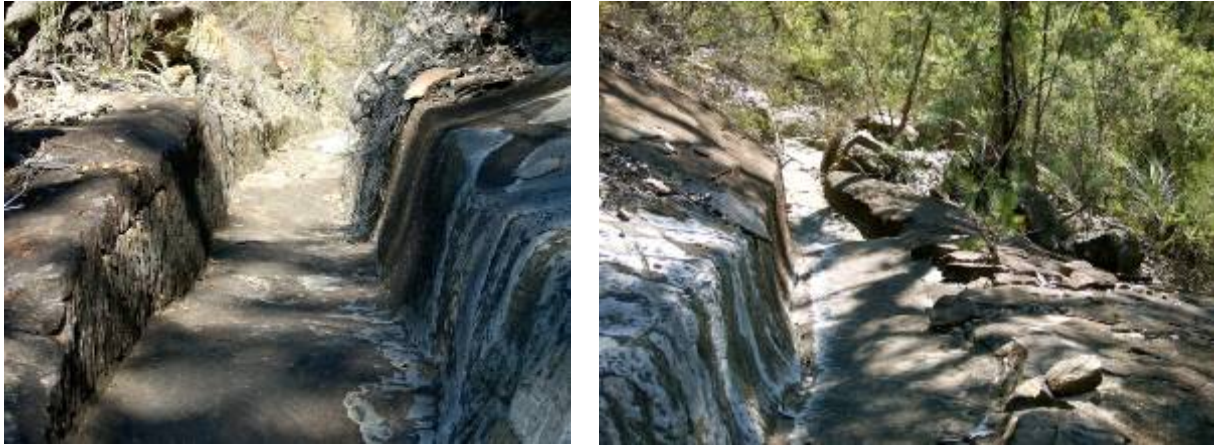
Figures 10 & 11

The intercept drain above the quarry on Devine's Hill provided protection from flooding during quarrying. Now it may be serving an important drainage function, reducing stress on an overcharged culvert (C32). The section on the right may need sandbagging to improve stormwater retention in the drain. The effectiveness of the drain should be checked during prolonged moderate to heavy rain.

4.1.3.9 The intercept drain above the quarry on Devine's Hill (Figure 10) should be cleared using the blower and rakes as in 4.1.3.2 above. Two thirds of the way along the drain there is a hollow which readily blocks with leaves. The hollow should be cleaned out and consideration given to building a short wall of sandbags to improve the 'connection' to the next section of sandstone drain. A section of the sandstone drain has a very shallow outer edge which may be spilling too much water in high flows (Figure 11). This section may also need sandbagging.

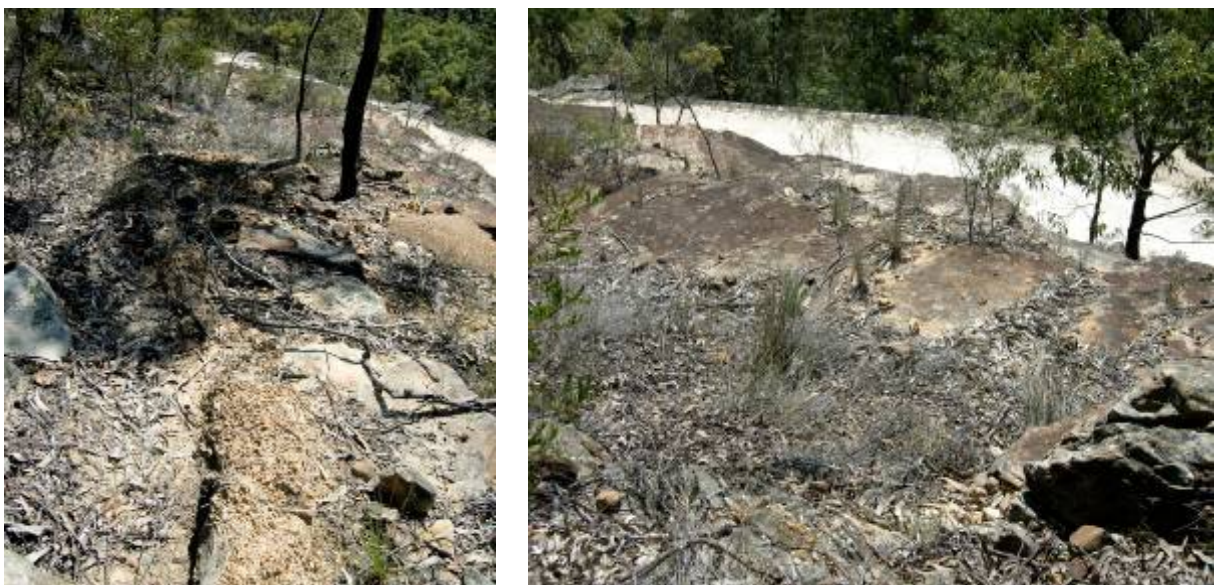
Figures 12 & 13

On the left are remains of the second of two short walls of sandbagging below the outfall of the intercept drain. These walls need to be rebuilt to redirect run off towards culvert 31. A third wall needs to be constructed from the large rock in the bottom right of the right hand photograph, running at an angle towards the edge at the upper centre and then curving towards the small leaning tree.

The deteriorated sandbagging at the toe of the intercept drain should be renewed and a third section of sandbag wall constructed below the first two (Figures 12 and 13), with the aim of maximising the amount of stormwater that reaches Culvert 31 (Buttress B2) rather than falling short into Culvert 32 which may be overcharged during high intensity rainfall (Jordan, 1997). This does not mean building major walls, but developing some understanding of the functioning of the intercept drain (by inspecting it during periods of rain) and making small non-invasive improvements to the outfall as necessary.

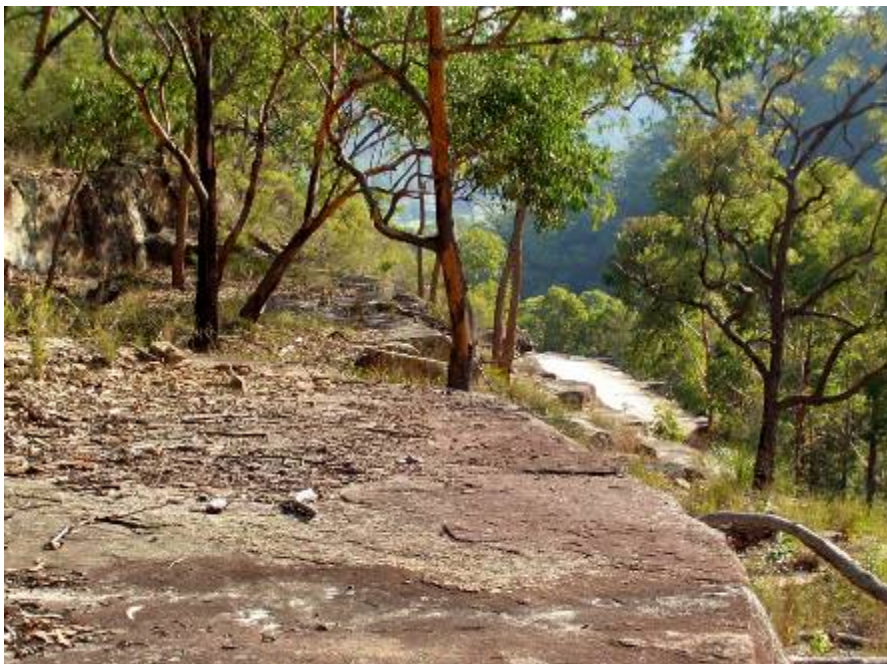
Figure 14

The quarry on Devine's Hill (precinct 1). Here the objective is to maintain the relatively open configuration so that quarry benches and faces are apparent.

The quarry on Devine's Hill is a special case of vegetation clearing (Figure 14). Here the *objective* of vegetation management is to maintain the quarry site in something like its present open configuration, with the quarry benches and faces readily apparent, yet with some tree cover so that the site does not appear too open.

The *vegetation management plan* for the site (as required by the Vegetation Management Procedure, Appendix 3, OGNR CMP, 2005) should be to maintain about 15–20 mature trees across the quarry area including those immediately on top of the rear faces. At present there are about 22 trees in this area. Selection of trees to be removed should be based on:

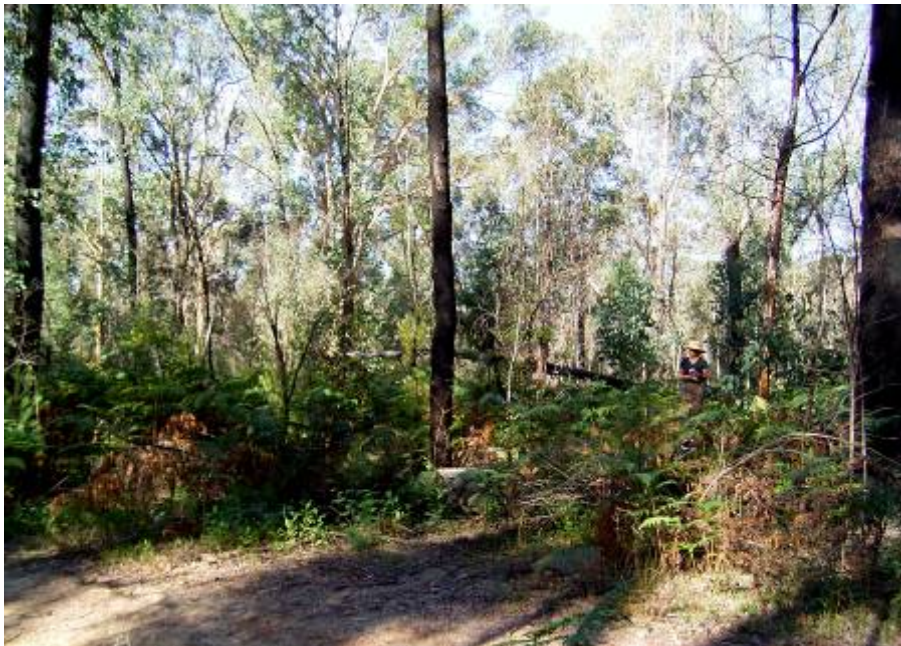
Figure 15  
10 Mile Hollow Inn Site.  
Here the objective is to limit damage to the archaeological remains by preventing further growth of trees and shrubs in a 6 metre radius from the exposed stone footings.

Here the *objective* of vegetation management is to conserve the archaeological remains. The *vegetation management plan* for the site is to prevent further growth of trees and shrubs in a 6 metre radius from the currently exposed stone footings. This area is currently covered by only a light cover of saplings, with only one mature tree, which should be cut and poisoned, stumps to be left *in-situ*. Woody vegetation should also be kept clear of the masonry walls. The current vegetation cover is shown in Figure 15.

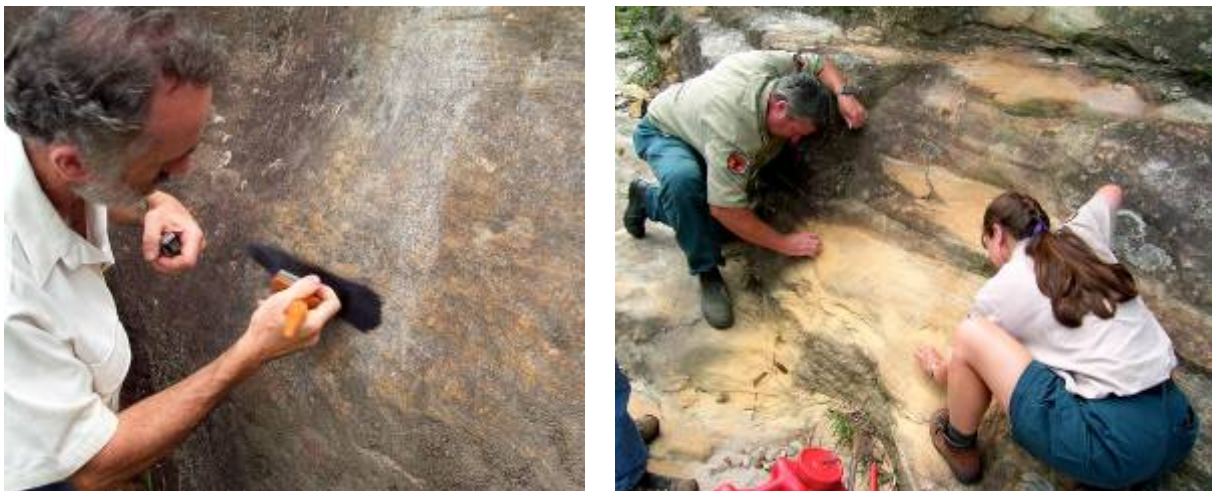
Figures 18 & 19

Removing modern graffiti. At left soft brushes are used dry to remove dust from light surface scratchings. At right hard stones (or sandpaper) are used to remove deep engravings. This work requires great care and should begin with a close examination to decide whether it's best to leave alone or to treat.

4.5.3.3      Then dry brush the surface with a paint brush to remove as much loose dust and organic matter as possible (Figure 18). Avoid following the pattern of lettering when brushing as that will simply widen the graffiti letters. Assess results — this may be enough!

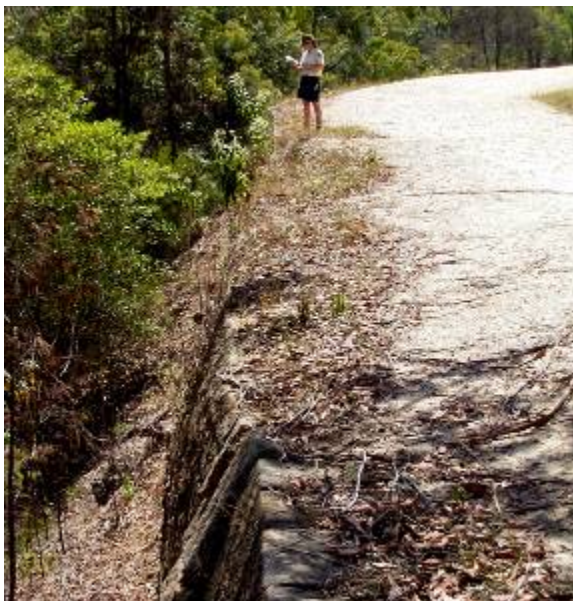
Figure 20

Bulge in retaining wall where failure has led to early reconstruction of the section between the displaced stonework in the foreground and a point just this side of Ranger Sarah Breheny. Bulges are monitored for any significant movement as an early warning sign of potential failure.

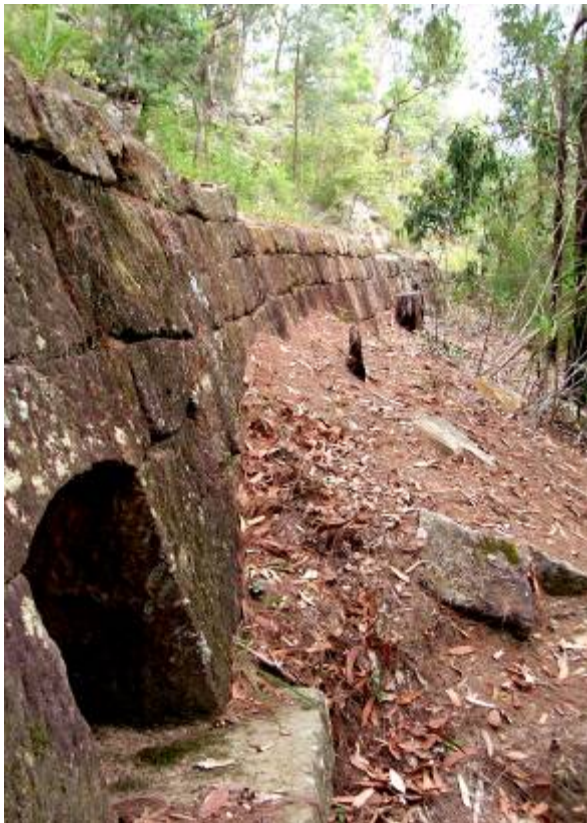
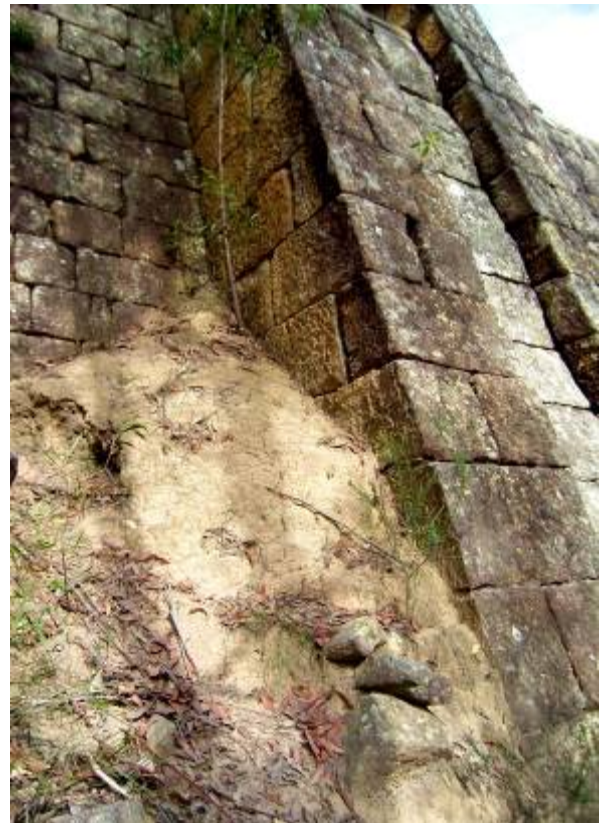
Figures 21 & 22

Mounds of sediment accumulating at the base of retaining walls. There is a risk that the sediment may trap excess moisture in the road structure and in any clay rich material in the foundations, leading to possible failure and collapse of a section of wall..

In places along the retaining walls there are areas of sediment and debris build up at the base of the wall (see Figures 21 and 22). This is most apparent at Devine's Hill where the steep road gradient and previous lack of maintenance led to material from the road surface being washed over the edge of the retaining walls. Though much better maintained, the process continues today: white dusty runs down the wall faces showing where material is washing over the top during high rainfall. The accumulating sediment at the base of the walls is potentially a threat as it may be trapping water within the wall and the fill behind, leading to the risk of excessive hydrostatic pressures within the base of the road structure. There is also a risk of softening of any clay-rich material in the foundations.

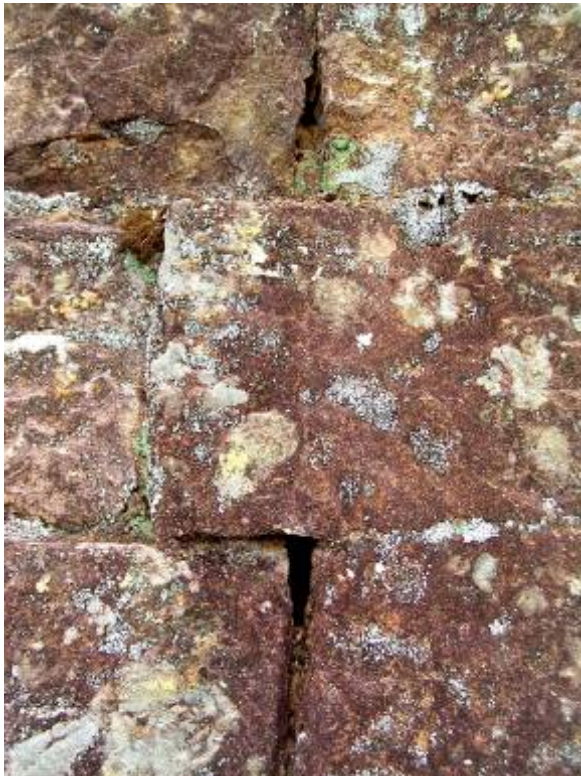
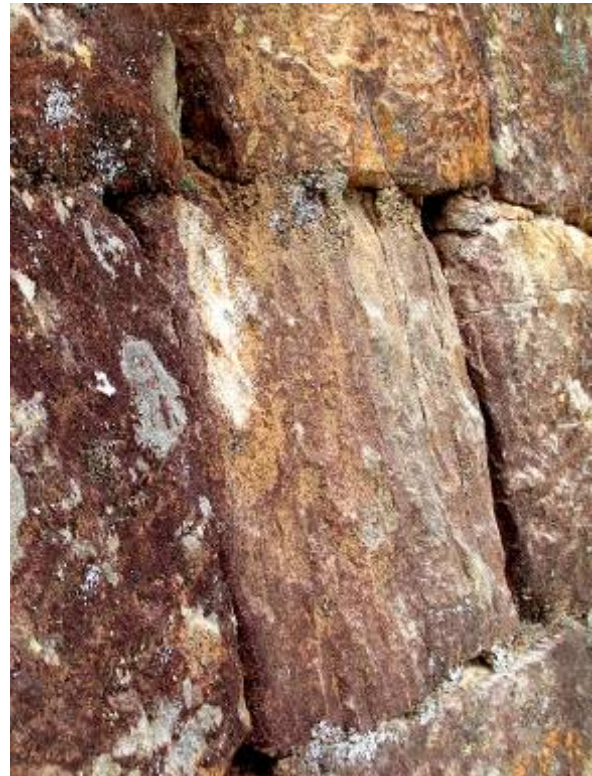
Figures 23 & 24

Stonework on Devine's Hill showing accumulation of 'natural mortar', a mixture of washed in sand, silt, clay and microflora such as lichens and also mosses. Progressive build up poses a long term risk of trapping water within the road structure leading to potential failure of the base of the walls.

There are places where a 'natural mortar' of sand, silt and clay bound with lichens and mosses is accumulating in joints low in the walls (Figures 23 and 24). This material is low in strength and shallow depths would not resist significant hydrostatic pressure from behind. However, progressive build up of the mortar over time may eventually pose a risk of damming too much water. Meanwhile the mortar will reduce the free-draining capacity of the road structure and will be retaining moisture in the walls leading to increased decay.

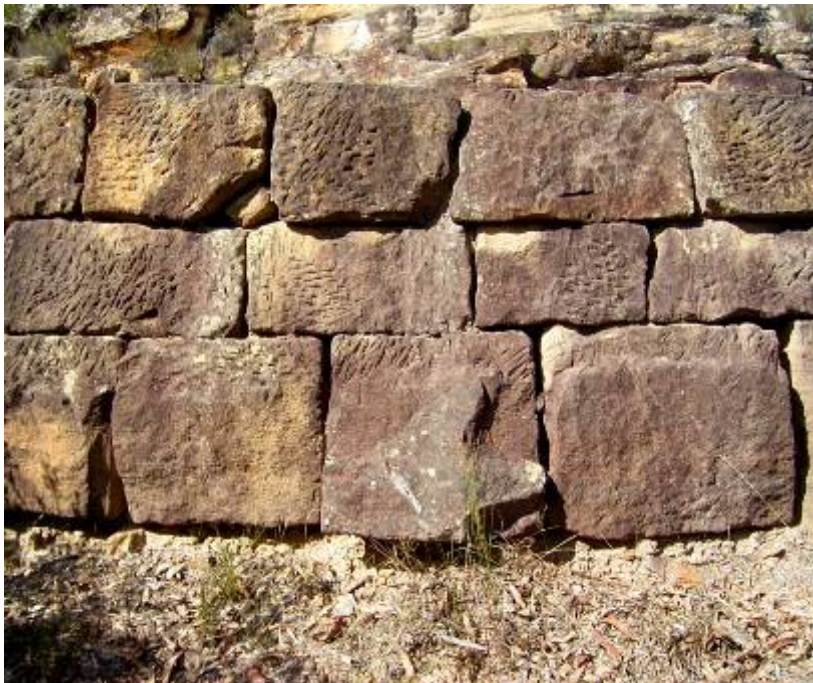
A section of retaining wall on Devine's Hill showing the distinctively dressed lower course which indicates that it was intended to be largely buried with only the upper portion visible. Erosion has removed earth from in front of the base, and if this were to continue it would pose a long term risk for the road structure. New material should be added to bury the lower half of the bottom course. Grasses and shrubs would help stabilise the slope below.

While not as common as mounds of excess sediment, there are areas at the base of the walls where there is too little material. Figure 25 shows a section of wall where the sandy gravel beneath the footings is being eroded. If this were allowed to continue the retaining wall would eventually collapse. In such cases material will need to be added to bury the toe of the footing and protect it from erosion. Consideration should be given to using small shrubs and/or grasses to bind the slope and so minimise erosion.

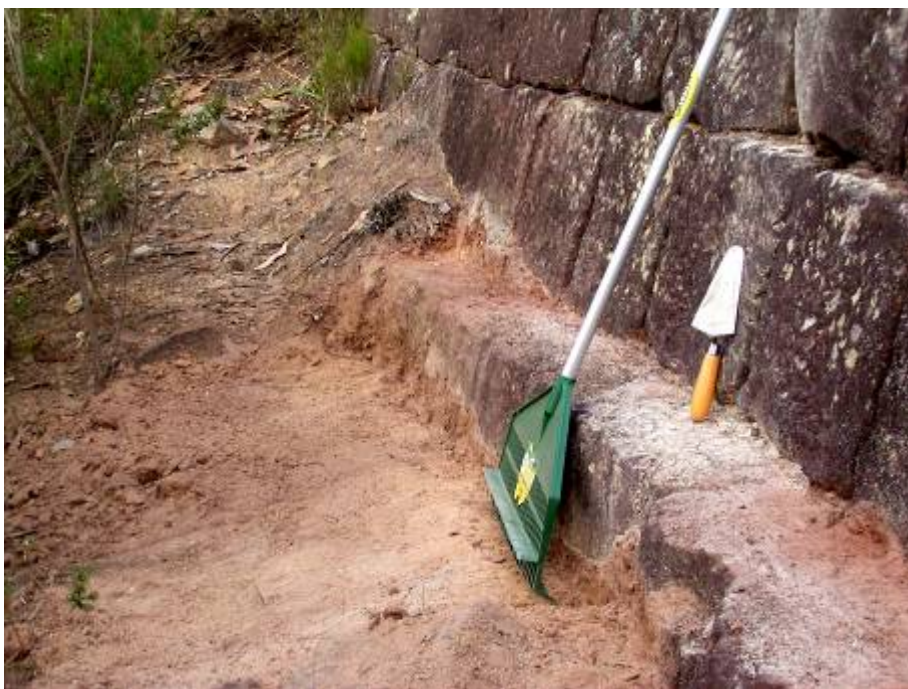
Figure 26  
Accumulated sediment is removed from the base of retaining walls using a strong plastic rake and a round-headed (gauging) trowel. The trowel is used to free root-bound earth from the stonework. The basal course of stone is left half buried to protect it from erosion.

4.7.3.1 Use a plastic rake to remove sediment from the base of the wall. Firmly bound lumps may require a (round-headed) gauging trowel to separate them from the wall, but this is the only metal bladed instrument that should be used. The aim is to produce a flat or gently graded profile away from the wall (Figure 26), but not a steep one which would promote erosion. Be aware of threatened species (see 4.3), and avoid damaging any specimens. Where erosion is exposing the foundation below the base course of the retaining walls, add new material (and plants, or seeds, as appropriate) to bind the slope.

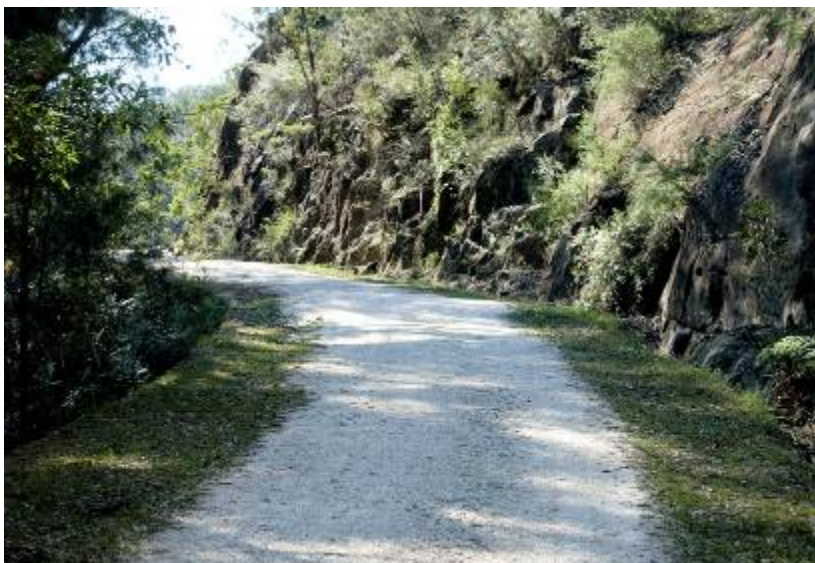
Figure 28

Grasses growing on the lower and well-shaded part of the Devine's Hill ascent. The grass roots effectively bind the road surface material and offer a solution to the challenge of stabilising sloping edges of pavement that cannot be readily compacted with rollers.

Some concerns remain, as the road edges, particularly the steeper outer edges, are soft with potential hazards to vehicles and pedestrians. The edges are soft because of the difficulty of safely compacting them with a roller. Two possible solutions are worth considering. One is the use of a vibrating plate compacter carried on a truck-mounted hydraulic arm, which would allow safe compaction of the steeper outer edges (while the vehicle is centrally located on the road). The other would be to promote the growth of grasses on the edges and achieve stabilisation through the binding effect of the grass roots. In the lower parts of the Devine's Hill ascent (where shading by trees has encouraged growth) there is already considerable grass growth on the edges of the road surface (Figure 28). Provided that appropriate grasses can be obtained, they offer a convenient way of binding the road surface, not only on the outside, but also on the inside where kerb stones are missing (Figure 8). Grasses may not survive on the more exposed (hotter, drier) parts of the ascent and for these areas mechanical compaction should be undertaken.

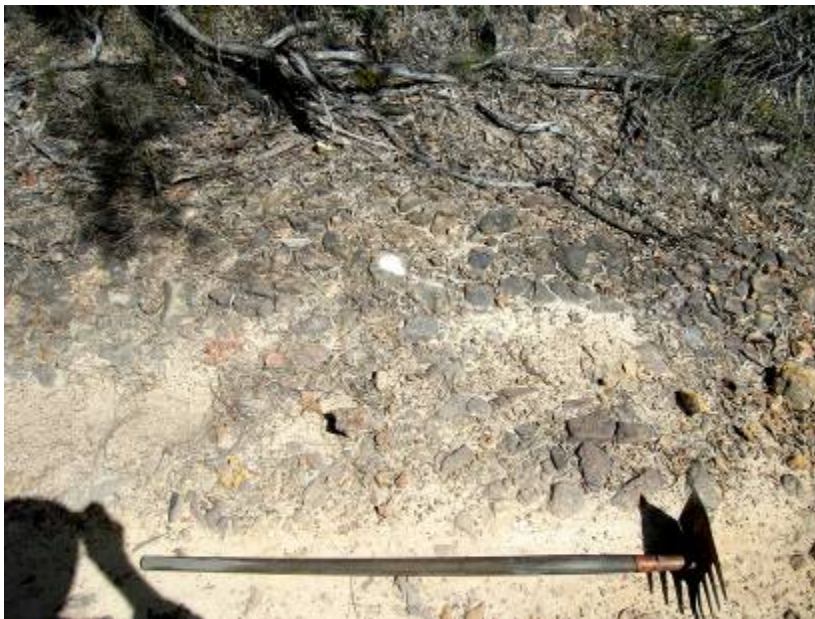
Figure 29

Original pavement in precinct 5 showing cobblestone-like effect of the coarse aggregate base course of the Macadamised road. The finer topping, or surface layer, has eroded away.

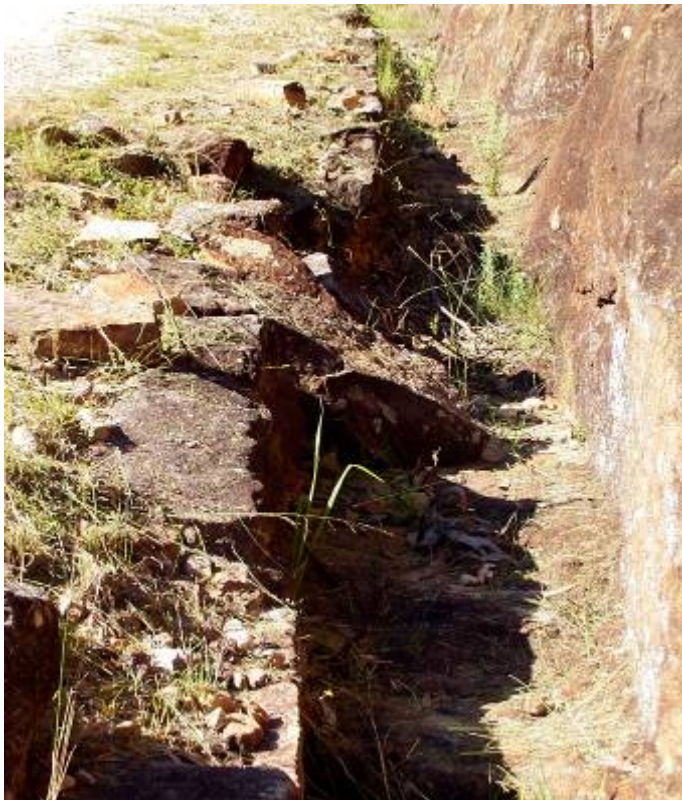
Figure 30  
Displaced kerb stones that have fallen into the side drain, reducing its capacity and risking erosion of the road pavement.

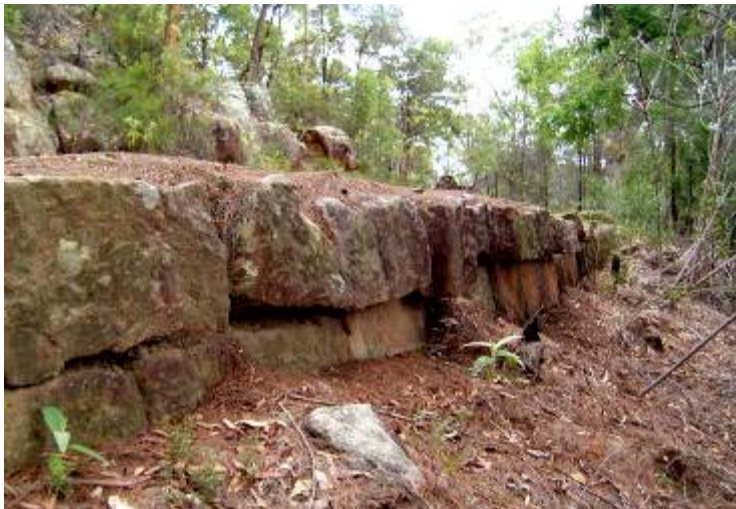
Figure 31

Coping stones displaced sideways. This is likely to have been due to trees growing in the road at a time when it was not maintained, though pressure from heavy vehicles on the pavement may have contributed. Repositioning of multiple stones like these should be a low priority Minor Works program.

As well as occasional stones missing from the coping, there are many that are now out of alignment due to tree growth or to pressure from the road surface material (Figure 31). Like the kerbing, re-aligning copings stones is best undertaken not piece by piece, but in a single campaign aiming to repair a complete precinct or section of a precinct. The advantages of a whole-of-precinct or sectional approach is the opportunity to train those involved in the work practices and to provide archaeological and supervisory input in an efficient and timely way. Such work is identified in the Maintenance and Repairs Matrix (Appendix 1) as Minor Works requiring Heritage Act approvals and appropriate specialist input.

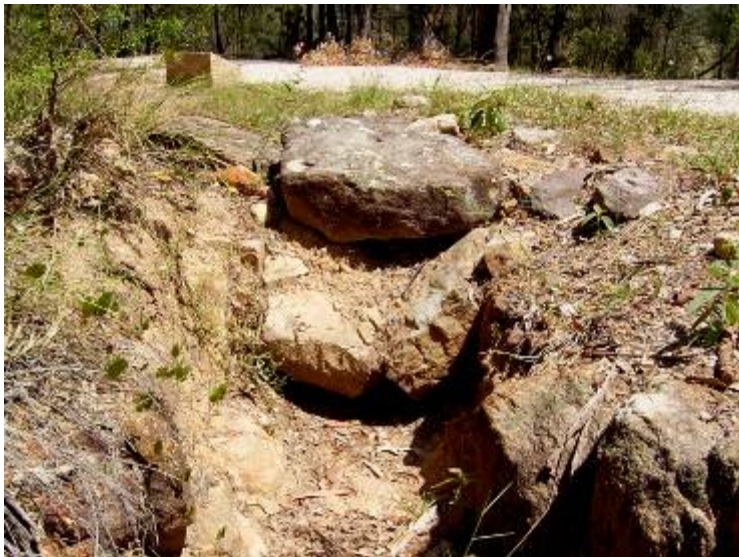
Figure 32

Broken culvert entrance cover now largely blocking the culvert. The risk of damage to the road structure during a storm is high, which is why individual examples like this should be repaired as a maintenance activity.

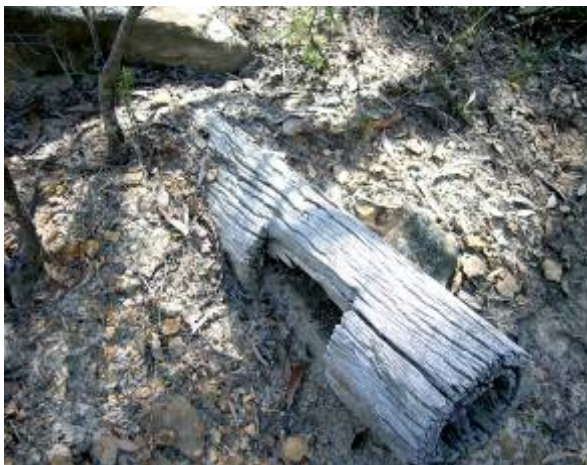
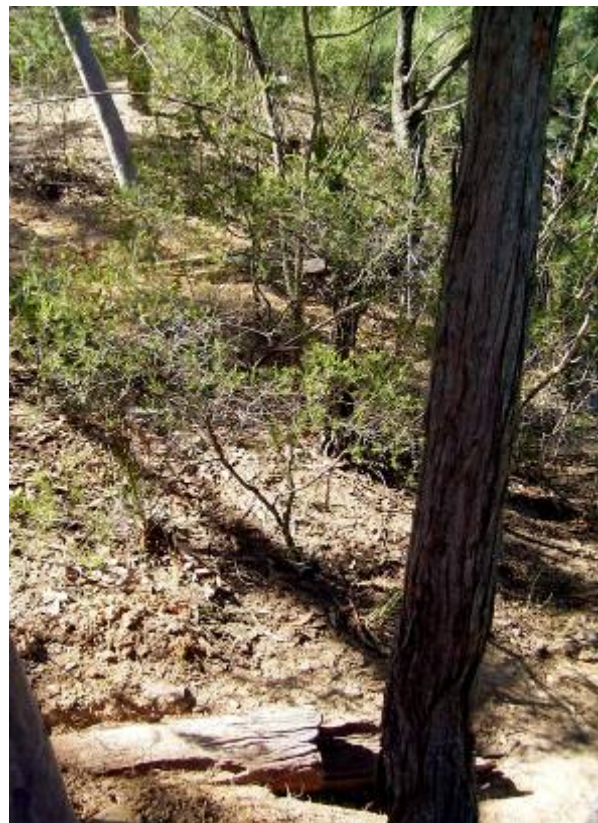
Figures 33 & 34

Partially buried bed logs at site 5/T1 showing above how these logs supported an upright post. Shallow bedrock at this site made bed logs necessary to support the posts. Soil and heavy stones help stabilise the bed logs. All four known bed logs at this site are (just) visible at right, with their outer ends in a line: the first (above) is near the top of the picture in the centre, the second shows as a dark shadow not far below it.

A preliminary investigation of the bed logs at site 5/T1 was undertaken by Ireland and Young in May 2004 and as a result, the opportunity of inspecting and undertaking initial treatment of all three sites was taken in September 2006 by Young in company with Sarah Breheny, Ranger. Figures 33–36 show two of these sites and give an impression of the extent and amount of remaining timbers. More photographs (Figures 37–56) follow the treatment recommendations. The survival of these elements is remarkable and a testament to the durability of the wood (ironbark?).

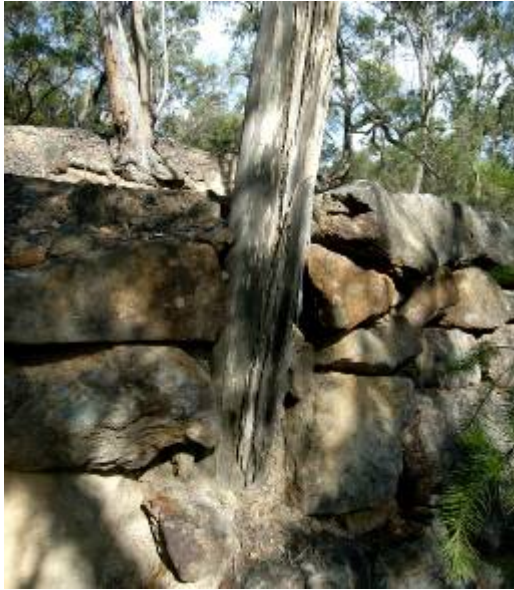
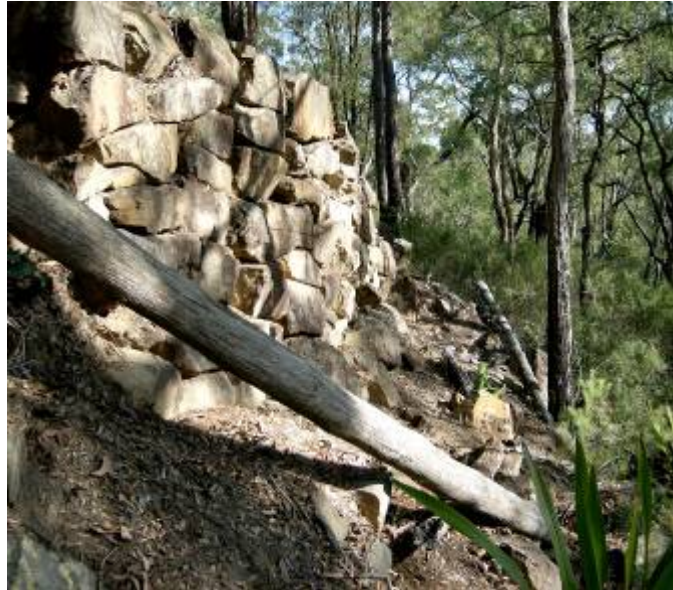
Figures 35 & 36

Post and collapsed rails at site 5/T2. At left can be seen how the post was built in as part of the wall and is not an afterthought. 'Mud' around the post base is termite gallery. No rails remain *in situ*, but displaced rails such as those at right occur at both 5/T2 and 5/T3. Inspection downslope at 5/T3 revealed more rails and posts than previously documented. Further investigation of all three sites is warranted.

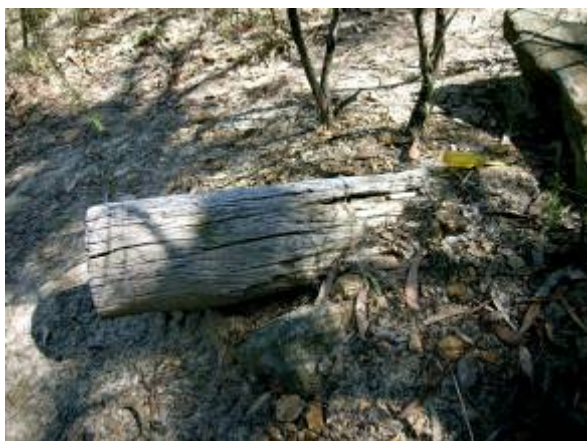
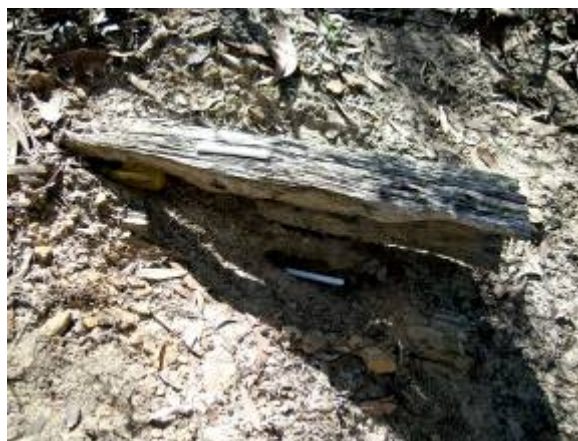
Figures 37 & 38

Bed log 1 at left and bed log 2 at right showing two loading points for fungicidal rods in each log. Large screwdriver indicates one point in each. Two rods are placed in the deeper (damper) point of all bedlogs.

4.12.2.2      Insert boron and fluoride based preservative rods (‘Polesaver Rods’, see Appendix 3) into existing gaps and holes in the timber elements. There is no need to make new holes in the timbers as there central voids, and also holes and depressions in the outer surfaces that are large enough to take the preservative rods. The locations of many of the fungicidal rods are shown in the pages of photographs that follow (Figures 37–56). Loading rates should be 2–3 rods per post or other element. The rods work by slowly dissolving when wet whereupon the boron/fluoride fungicides diffuse through the wood thus protecting it from further decay. Keeping the posts topped up with new rods is all that is required.

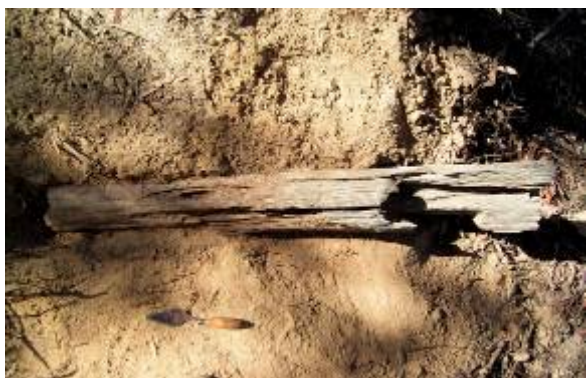
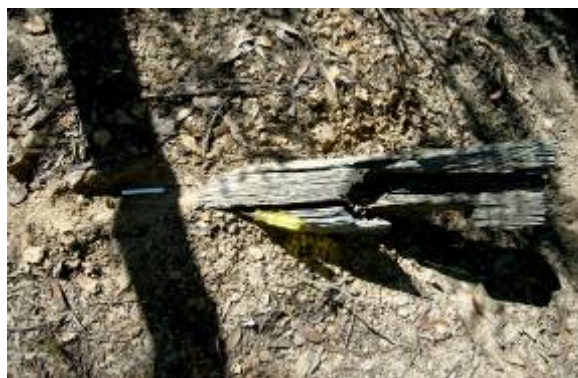
Figures 39 & 40

Bedlog 3 during archaeological investigation in May 2004 at left, and in September 2006 at right showing loading points for fungicidal rods. The screwdriver indicates one point. It is conceivable that the hole in the top of the log at left is from an iron spike inserted as a brace for the post.

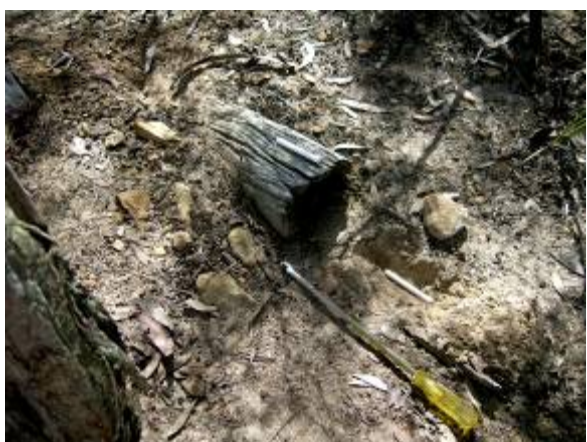
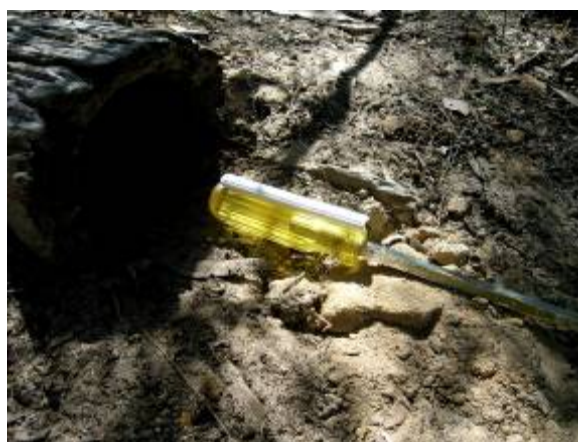
Figure 41 & 42

Bedlog 4 showing at left, burial of fungicidal rod in sand covering bottom portion of log. Large screwdriver has 300mm shaft and 115mm handle. At right showing how a groove in the handle is used to deliver rods deep into the hollowed out centre of the log, which has a total measured internal depth of 1550 mm.

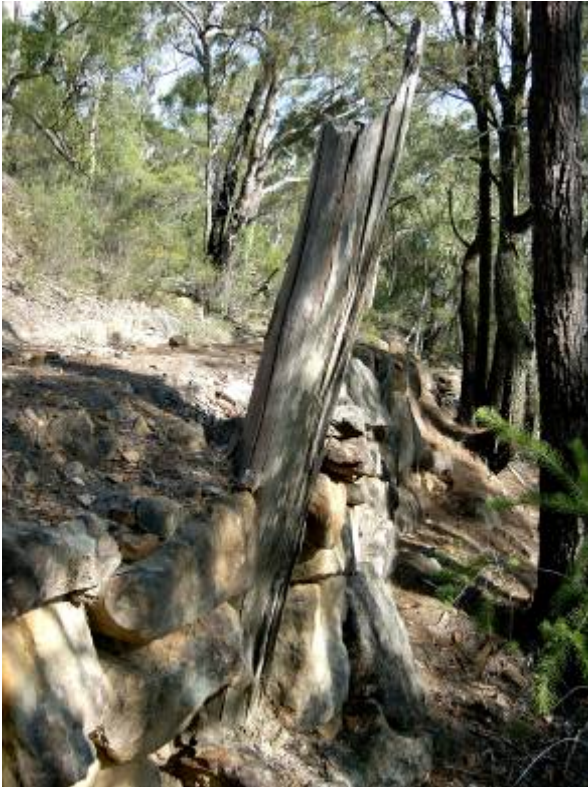
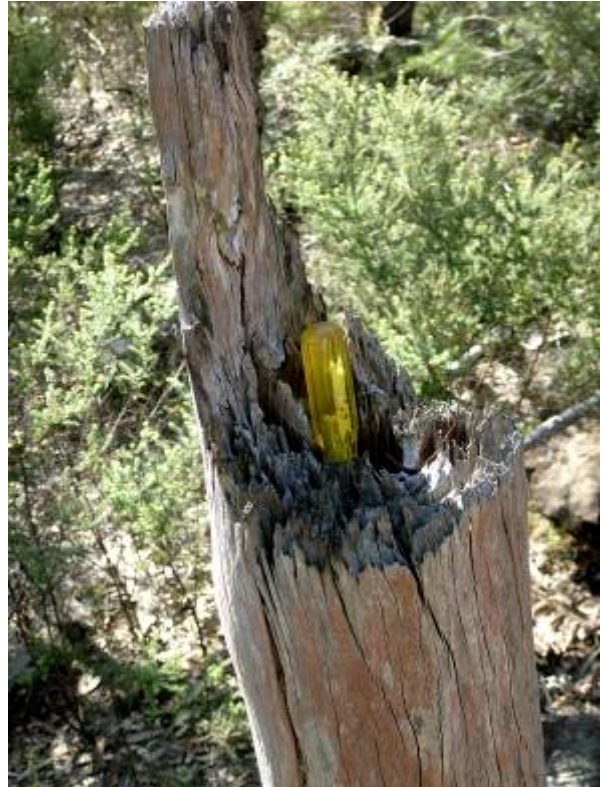
Figures 43 & 44

Remaining *in situ* post at 5/T2 (see also Fig 35). At right, top of post showing fungicidal rod loading point.
