# Old Great North Road

Dharug National Park

Maintenance Plan

March 2007

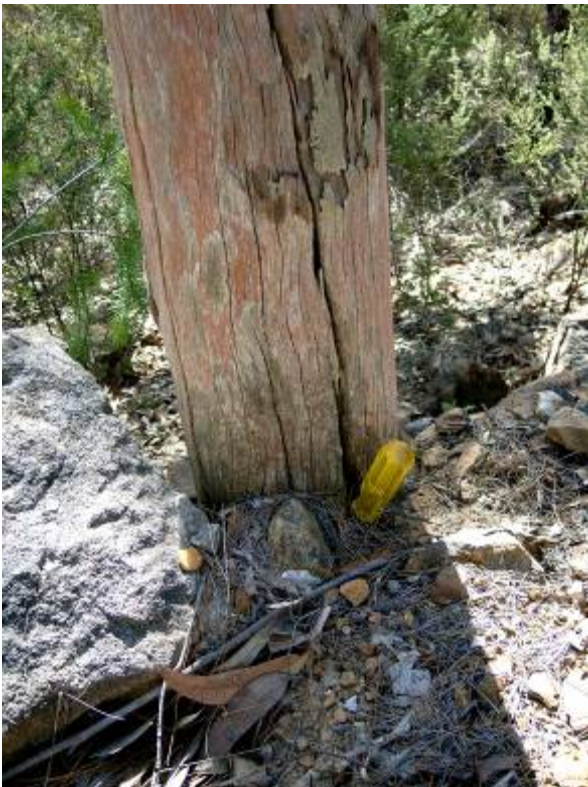
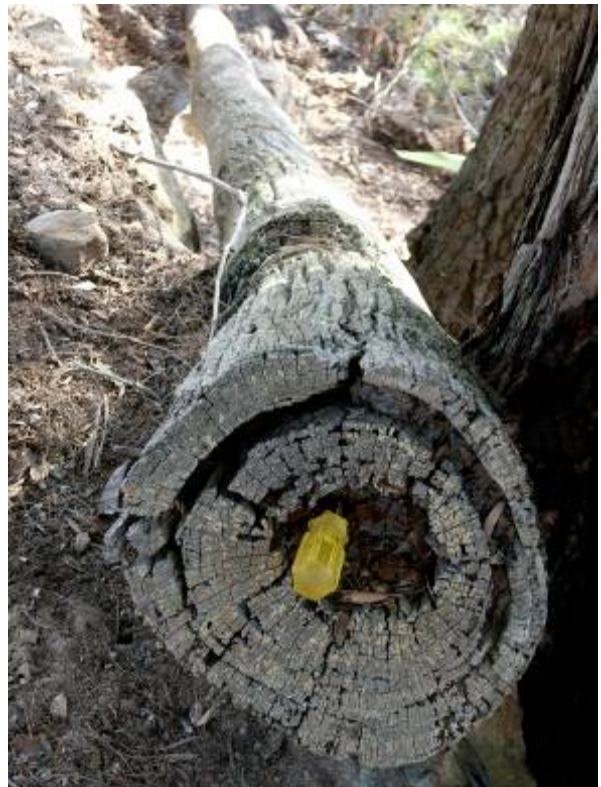
Figures 45 & 46

At left, base of post seen in 43 and 44 above. Fungicidal rod loading points. End of displaced rail at right.

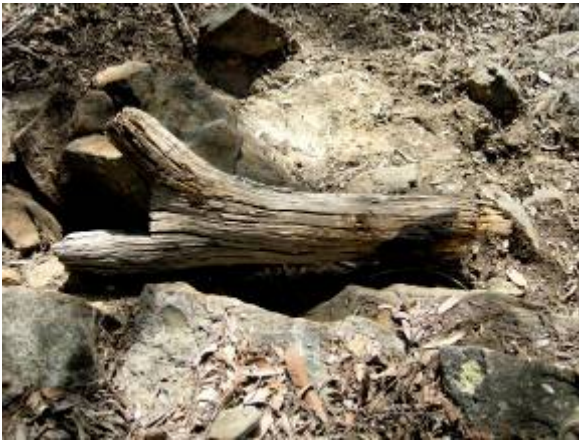
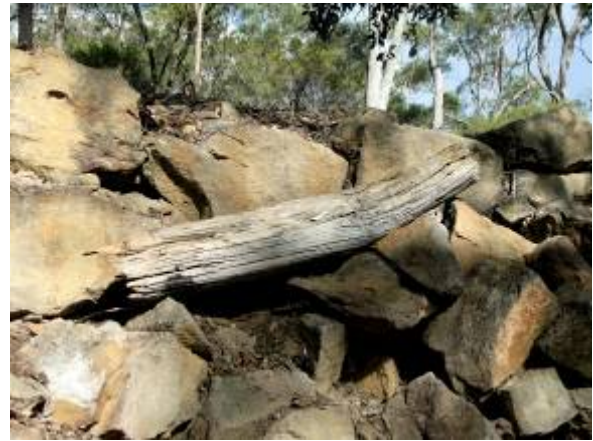
Figures 47 & 48

At left, looking down on post removed from relocated site, note fork to carry rail. Side view at right.

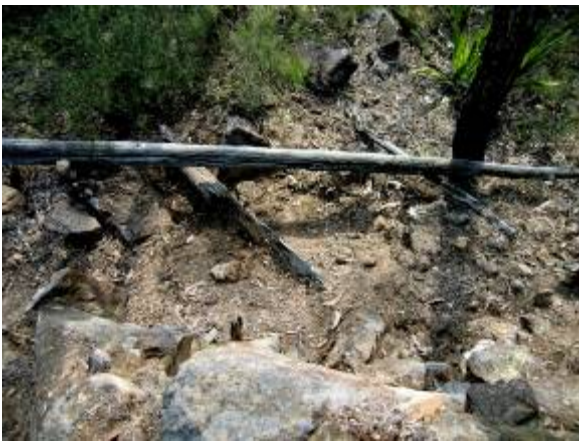
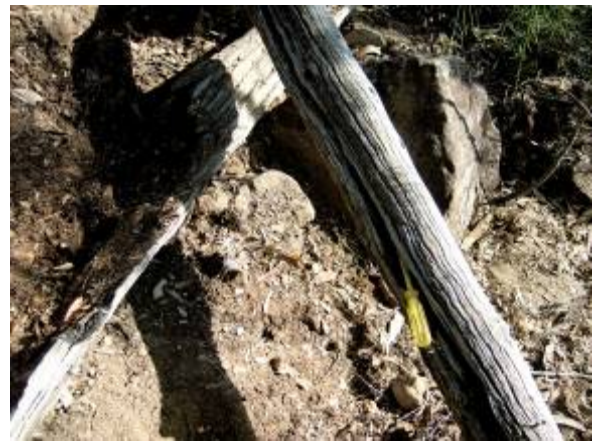
Figures 49 & 50

Collapsed rail and posts after clearing firebreak at site 5/T2. More posts lie nearby.

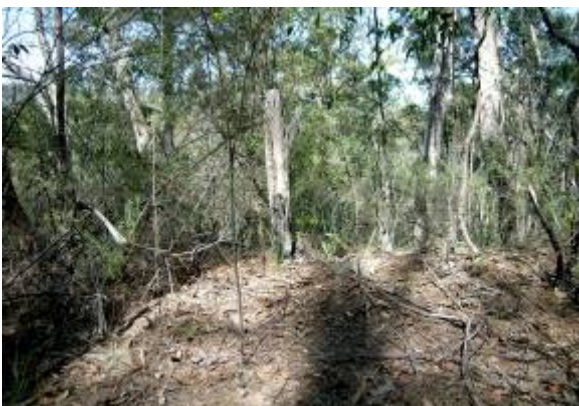
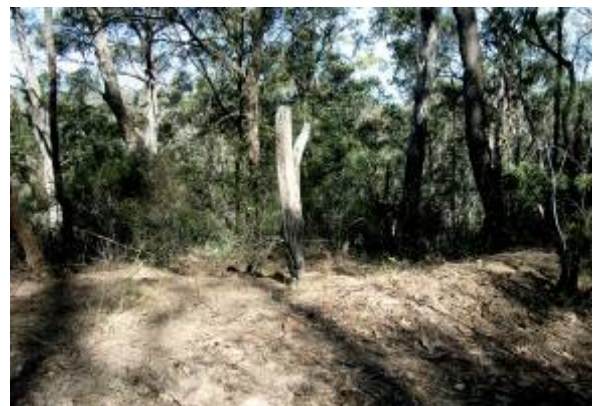
Figures 51 & 52

Before and after clearing firebreak at one of two standing posts at site 5/T3. The post has already been damaged by fire and is now very fragile. Take care when working around it and do not lean tools against it!

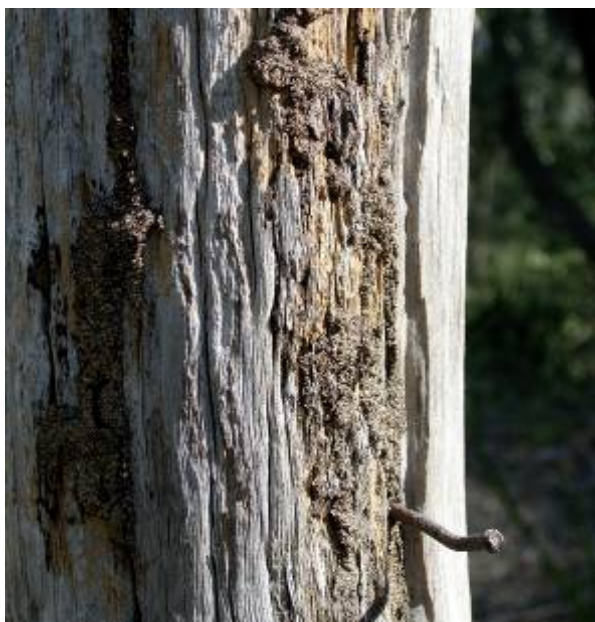
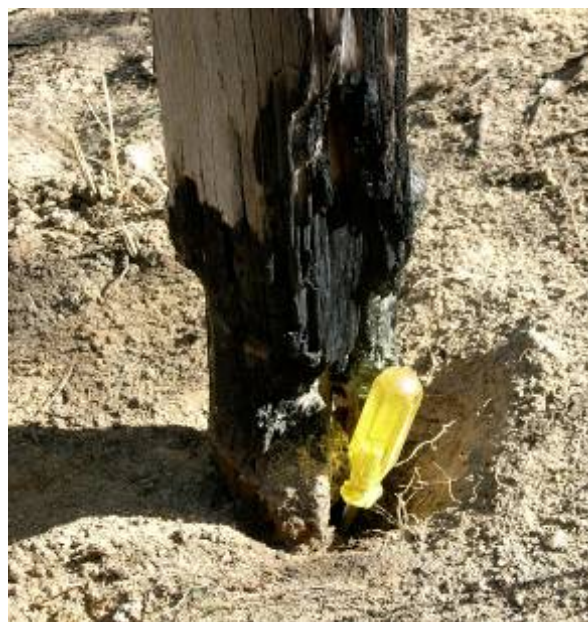
Figures 53 & 54

Same post as in Figures 51 and 52, termite galleries at left. At right the base of the post showing extreme thinning from termites, fungal rot and fire. Post is now very fragile: take great care when working around it.

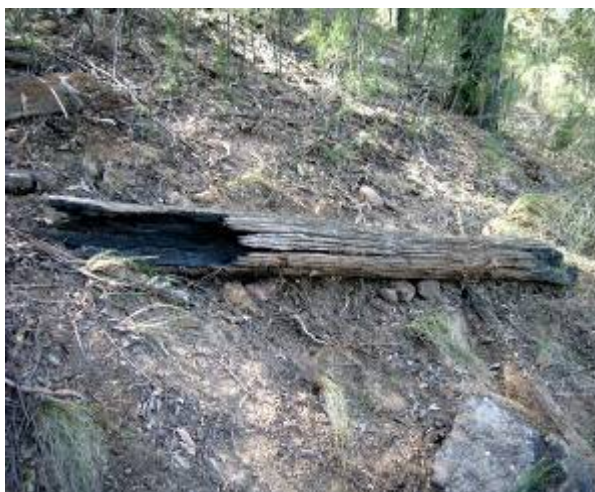
Figure 55

Timbers lying downslope at 5/T3. There are several more close by and the area warrants further investigation. This ?rail timber was lifted slightly onto stones to improve drainage and reduce risks of fungal rot and termite attack. Another timber lies partly buried to the right.
