Title
Erosion and recession hazard zones - Present Day: Sandon

Project
2021s1471 - Hydrosphere - CVC CMP Stage 2 - 4

Client
Hydrosphere Consulting

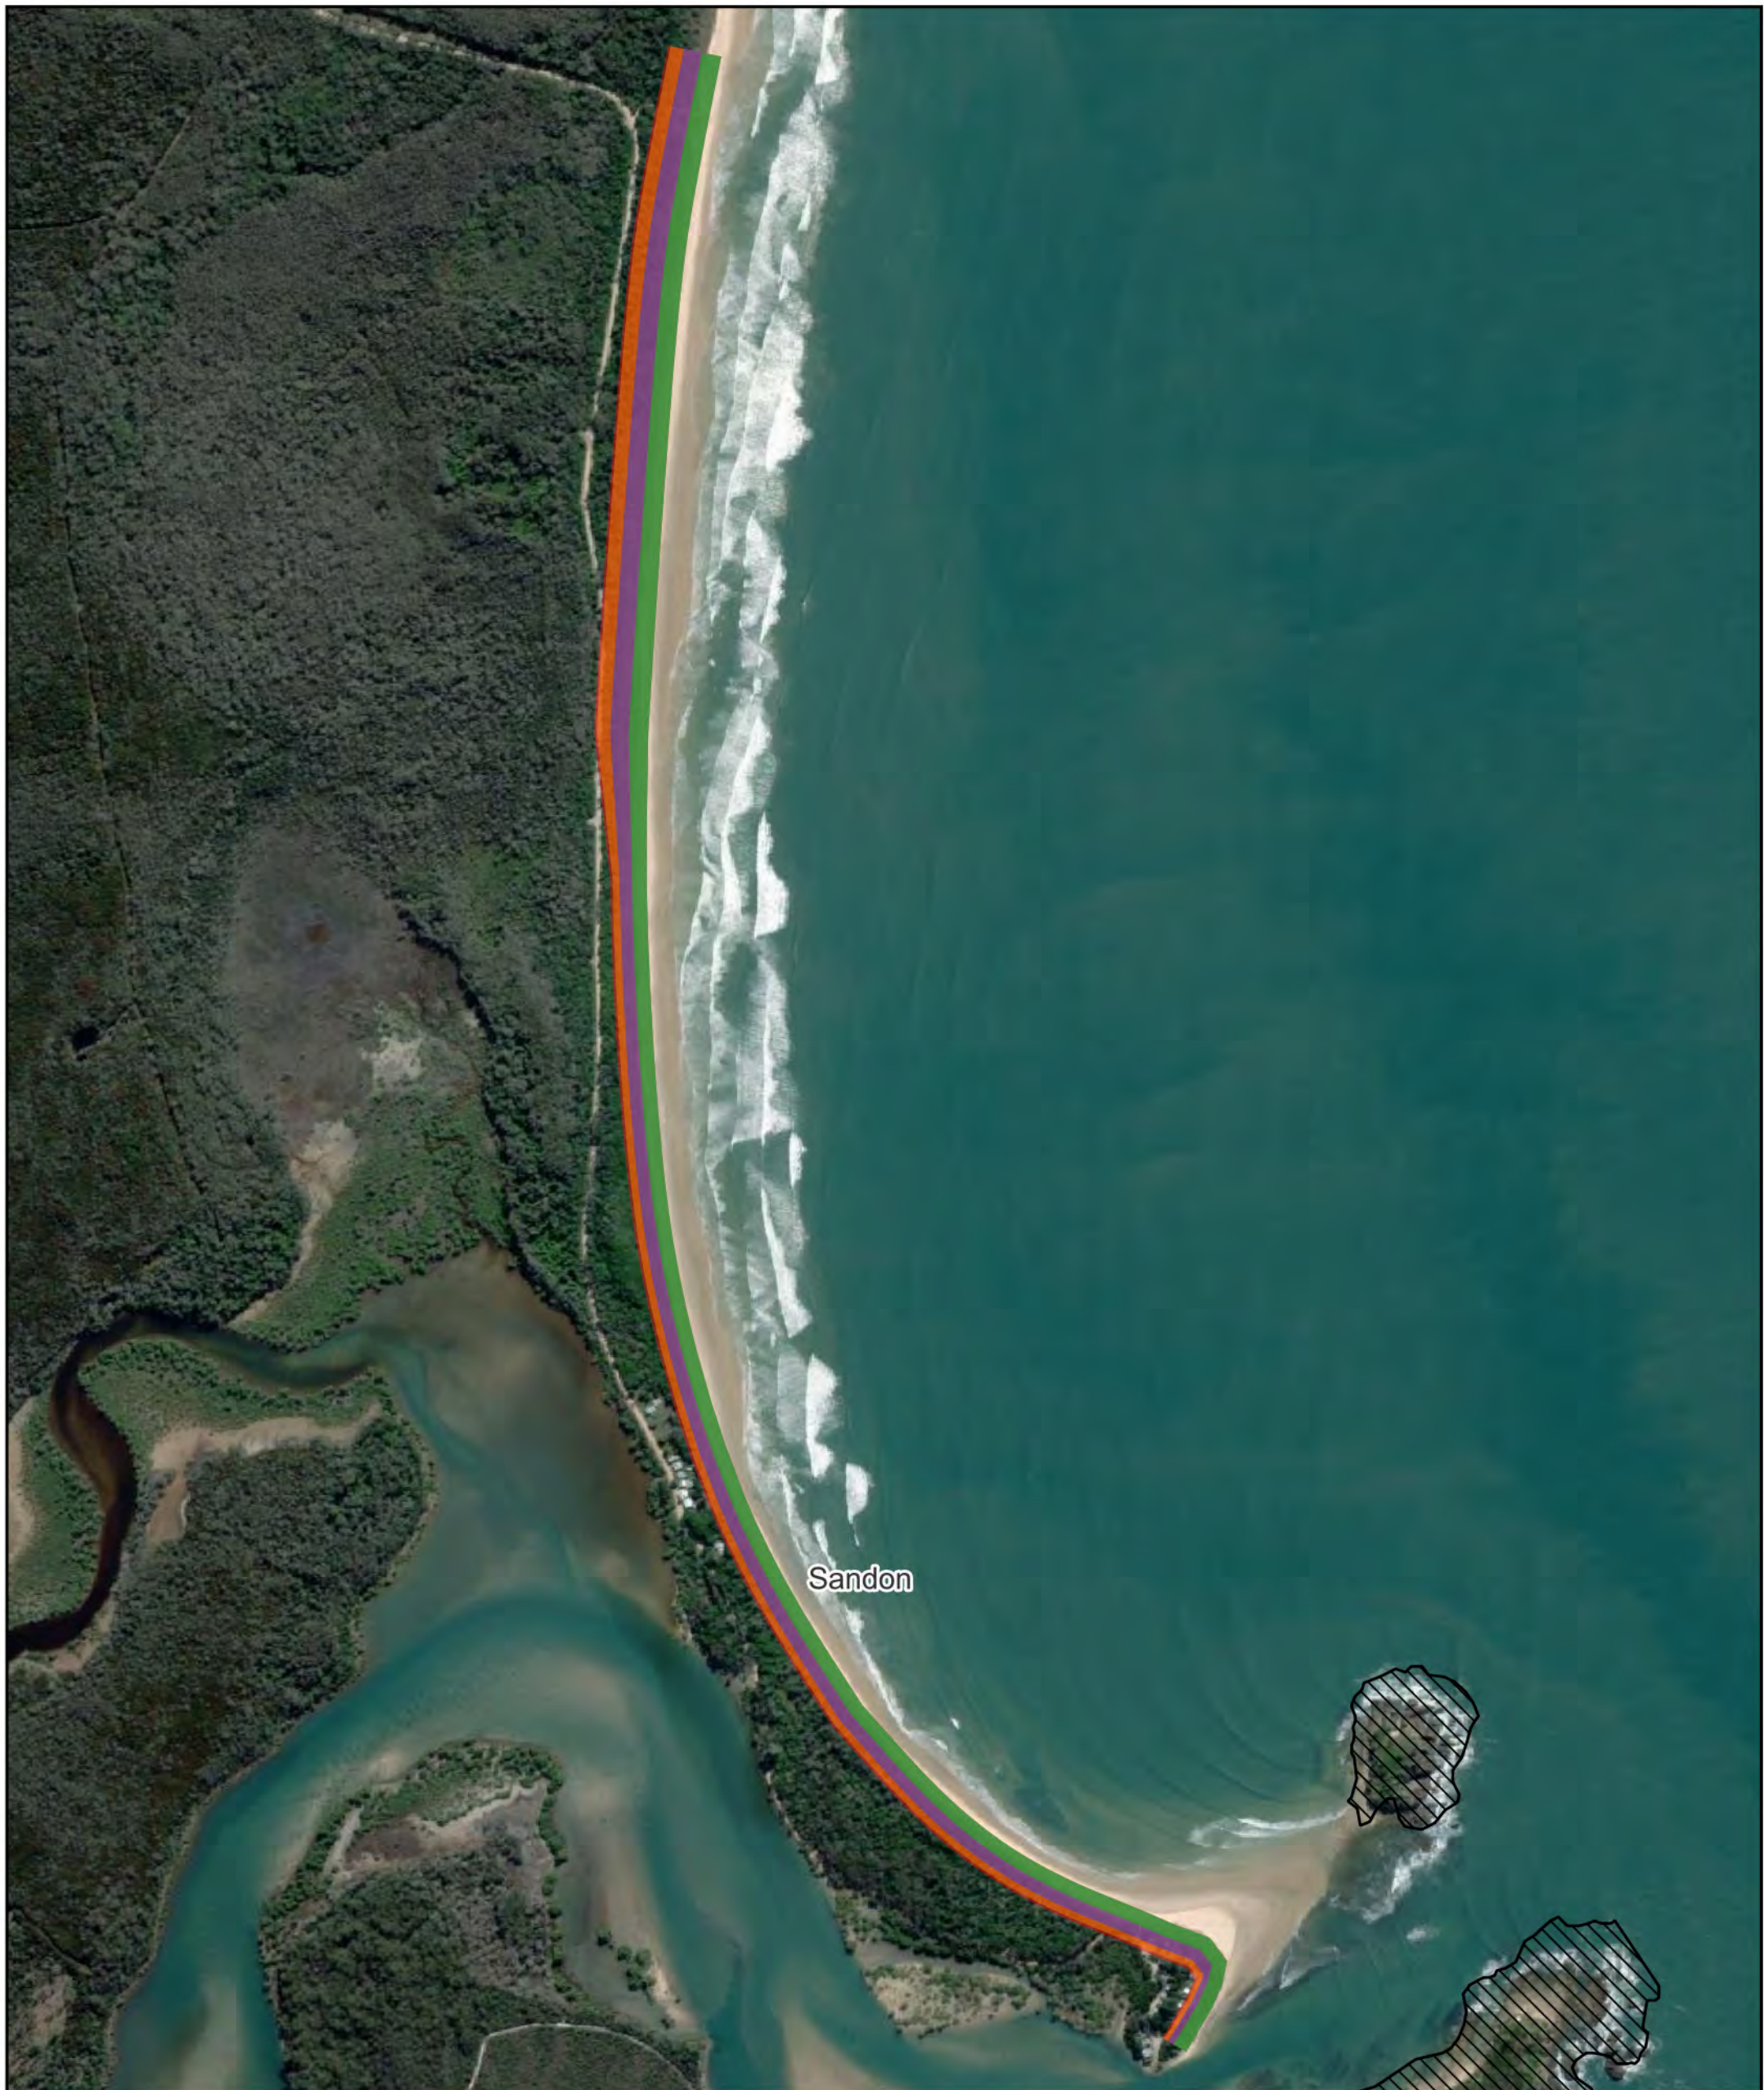
Erosion and recession hazard zones (without protection)

50% exceedance probability

10% exceedance probability

2% exceedance probability

1% exceedance probability

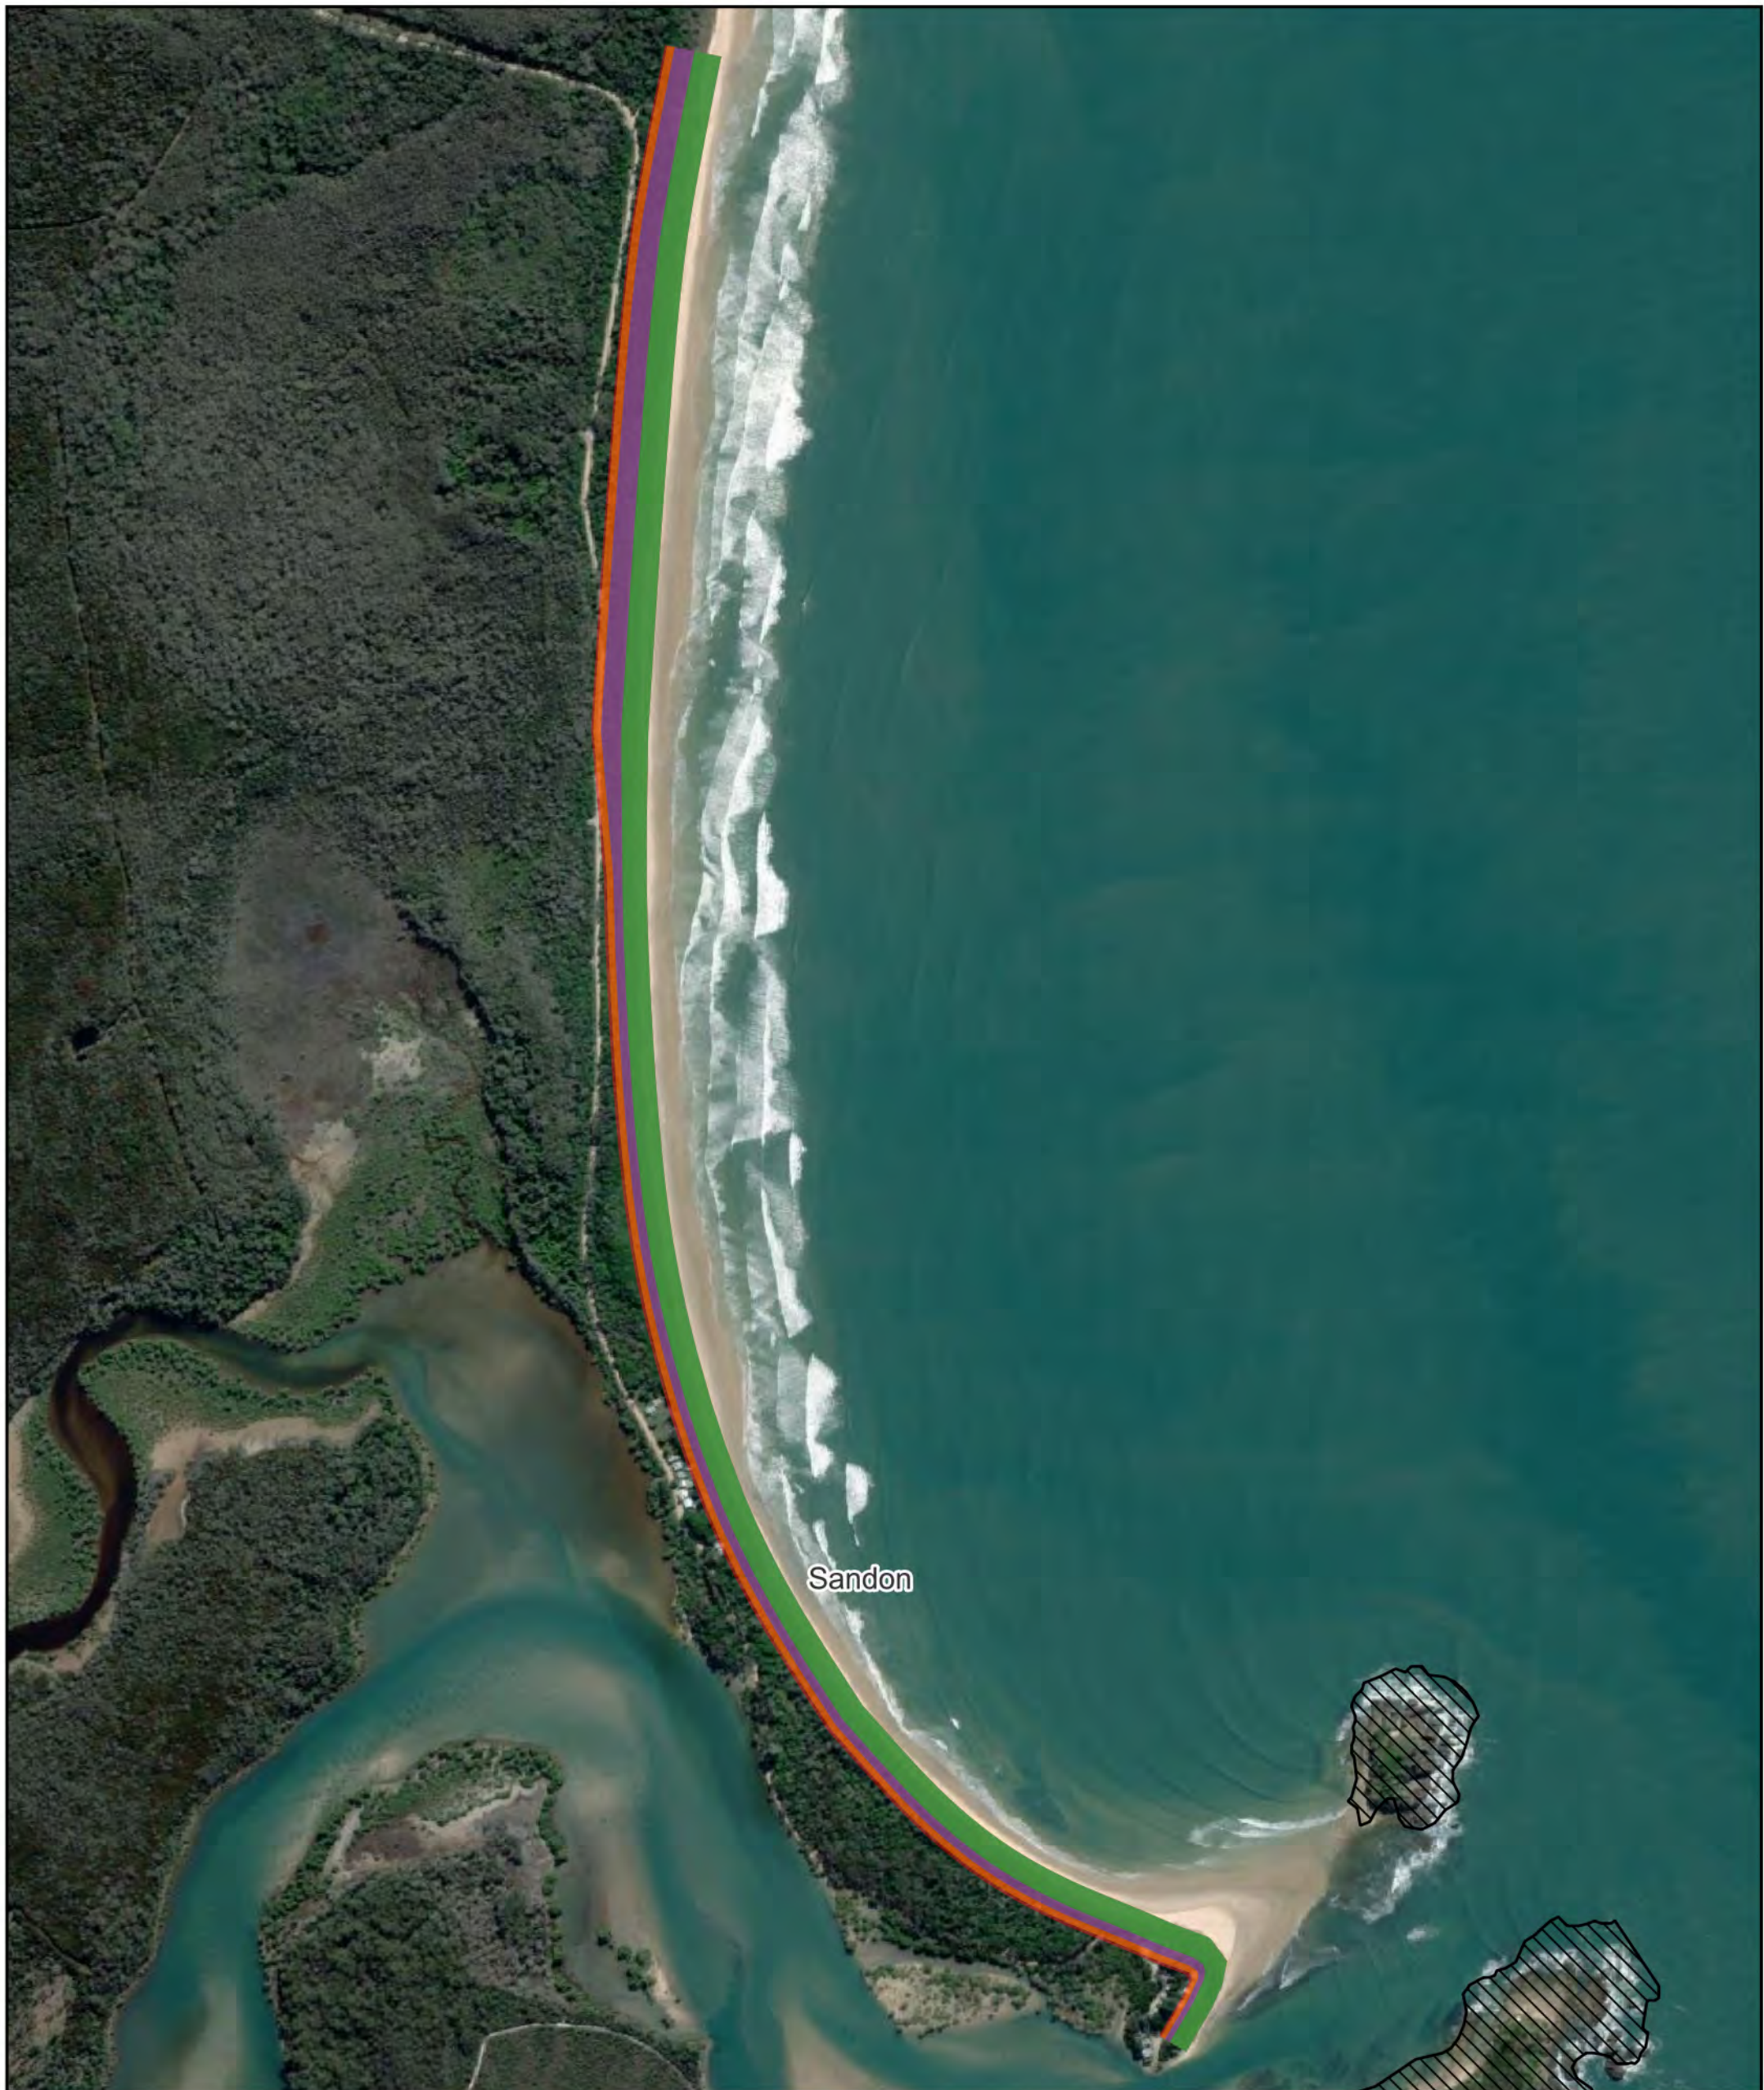
Title
Erosion and recession hazard zones -SSP2 2043: Sandon

Erosion and recession hazard zones (without protection)

50% exceedance probability

10% exceedance probability

2% exceedance probability

1% exceedance probability

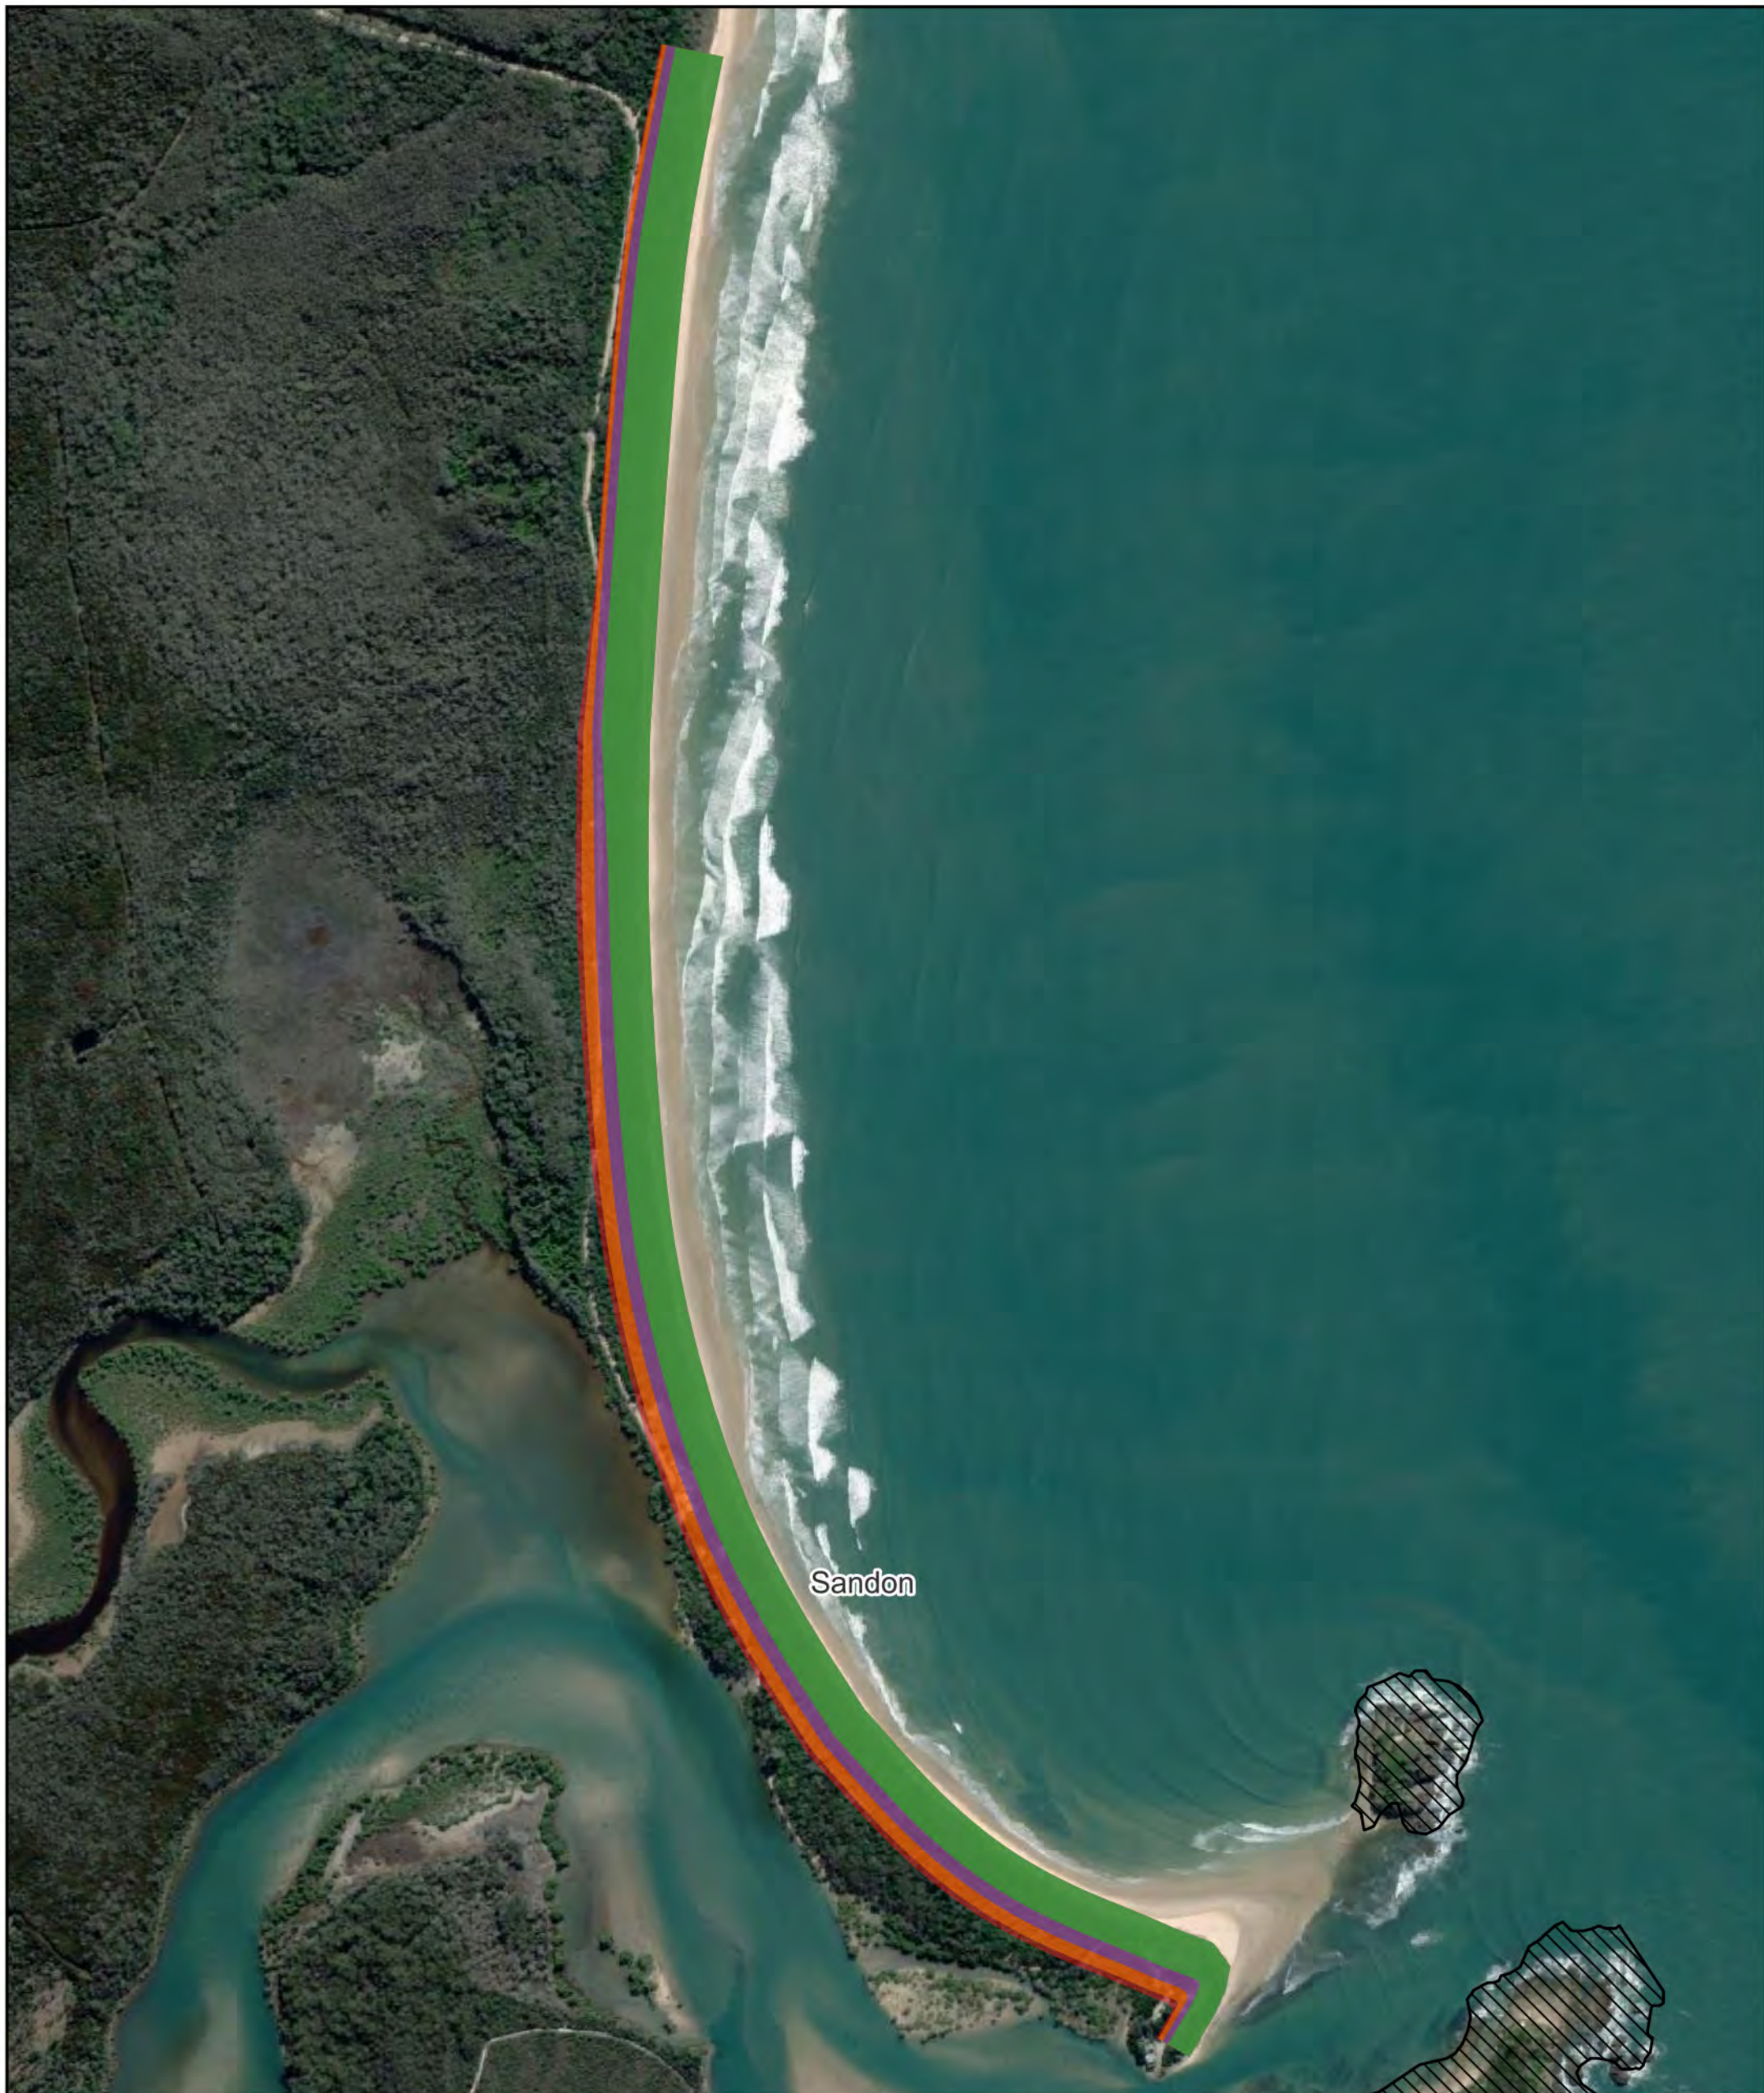
Title
Erosion and recession hazard zones -SSP2 2073: Sandon

Erosion and recession hazard zones (without protection)

50% exceedance probability

10% exceedance probability

2% exceedance probability

1% exceedance probability

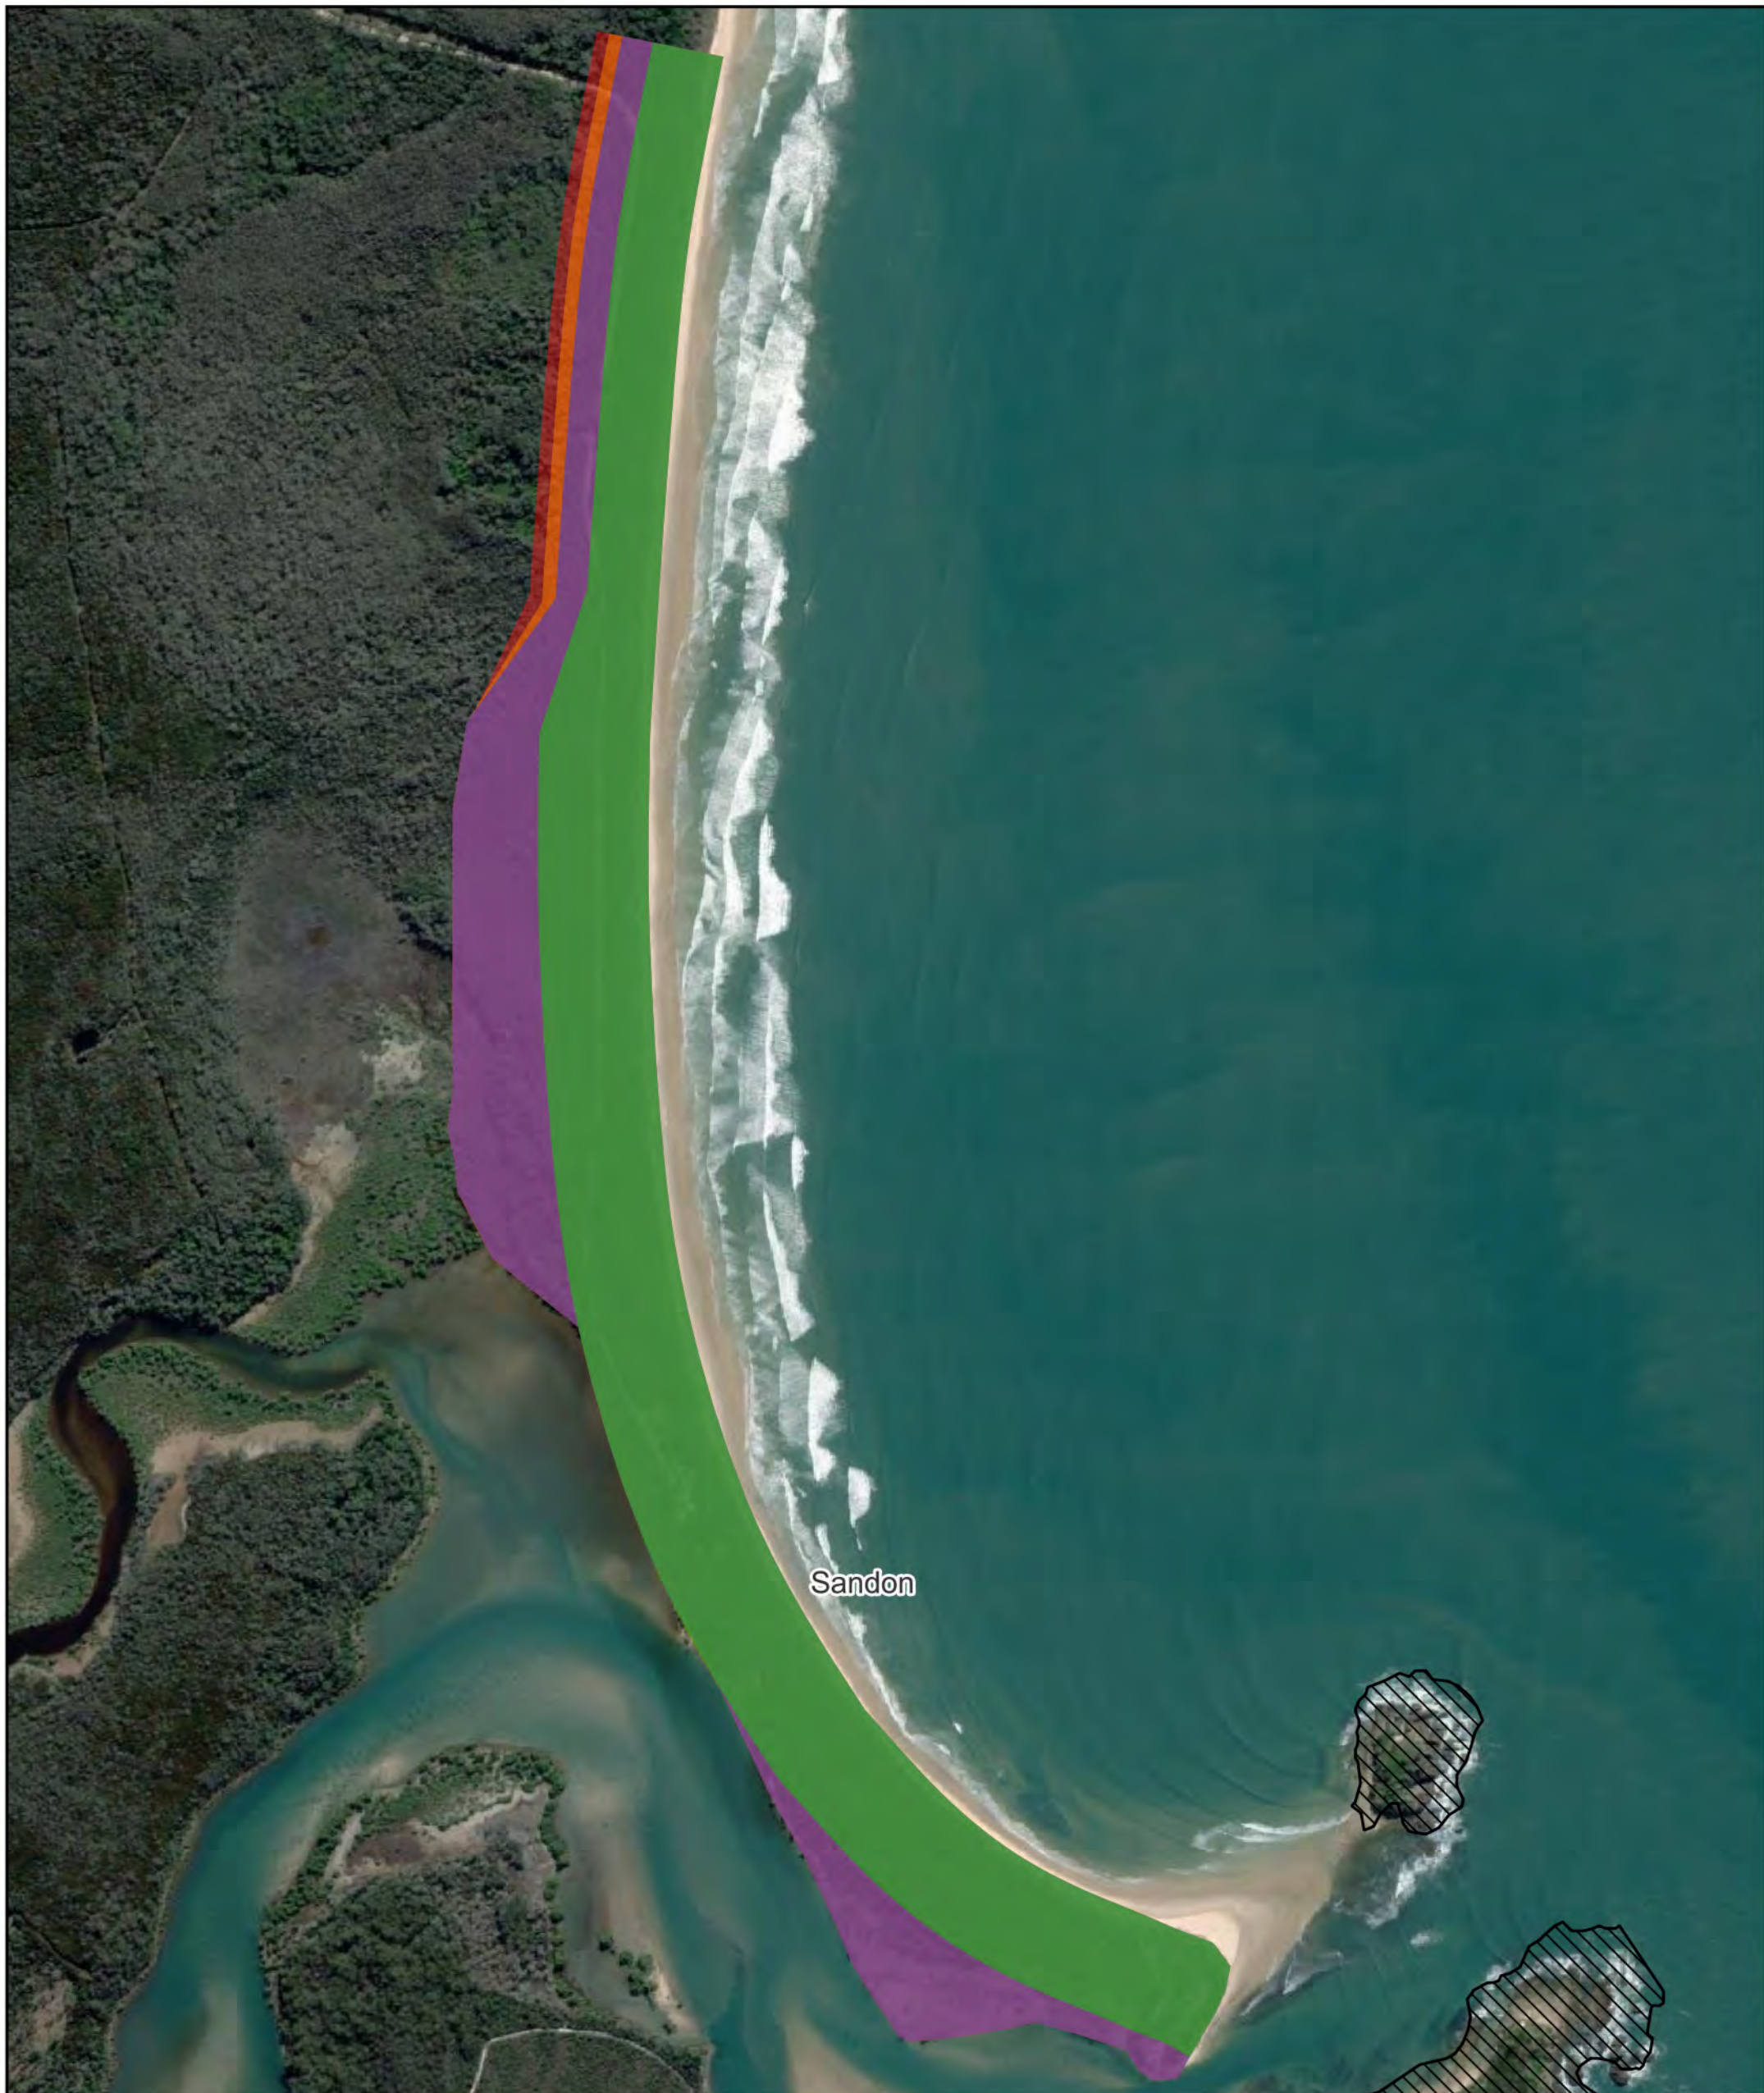
Title
Erosion and recession hazard zones -SSP2 2123: Sandon

- Erosion and recession hazard zones (without protection)
- 50% exceedance probability ■
 - 10% exceedance probability ■
 - 2% exceedance probability ■
 - 1% exceedance probability ■
 - Bedrock
