**PS RAINBOW 1860 - 1864**  
**Maritime Archaeological Survey**

**June 2004 – March 2005**

Report prepared by: Sean McMahon, March 2005.

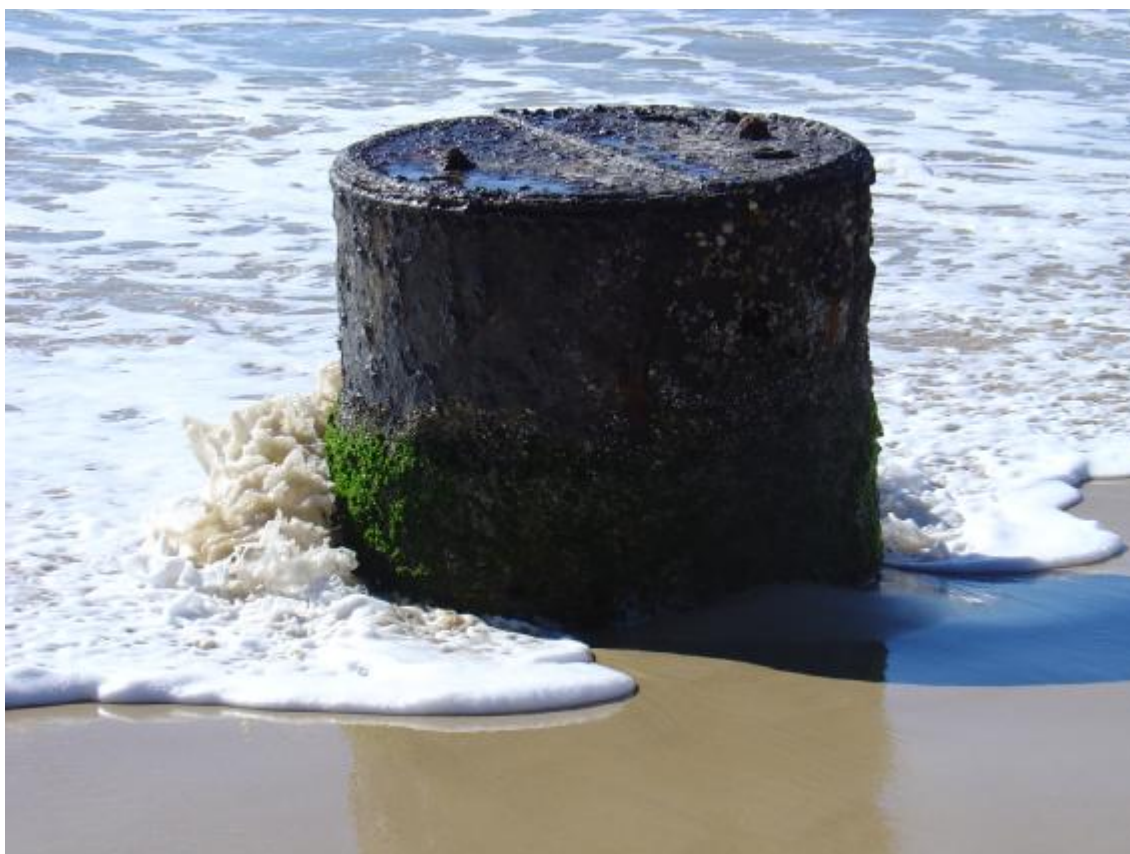
Figure 1: Trio Boiler. Photograph by Sean McMahon

In 1870, six years after the *Rainbow*'s loss, the paddle steamer *Trio* was wrecked on the beach a few hundred meters from the *Rainbow* and her boiler is still visible at the waters edge today. During 1896 the Sydney based salvage ship *Sophia Ann* was recovering gold sovereigns from the wreck of the SS *Catterthun* and spent weeks at a time anchored in the bay waiting for suitable conditions to continue with the salvage.

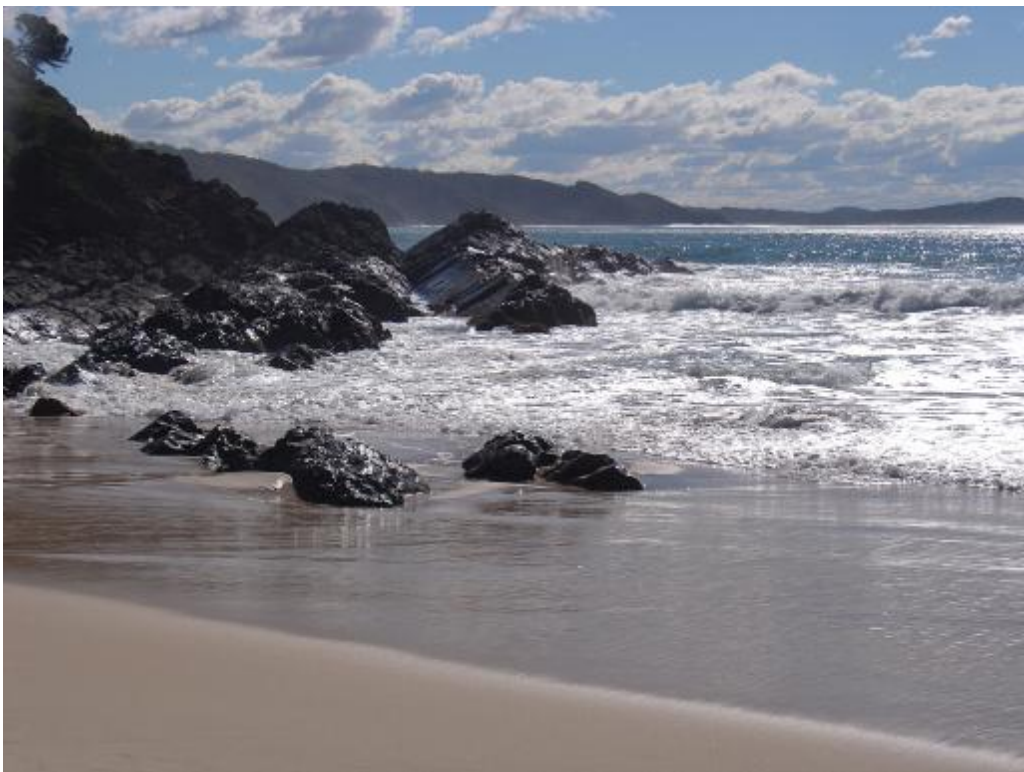
Figure 5: Gutters leading out from the beach. The wreck site is located near the gutter's further most tip in this photograph, which was taken at low tide. Photograph by Sean McMahon

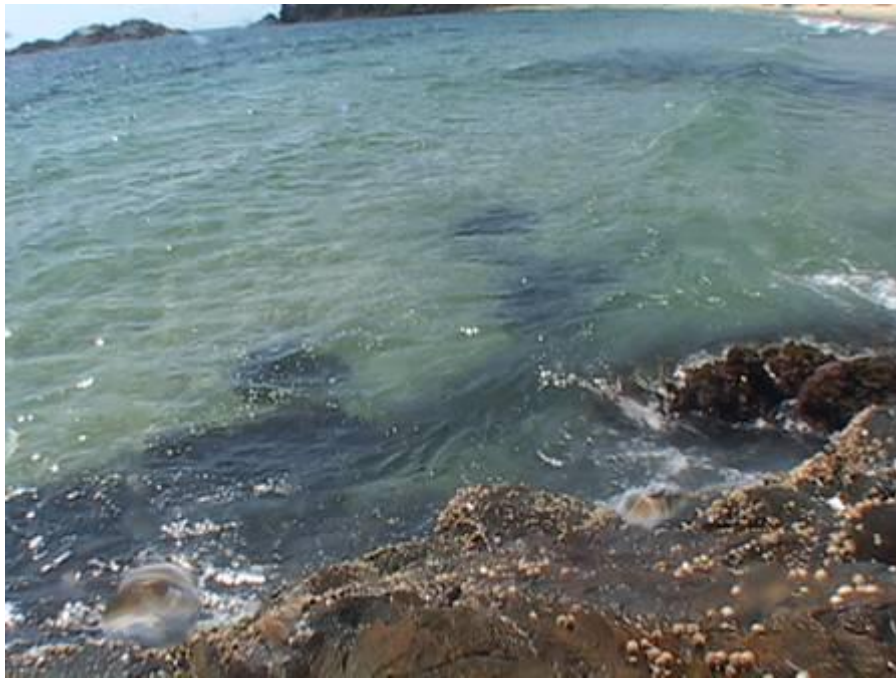
Figure 6: Site from rock platform. Photograph by Sean McMahon

The remains of the *Rainbow* are located against a rock wall in the surf zone of an isolated beach. Although the site was small, the environmental factors in terms of isolation and conditions provided the greatest challenge to the survey project.

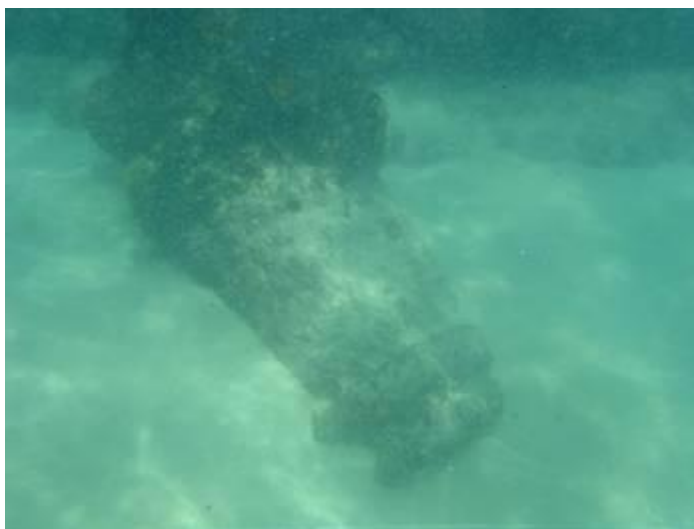
*Figure 7: First Cylinder. Photo by Sean McMahon*

This is the more intact of the two cylinders and appears to have slide guides still attached to the piston shaft. It also has what appears to be a slide valve attached to the cylinder body. This item is most likely constructed of cast iron.

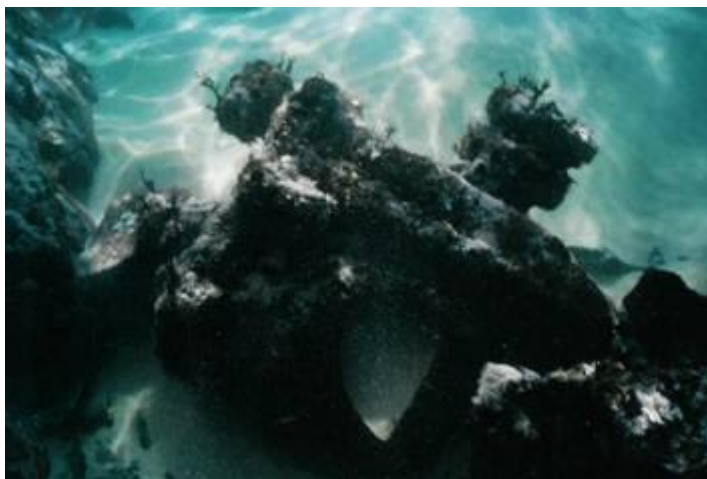
*Figure 8: Second Cylinder. Photo by Sean McMahon*

This cylinder is lying against the side lever and has a half-rounded hole on its side. It also has what appears to be a slide valve attached to the cylinder body. This item is most likely constructed of cast iron.

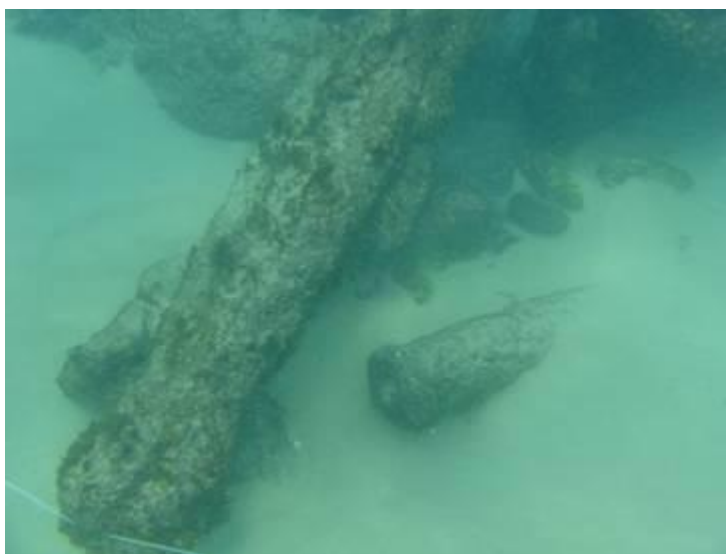
*Figure 9: First Pipe. Photo by Sean McMahon*

Protruding from the sand near the side lever it has an outer diameter of 150mm. This pipe has an unusual shaped flange protruding from one side only. It is difficult to tell what this item is made of due to the thick concretion. This concretion gives the appearance that it is cast iron rather than a more likely copper pipe. During December of 2004 a rounded piece of shiny brass was noticed at sand level between this pipe and the side lever. It appeared to be relatively large under the sand and well secured to the site.

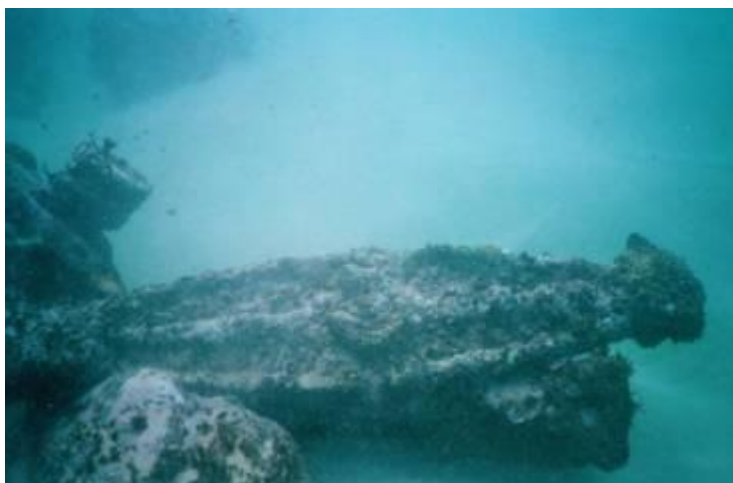
*Figure 10: Side Lever. Photo by Sean McMahon*

This is the most obvious item at the site and the eastern edge of which was used as the datum point for the survey. The lever has a good layer of concretion however the 'design' on the face of the lever is visible. It is two meters long, 400mm wide at the center and 120mm thick with three 80mm holes in it. The center hole appears to be still attached to a section of the engine and comes together near the second cylinder under the sand.

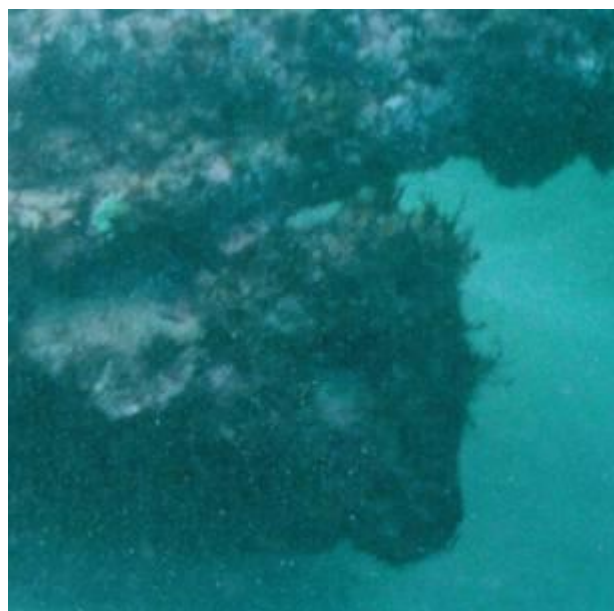
*Figure 11: Second Pipe. Photo by Sean McMahon*

This pipe is located underneath one side of the side lever running north / south. It is the same size as the 1<sup>st</sup> pipe and also has the same strange shaped flange. It also appears to be constructed of cast iron due to the concretion.

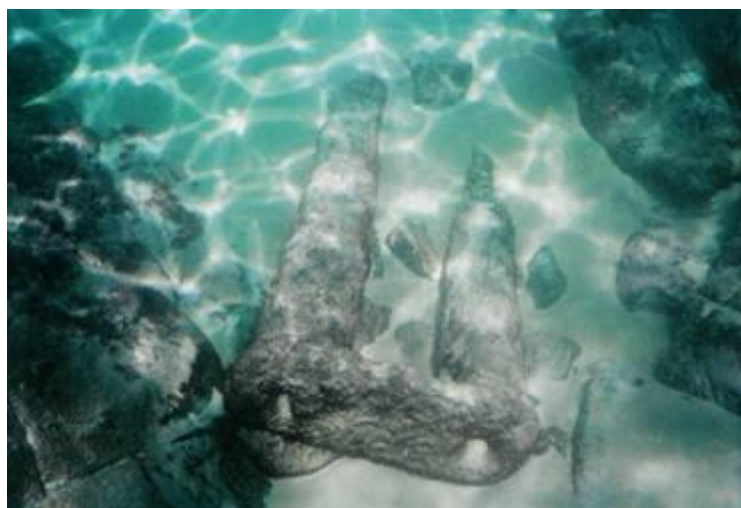
*Figure 12: Joined Pipes. Photo by Sean McMahon*

Located further inshore from the previous items they are protruding from the sand and joined by a long flange. This is a possible explanation for the flanges on the first two pipes. Again they appear to be constructed from cast iron rather than copper due to their size and level of concretion.

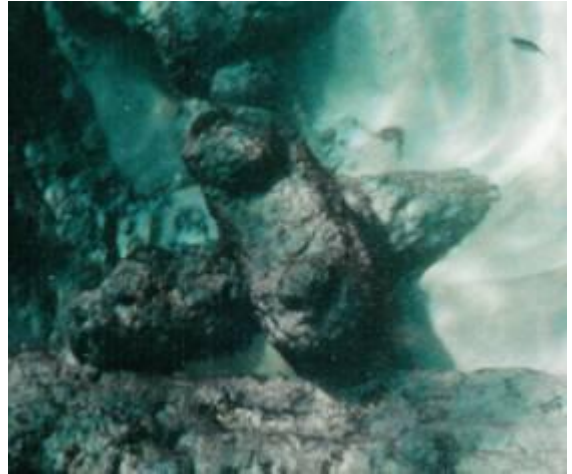
*Figure 13: Shaft and Bearing. Photo by Sean McMahon*

This is an interesting item as it shows a small shaft with a 300mm wide bearing block. Both items are fused together with heavy concretion, which again gives the impression of both items being constructed from cast iron. It would seem more likely that the bearing block should be made of brass but this may not be the case.

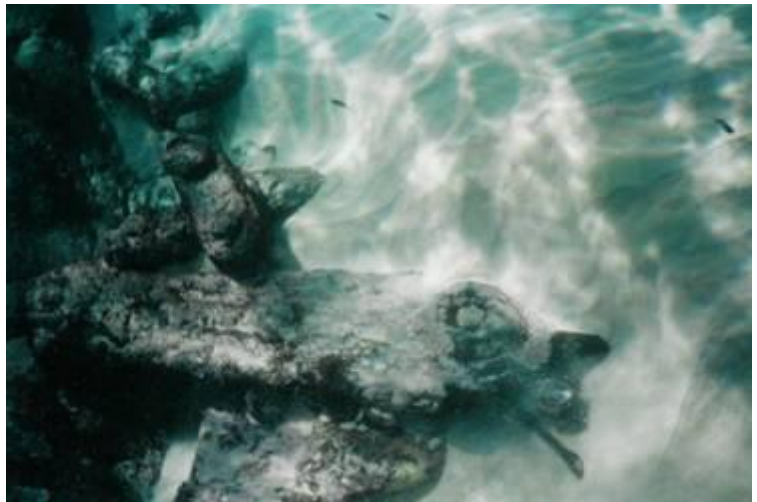
*Figure 14: Lever. Photo by Sean McMahon*

The only other lever visible at the site, it is 1.8 meters long with only two holes. This lever is located with the bearing block and is most likely constructed of cast iron.
