Corrugated roofing

Introduction

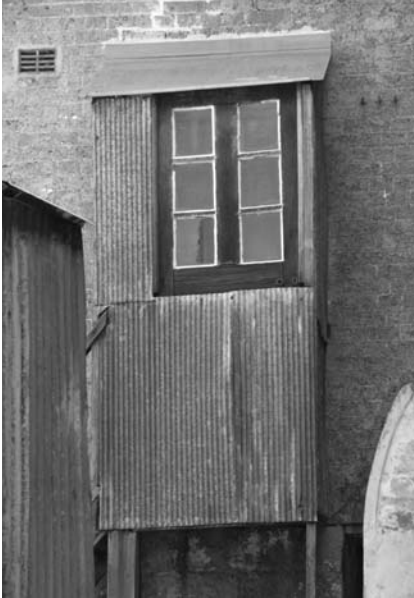
Corrugated sheeting was also used for walls, as at the rear of Susannah Place in The Rocks.

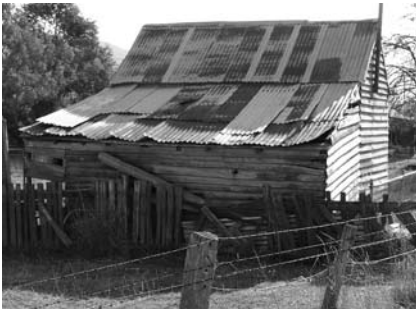
Patterns of rusting on an old corrugated roof.

The single-sheet system often produced uneven coatings and generally the coating was thicker on one surface than the other. The common practice of laying alternate sheets upside down (to save on overlap, if not watertightness) has left us with many old roofs with a striped appearance resulting from the more extensive rusting of the more thinly coated surface. Thicker coatings also occurred at the ends of the sheets. These problems have been largely overcome by continuous processing.

Although only one metal (zinc) is involved, the result is that the less noble area deep in the crevice corrodes in preference to that near the open end. The practical effect is that zinc is lost from the area of the crevice at a much faster rate than elsewhere. This is an important reason why rusting of corrugated sheets usually occurs first at the overlapping joins.

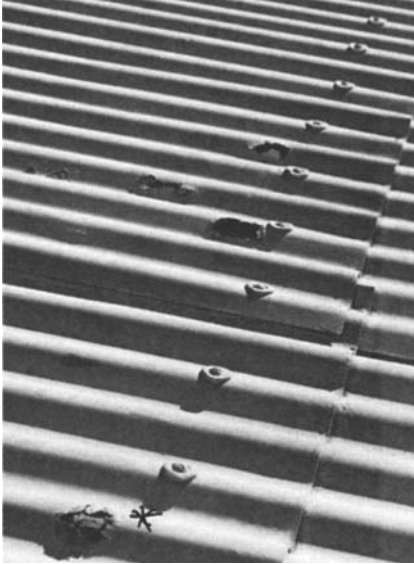
Rusted lap sheets can be repaired by the insertion of a slip sheet.

When lap sheets have rusted around their fixings the insertion of a slip sheet can extend the life of the roof covering. This can be a metre length of matching profiled corrugated sheeting placed between a rusted lap joint. It protrudes 100 mm below the lap joint and is secured on the adjacent corrugate.

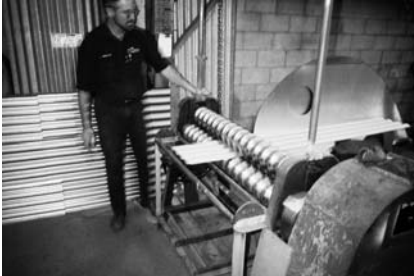
Re-rolling corrugated steel sheet to remove imperfections, Parramatta Tank Works.

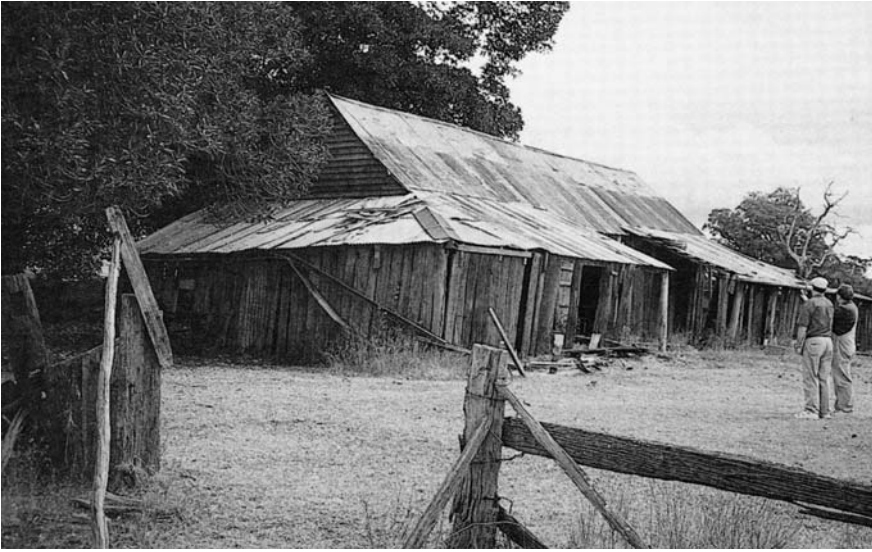
With weathering, the traditional shorter length of corrugated sheets can be seen on timber barns at Bella Vista, Kellyville.

These advantages need to be weighed against the change in appearance that full-length sheets bring. On steeply sloping roofs of short sheets the joints can be seen as the shadow line of the overlapping sheet and, less obviously, the additional nailing needed at the joint. These provide a distinct horizontal element to the appearance of many roofs and their loss may lead to a change in the character of the roof. On the other hand, there can be little objection to full-length sheets on planes of a roof that are not readily visible.
